LOCK-N-STITCH Inc.
 Casting Repair Specialists
 1015 S. Soderquist Rd.
 Turlock CA 95380

Final Report

Part: 10 x 10 Discharge Head Mfg. Marcy

Serial number: #18

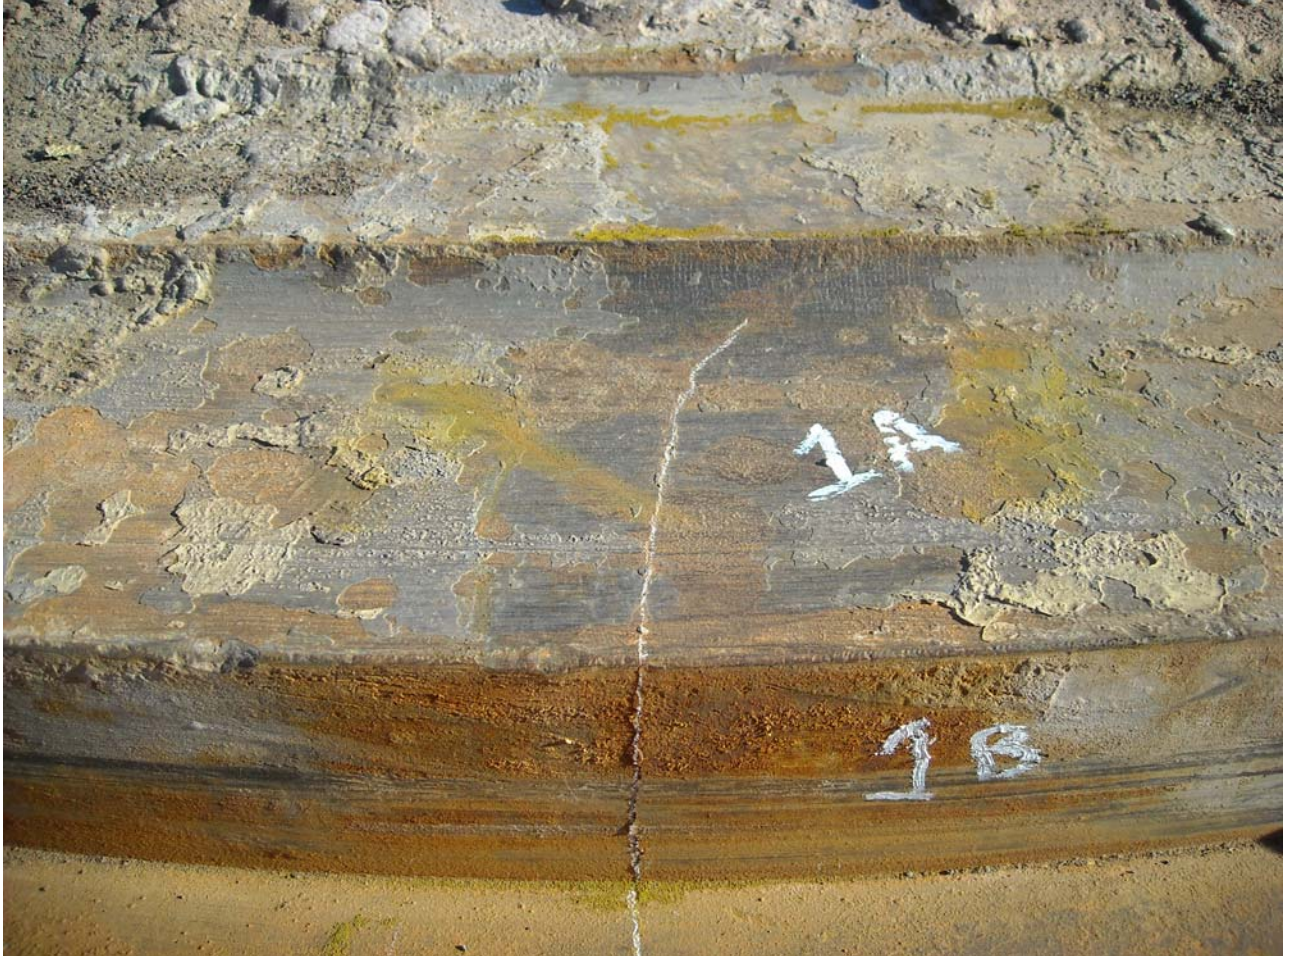
1A and 1B

Crack starts at 1A, measuring 4.5" long. It proceeds onto surface 1B, and measures 2.75" long. 1A is in rough casting, while 1B is a machined surface.

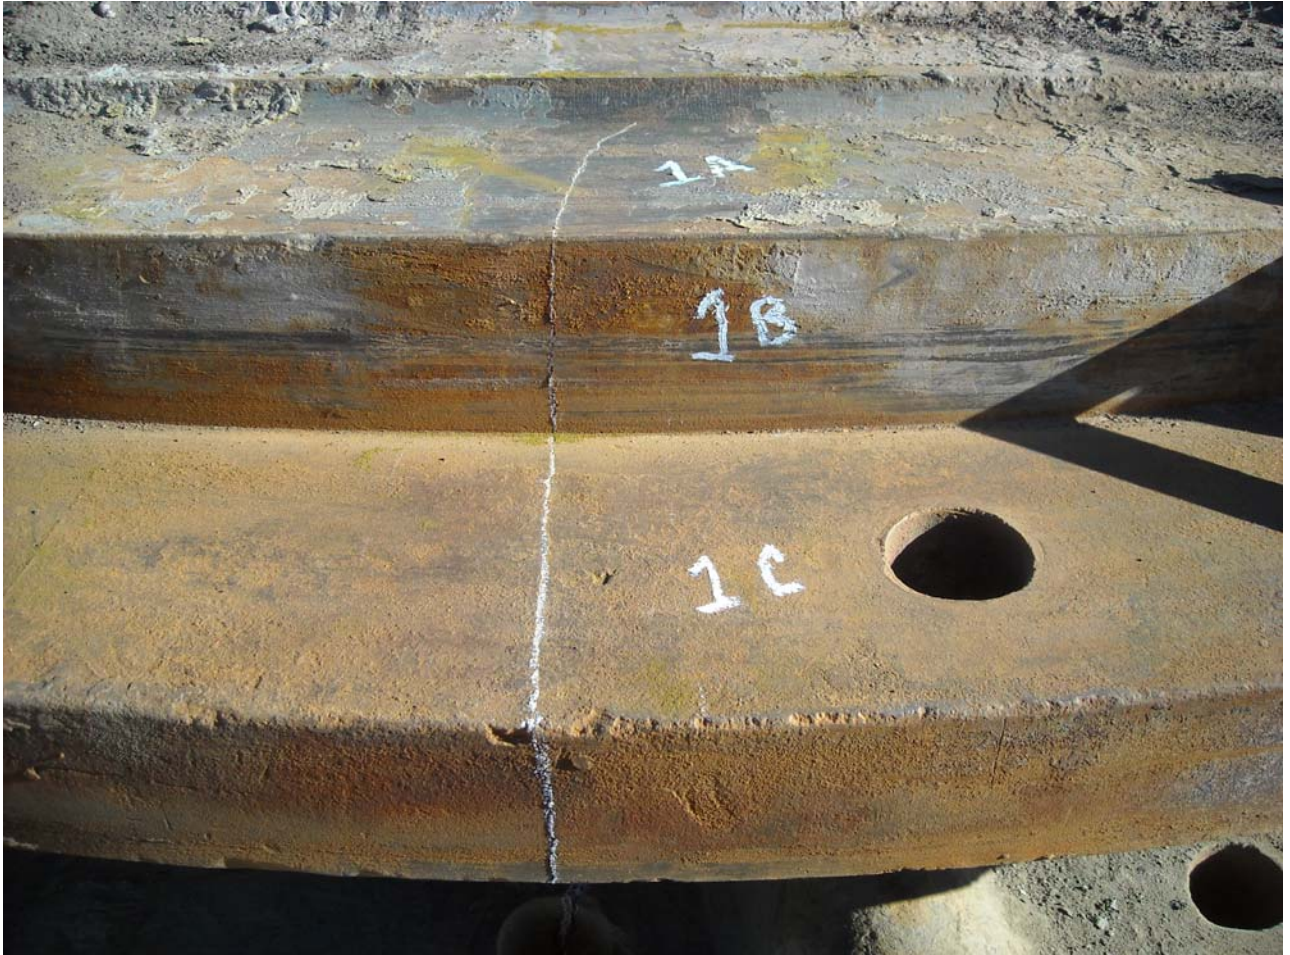
1C

This is the top flange with thru-hole bolt holes. The crack runs through the flange completely. Measurements of the flange are 5.125" x 2.5" thick. Crack measures 3.75" from the hole shown.

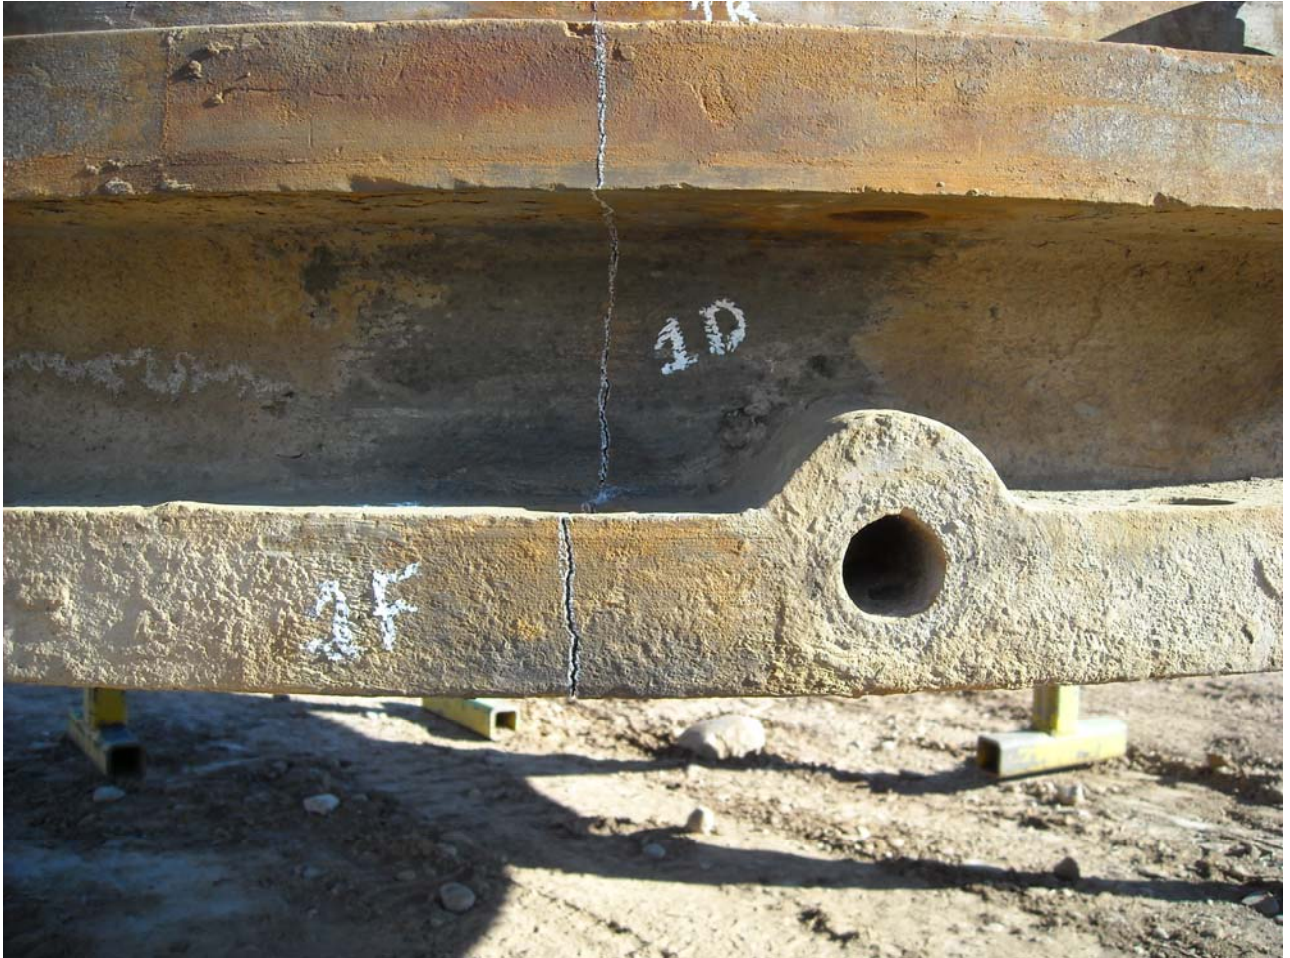
1D

Crack is 5" long before it runs into lower flange. Crack is 3" from hole shown in this photo.

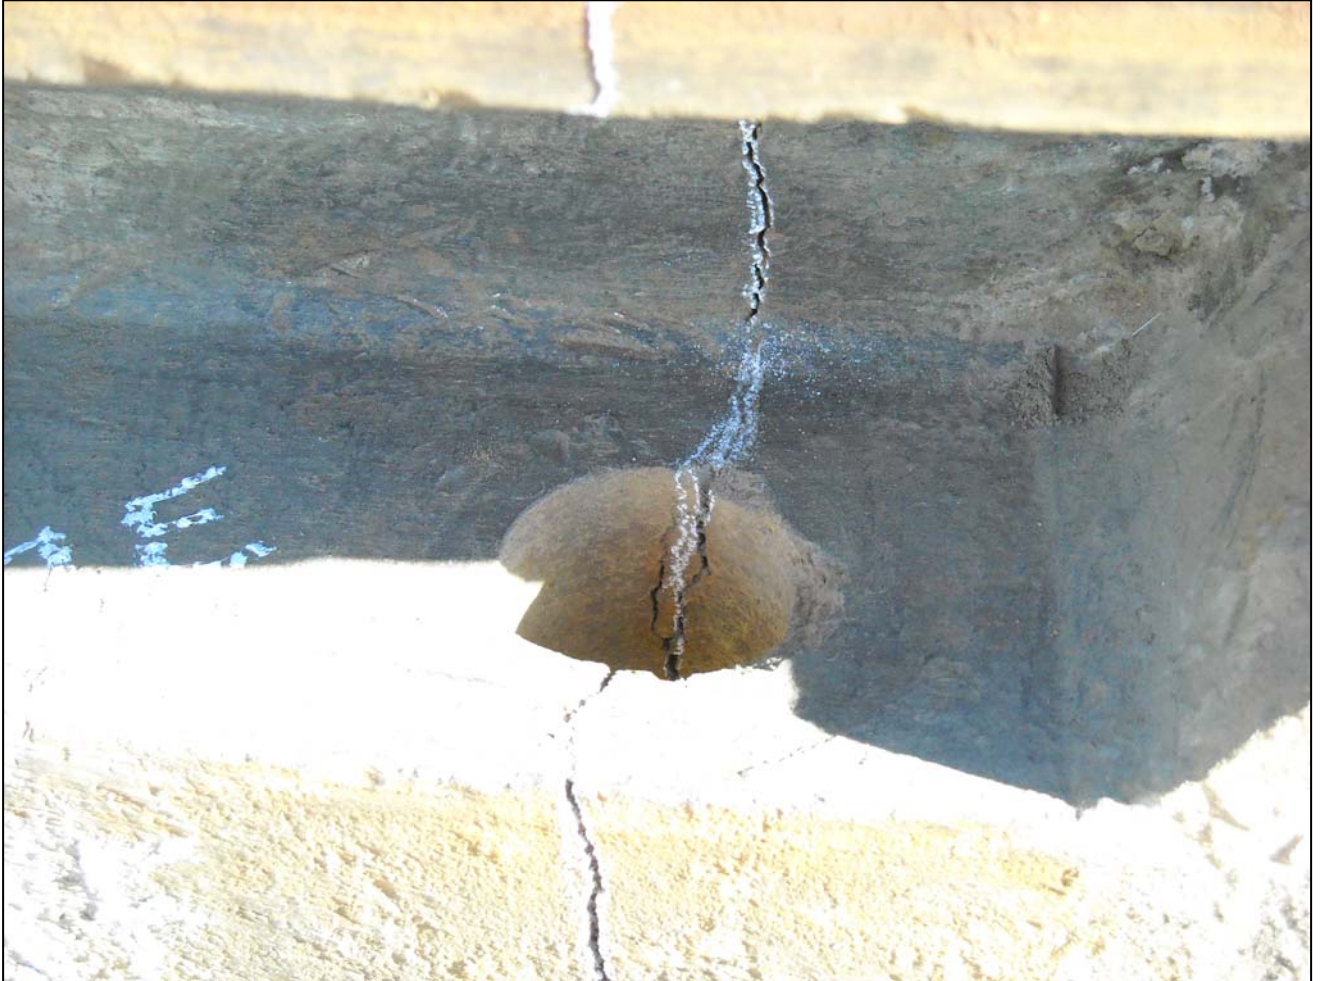
The crack then runs through the thru-hole bolt hole. The bolt hole measures is 1.620 x 2.75 deep. The lower flange is 3.75" x 2.75" thick.

Metal stitched 1E using (1) C4C stitching pin and (1) C3C stitching pin.

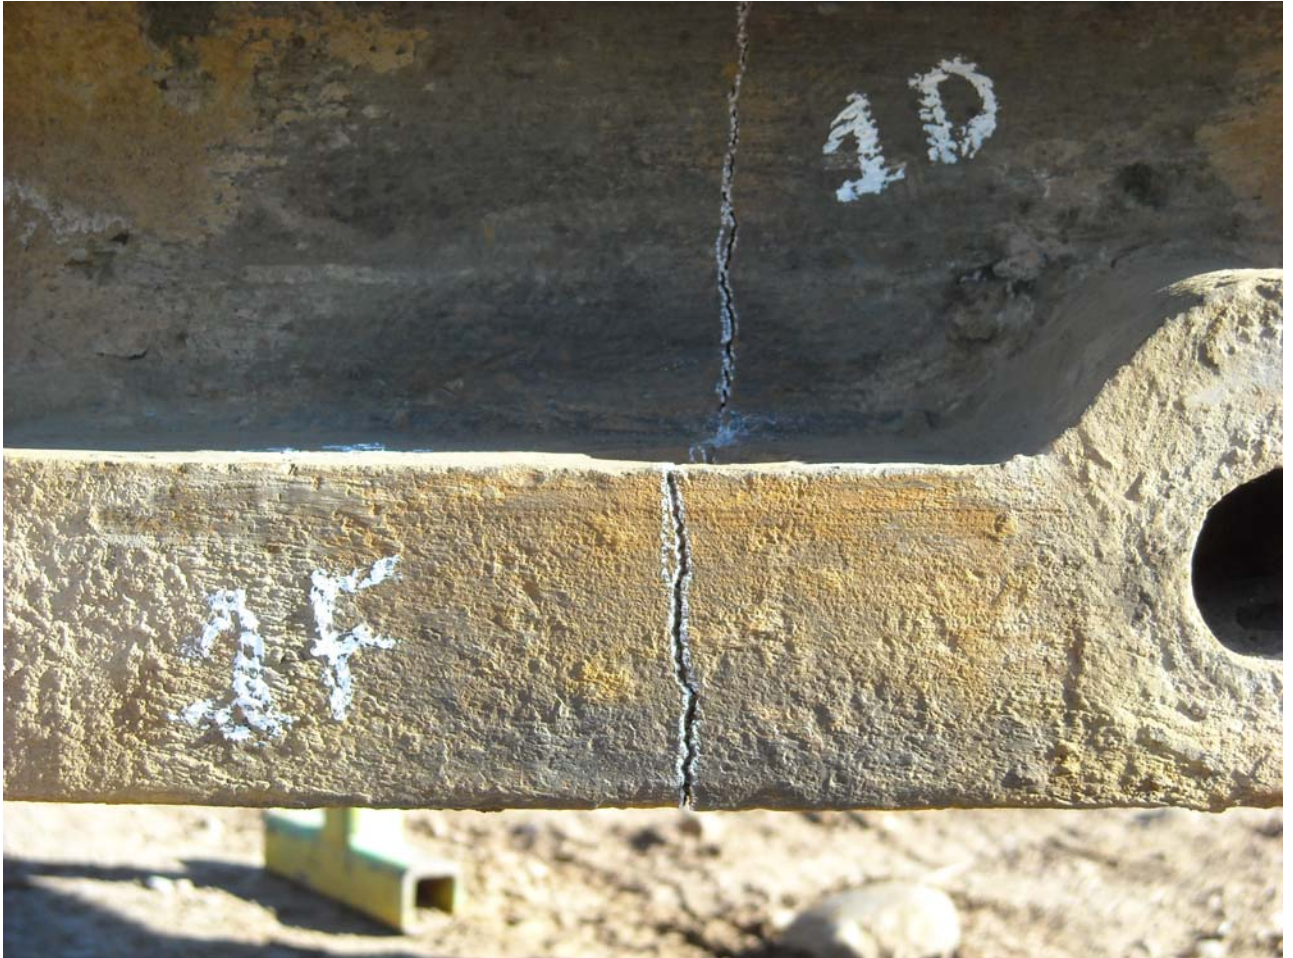
Shows the thickness of the lower flange (2.75" thick)

Metal stitched 1F crack, 2.75" long by 0.5" deep, using C2.5A stitching pins.

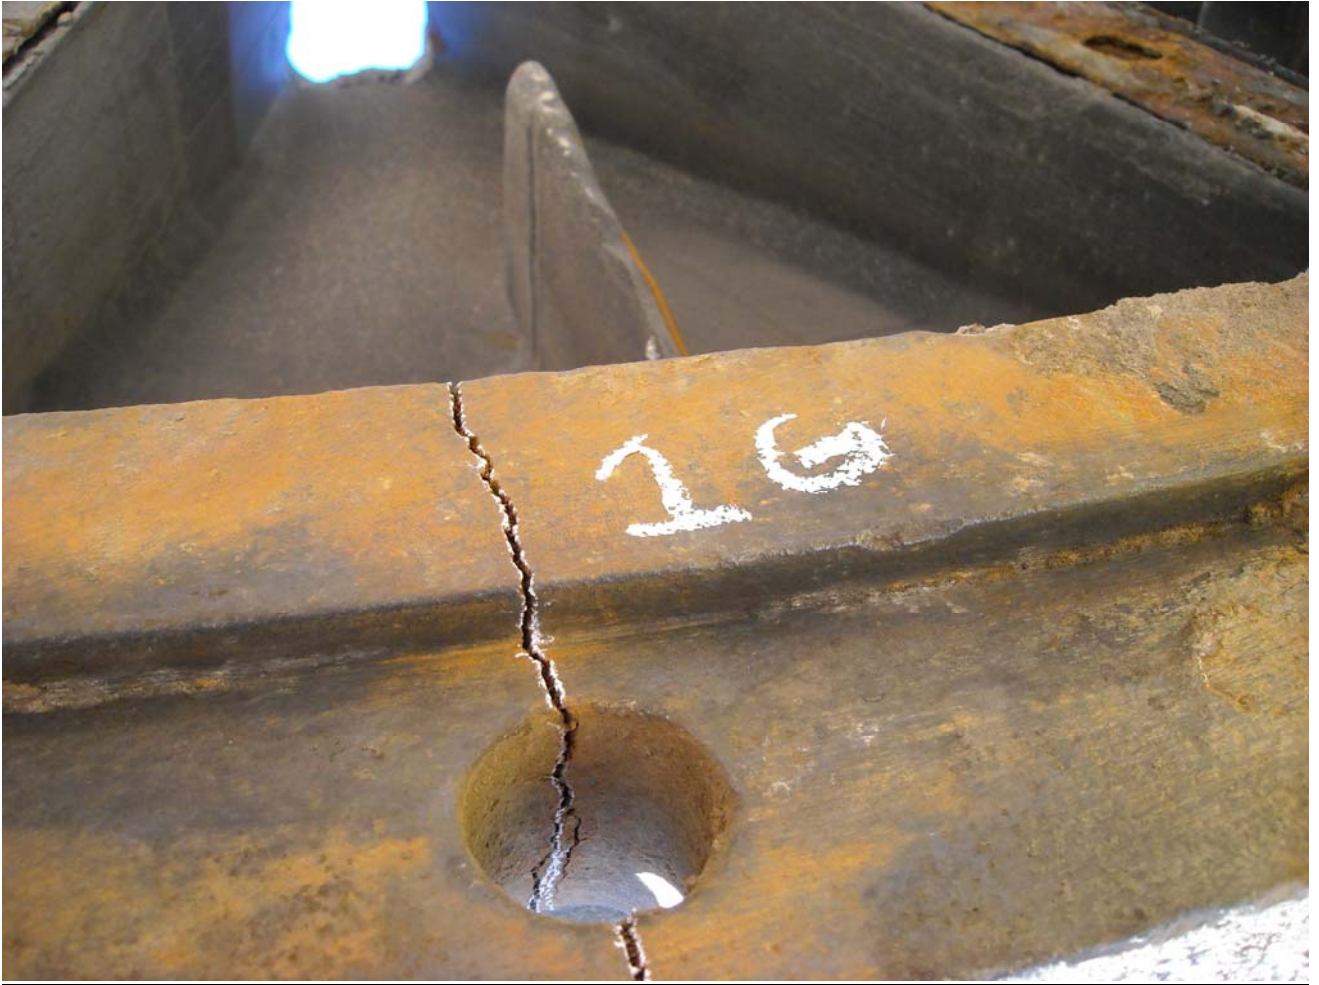
1G

This is the surface on the bottom, next to the lower flange. It measures 2.75”.

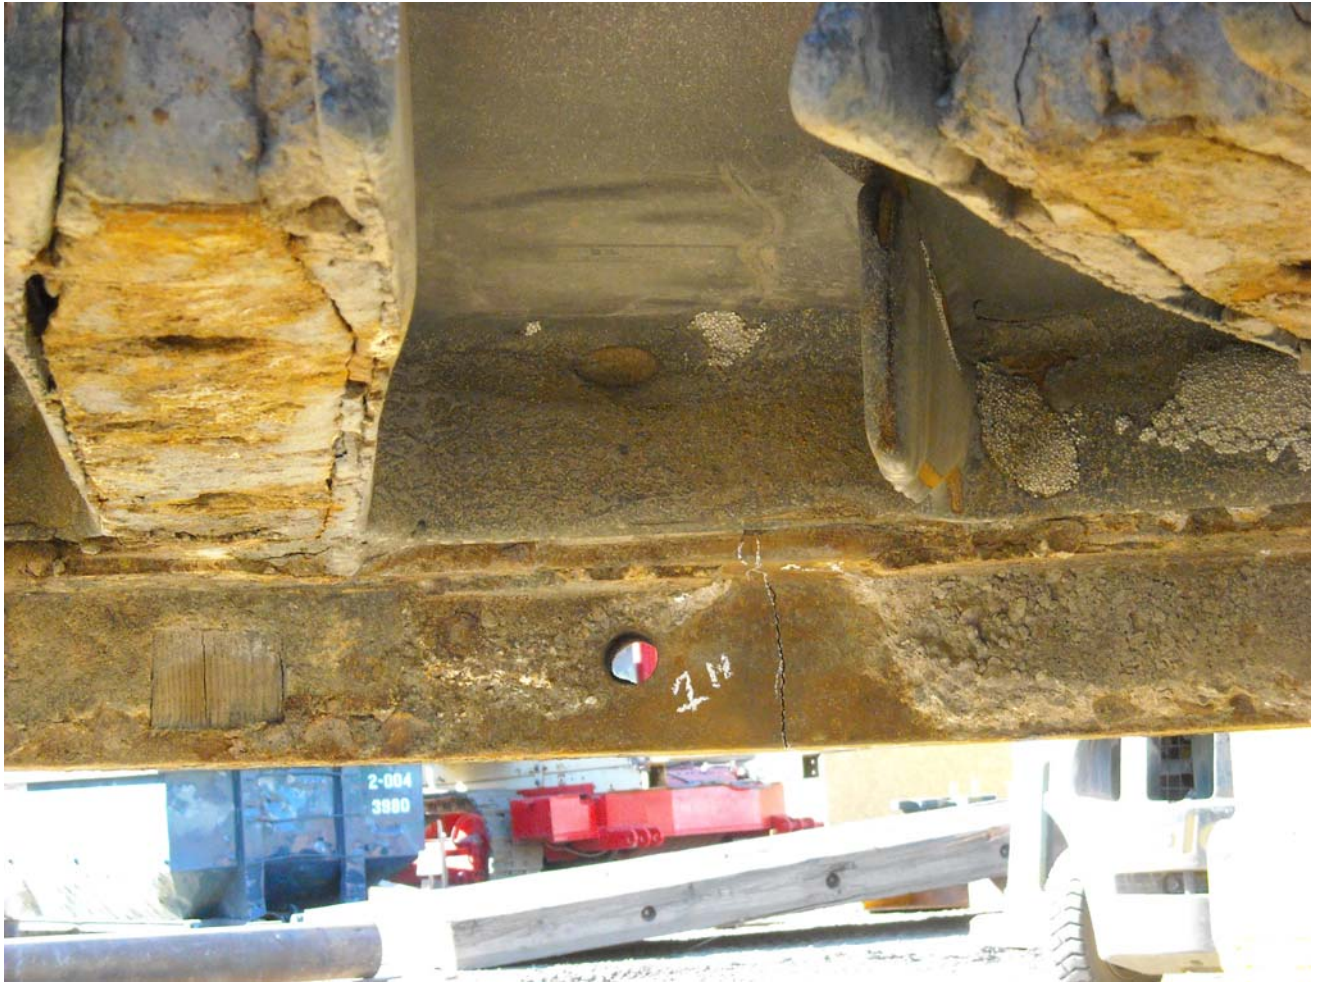
1H

This is the back side to 1D (or inside the Discharge Head). It measures 4.5”.

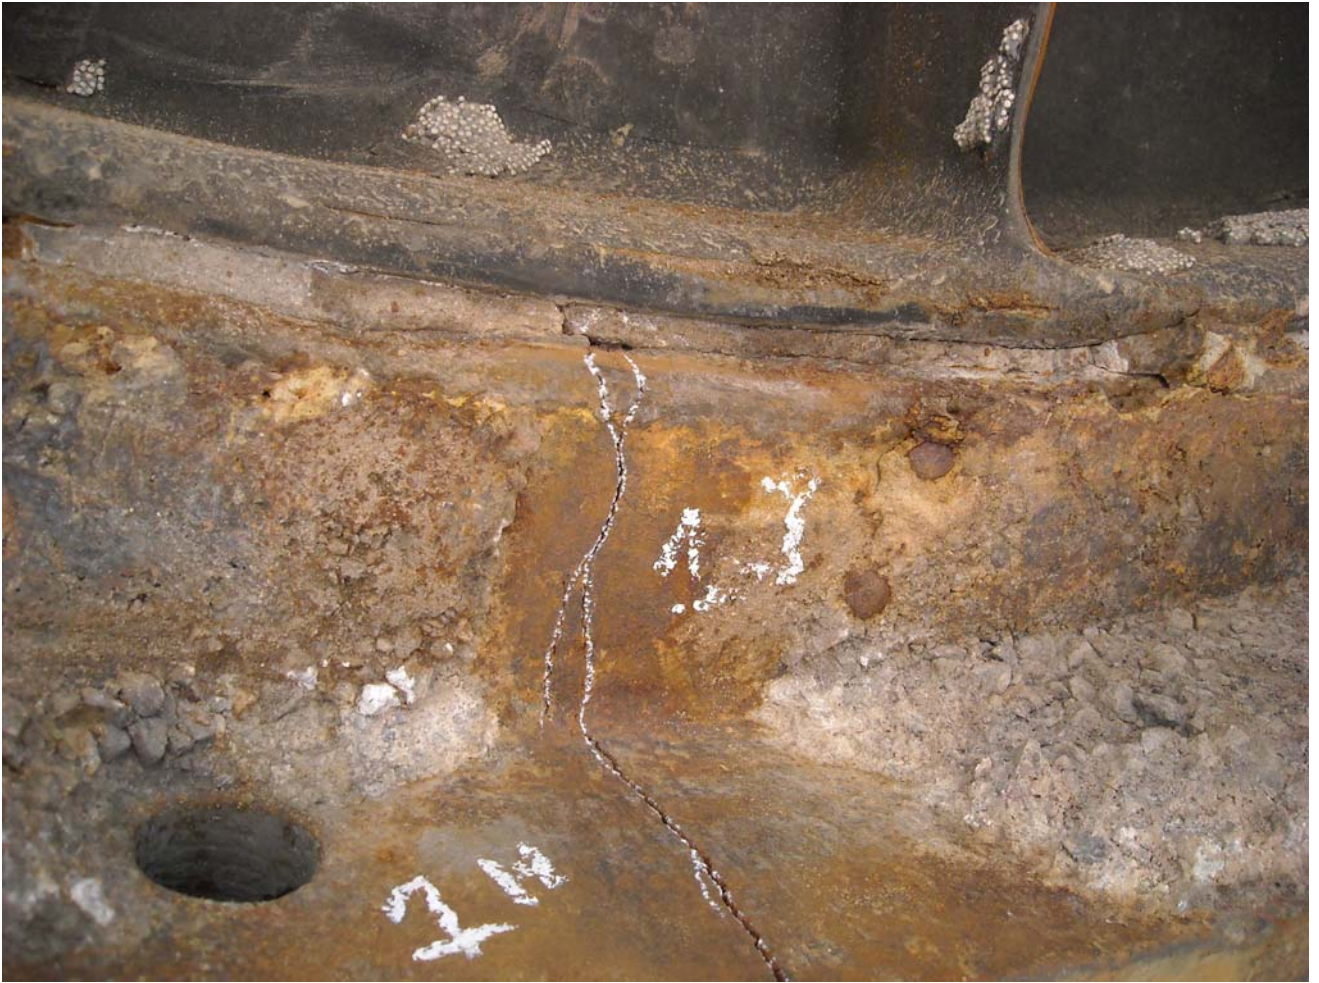
1J

Measures 3.75" before it turns up behind the liner. They are removing the liner for more measurements.
