100 year old statue
broken by vandalism
is shipped to our
facility to be welded
back together. This is
the top half.

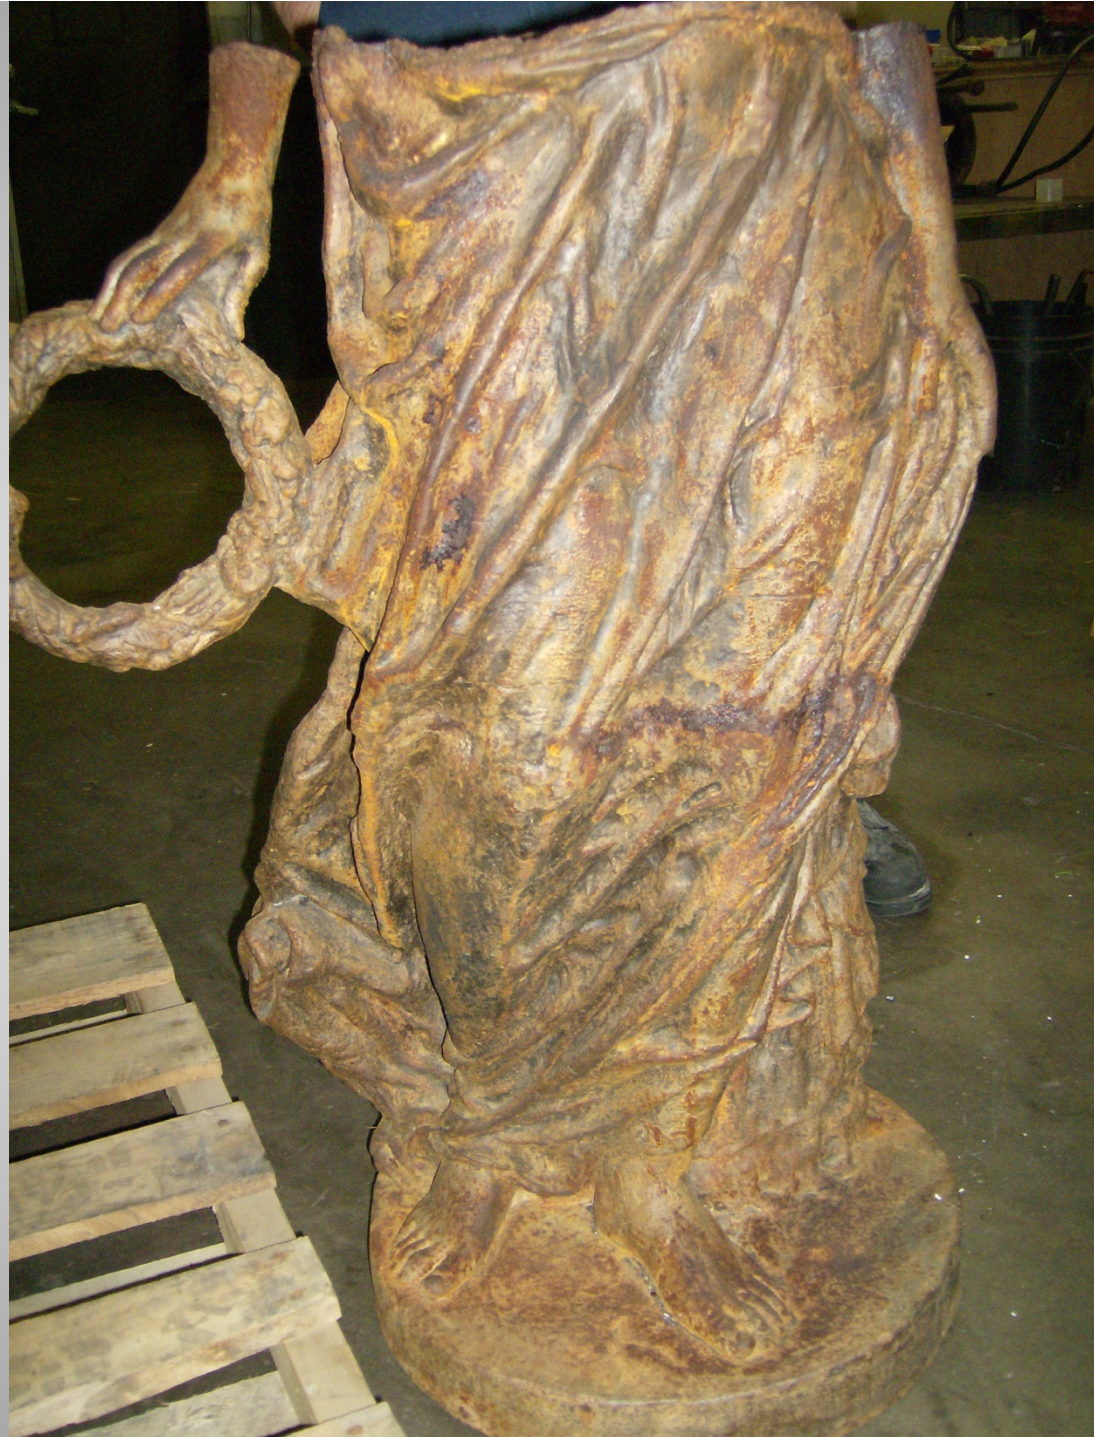
Bottom half of
statue that will
be welded
together.

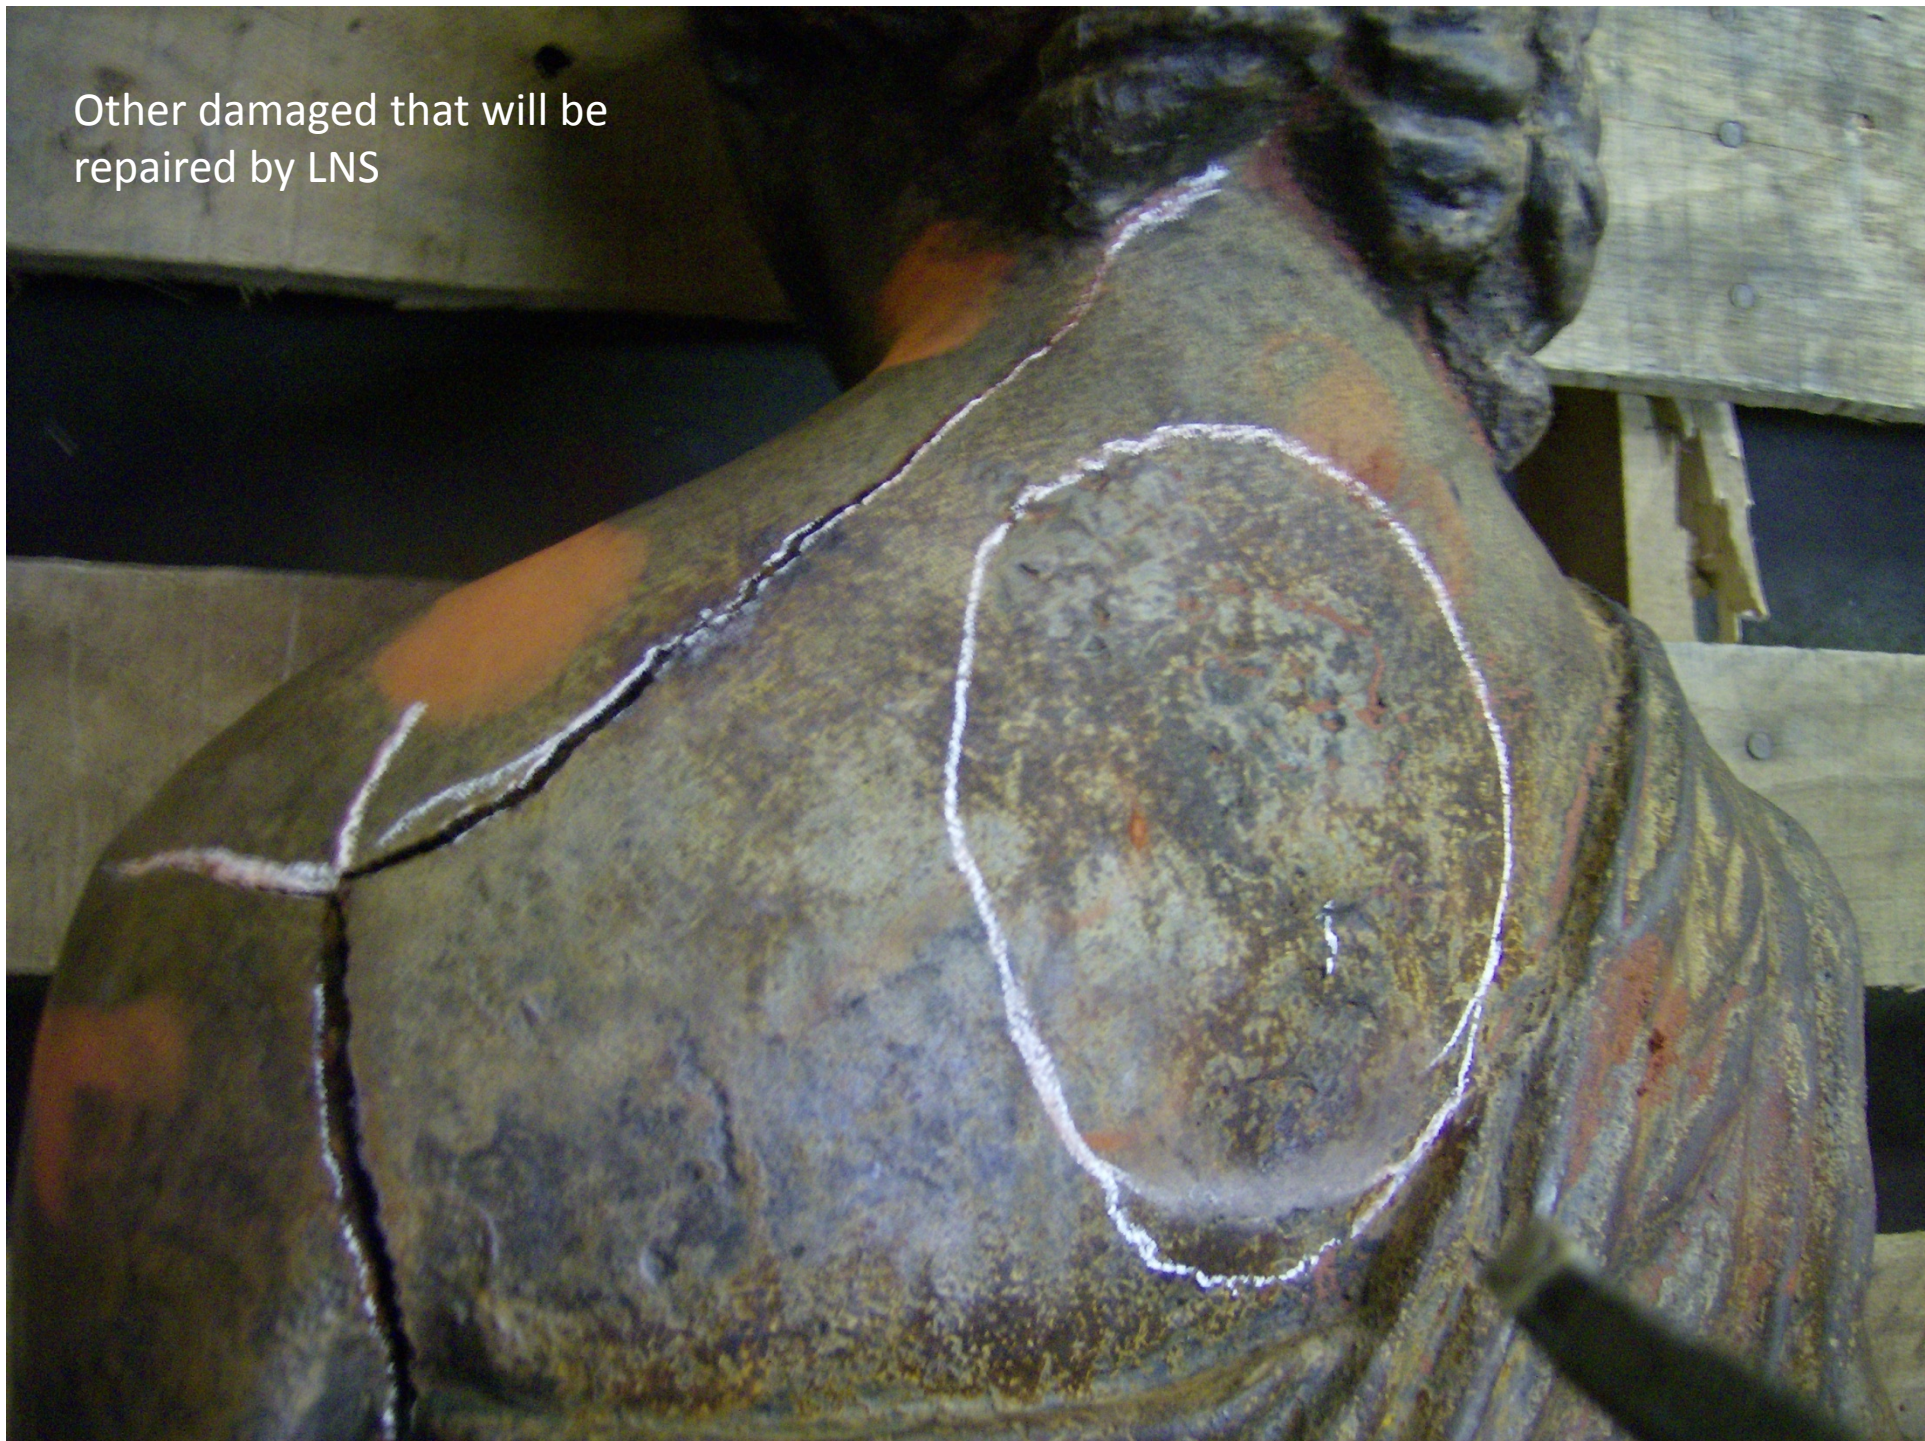
Other damaged that will be repaired by LNS
