LOCK-N-STITCH Inc.  
Casting Repair Specialists  
1015 S. Soderquist Rd.  
Turlock CA 95380

## Inspection Report

Customer: Chevron \_\_\_\_\_

Part: K550 Diaphragm #4 and #5 \_\_\_\_\_

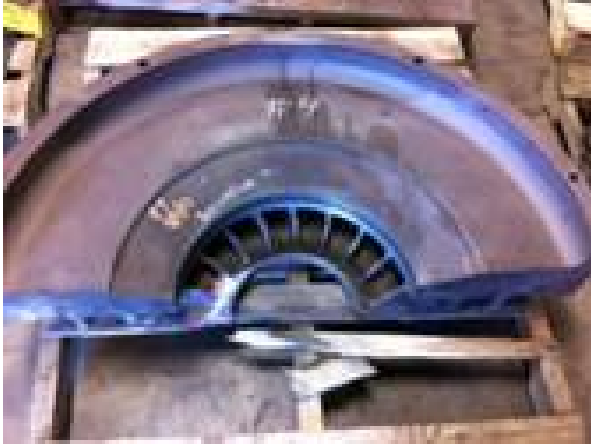
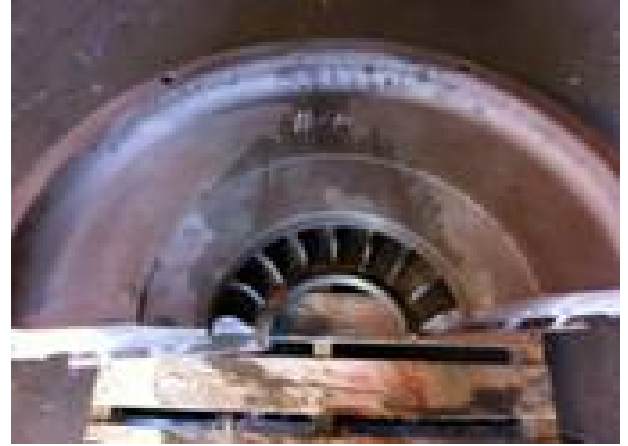
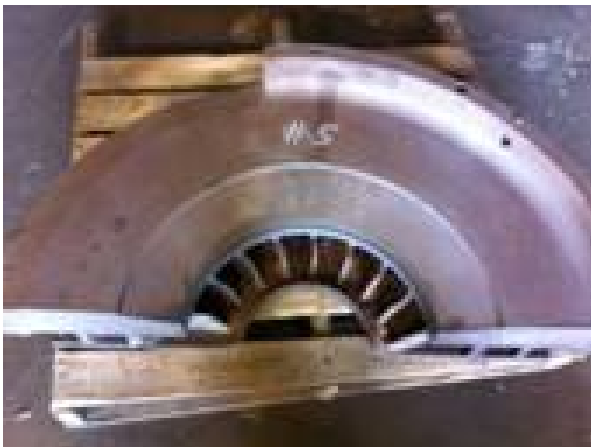
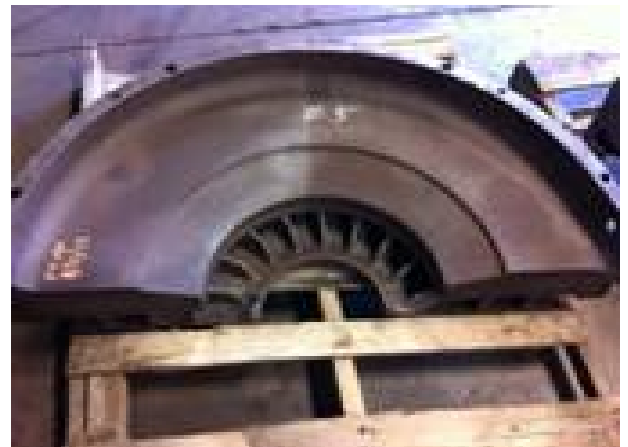
Damage found: When receiving Diaphragms into *LOCK-N-STITCH* facilities the parts were inspected. We found cracks and breaks and one welded area at the split line and in the labyrinth ring grooves.
