Cooper Bessemer LSV 20 Crankshaft repair

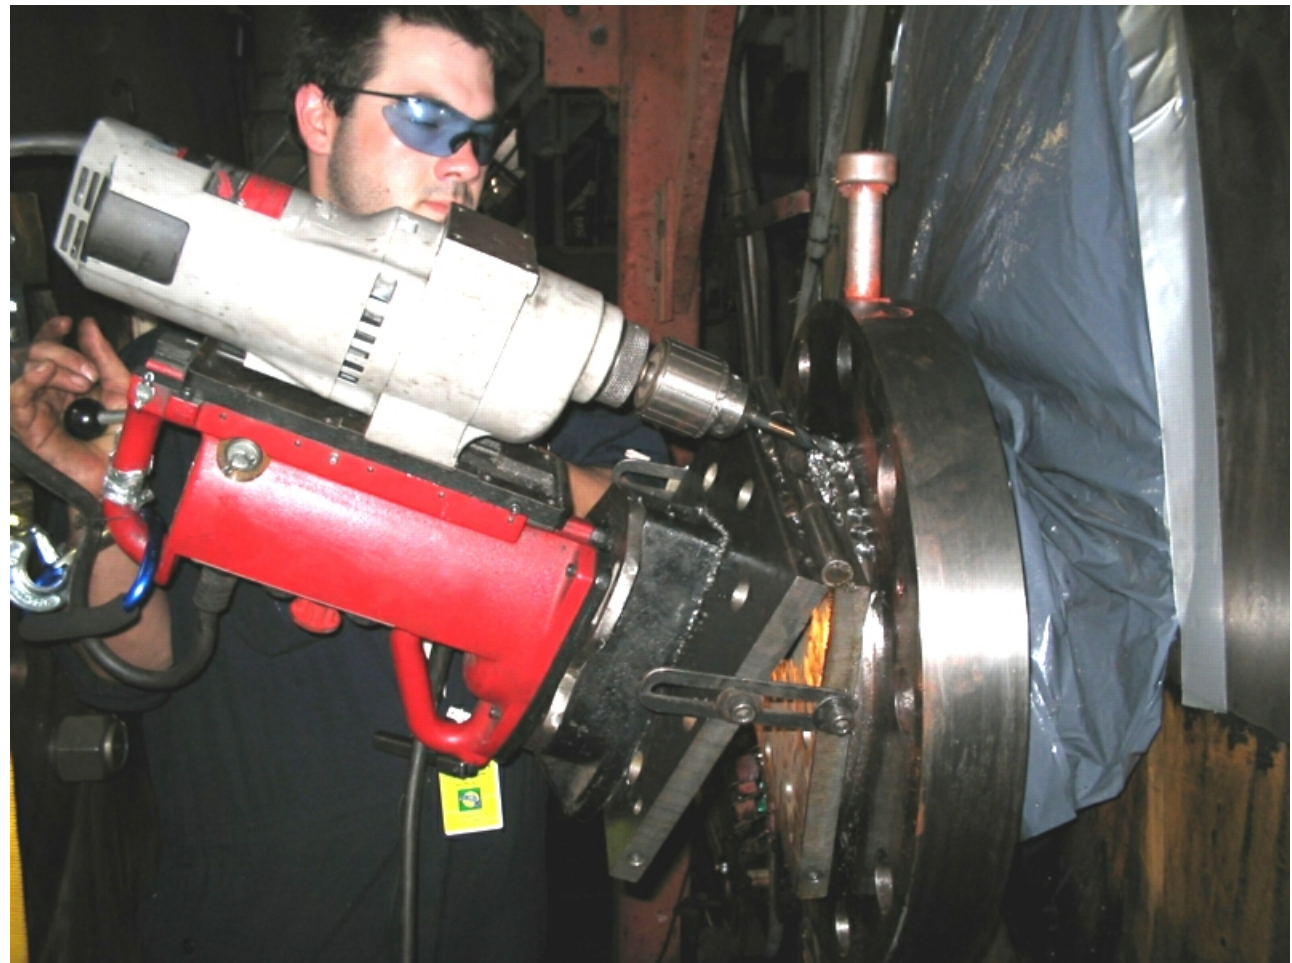
Stitching the crack

The crack was found to be 3" deep over most of its length

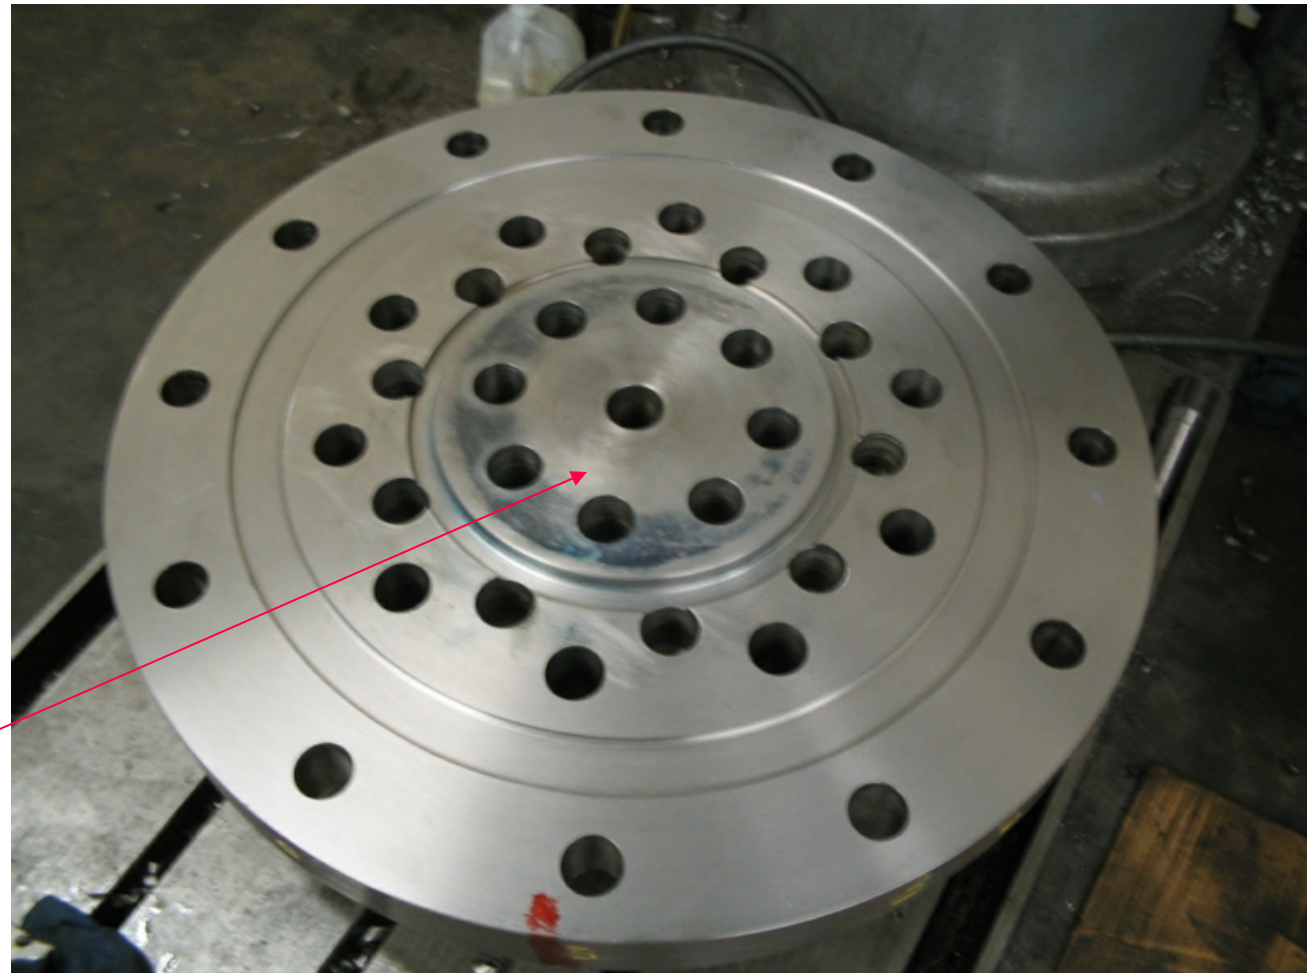
New adapter plate and flywheel are mounted to the crankshaft

8 new holes were drilled and tapped into the crankshaft to accept bolts for additional strength.

New oversize stretch bolts were manufactured and installed through the crankshaft, spacer and flywheel

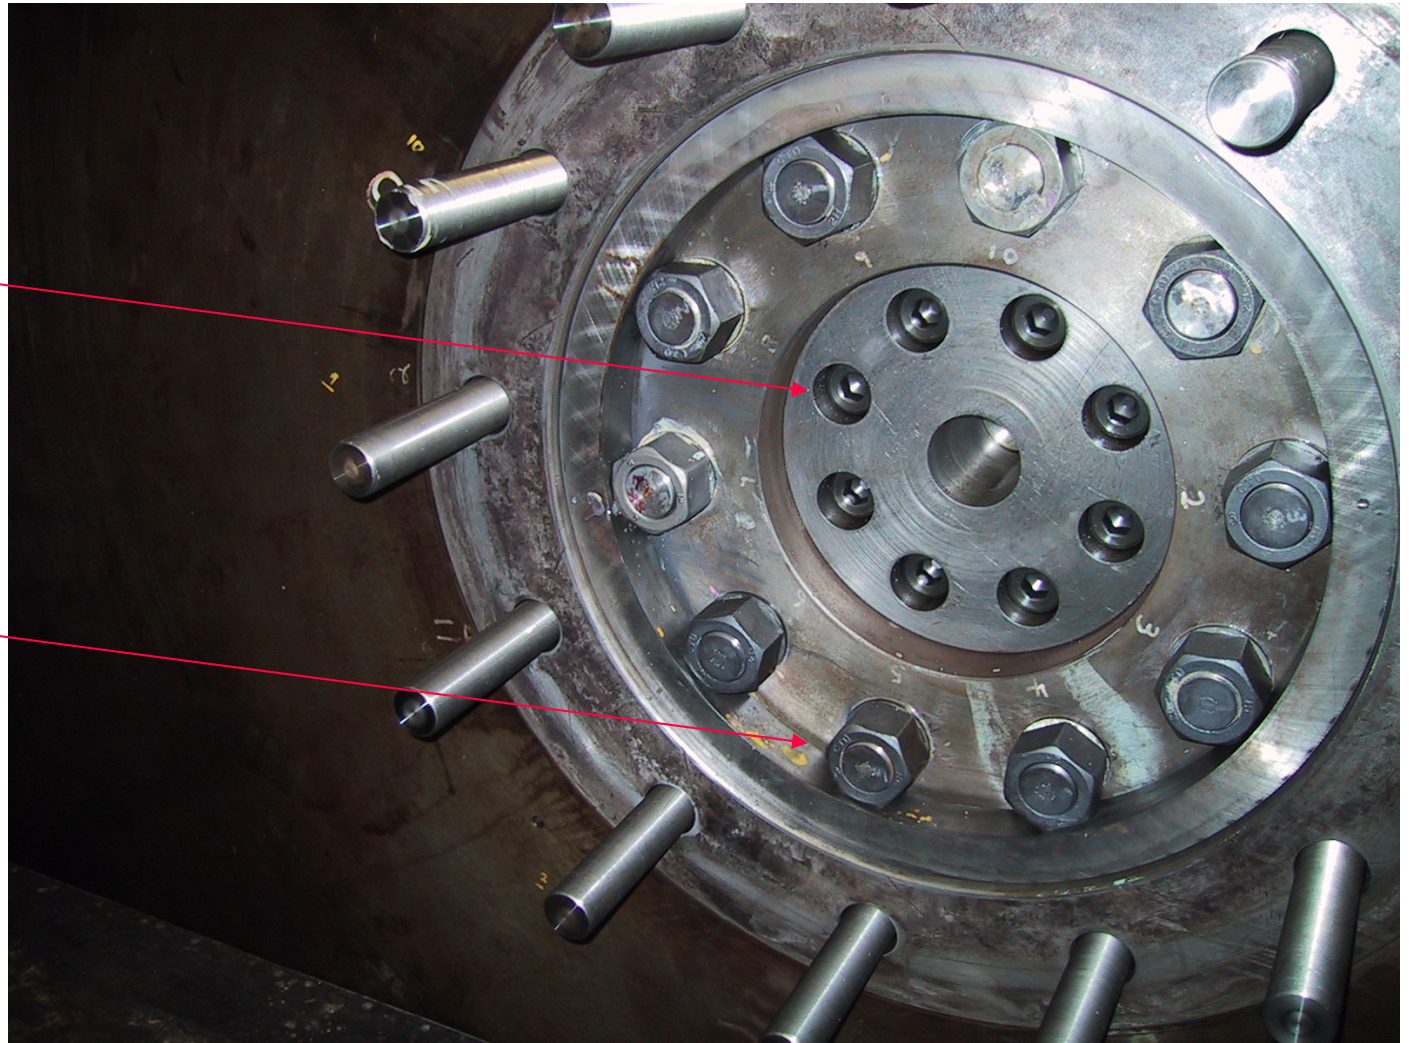
Assembly is complete and the unit is placed back on-line
