Damaged Cooper compressor frame

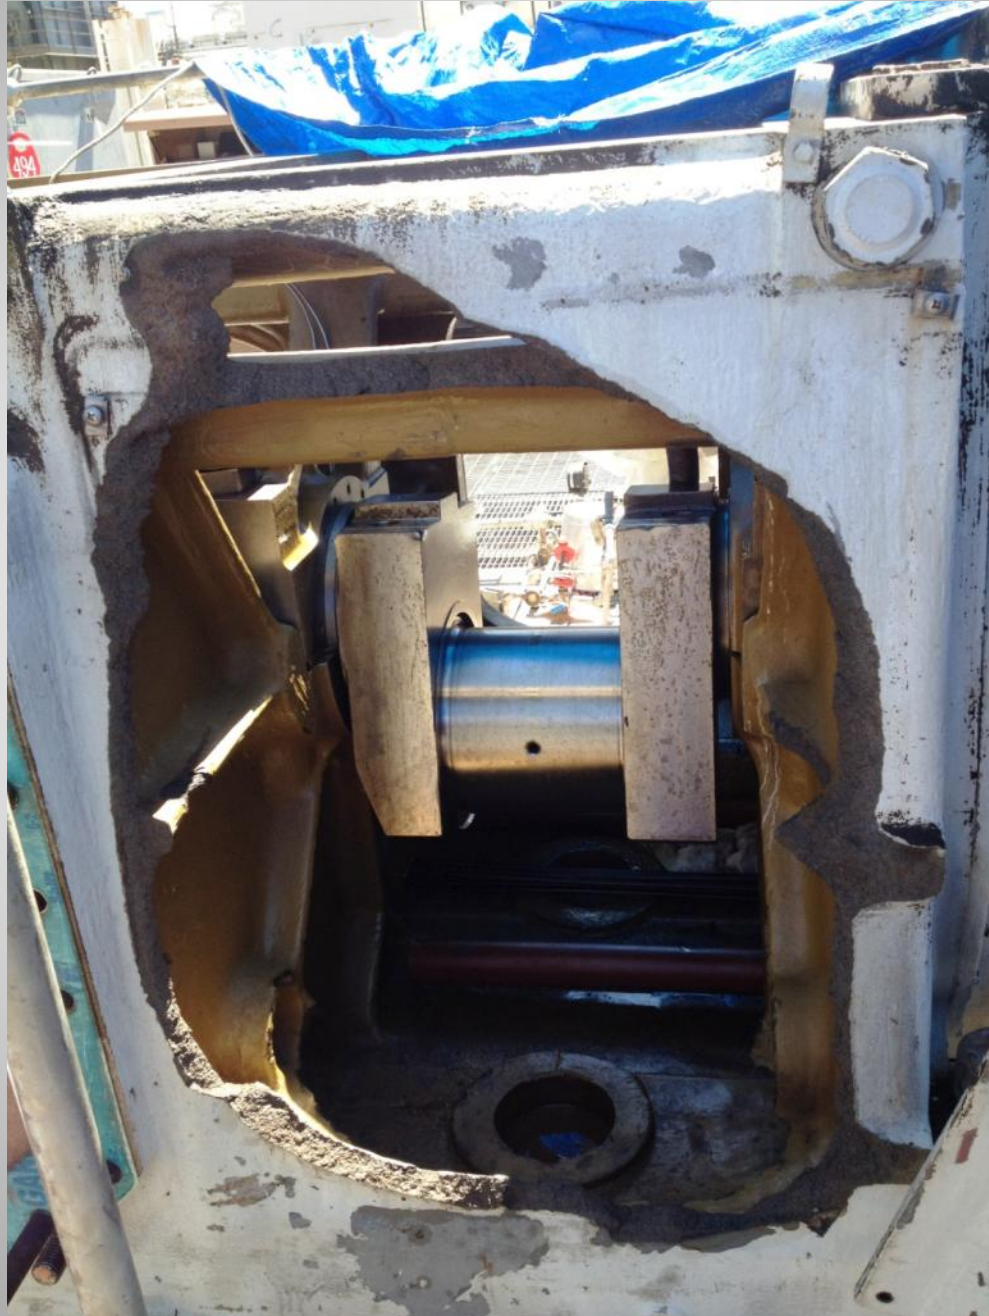
Frame damage that was seen on initial inspection on-site

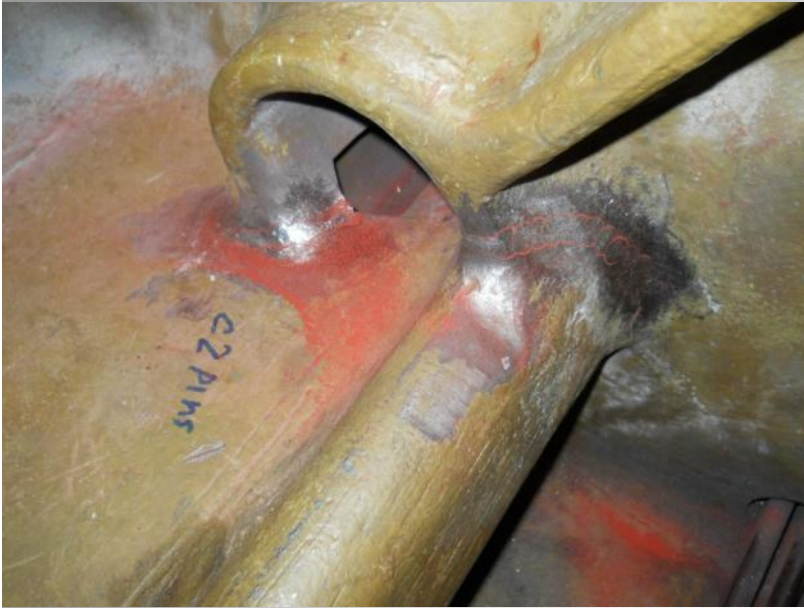
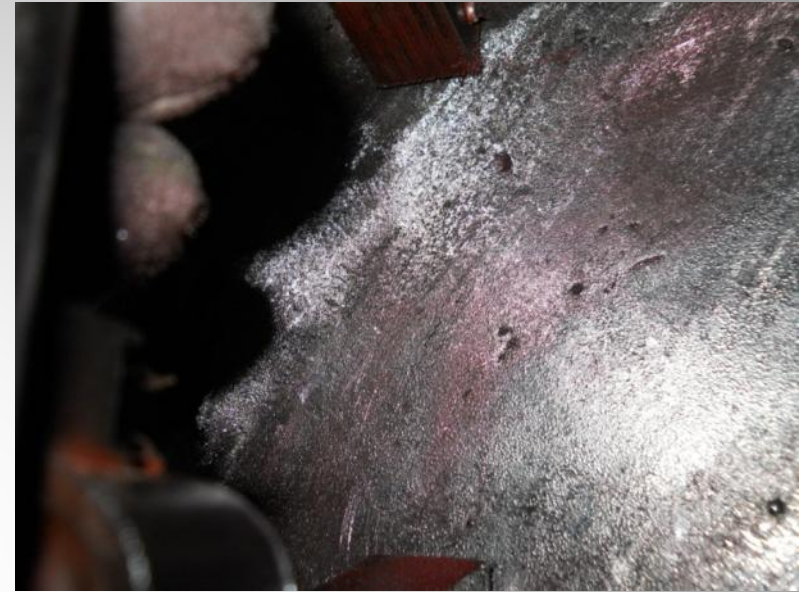
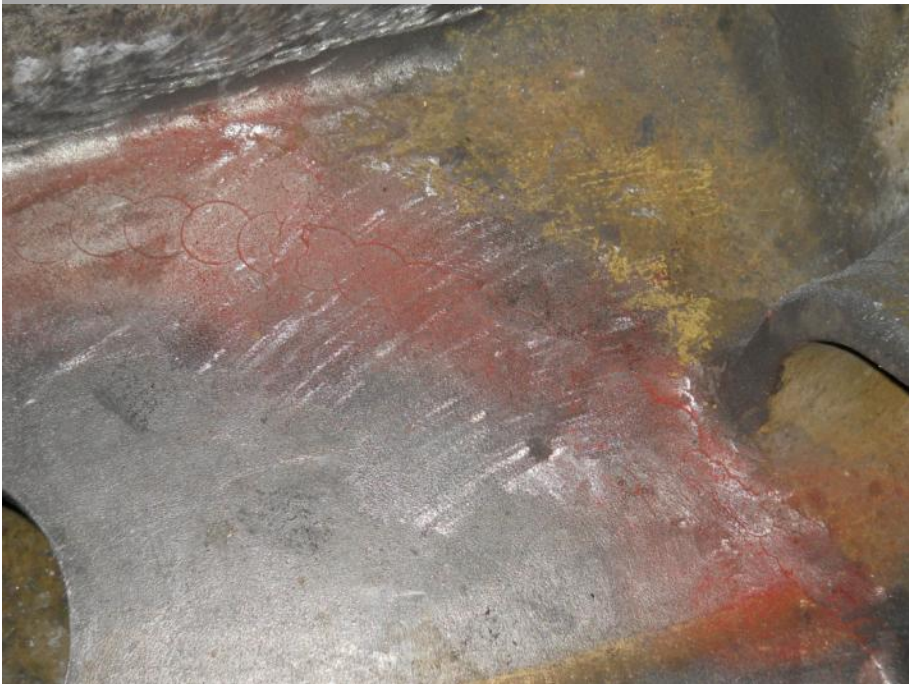
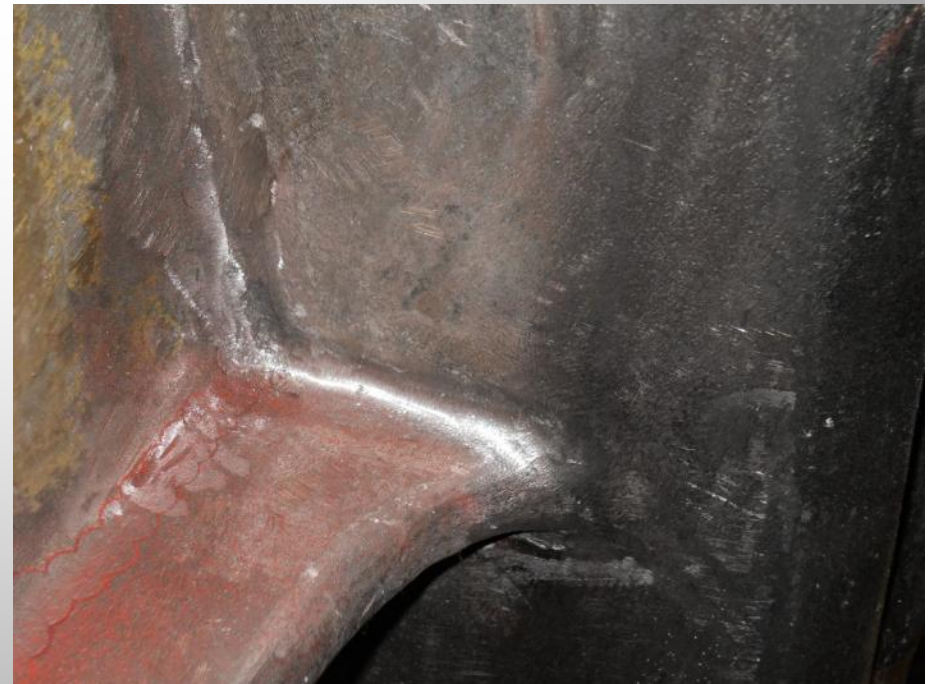
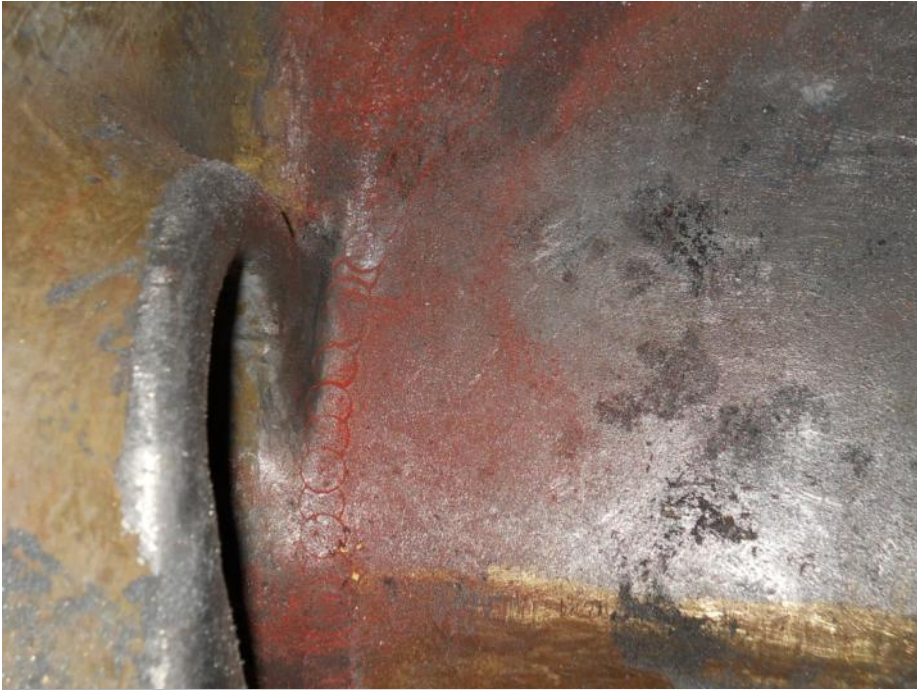
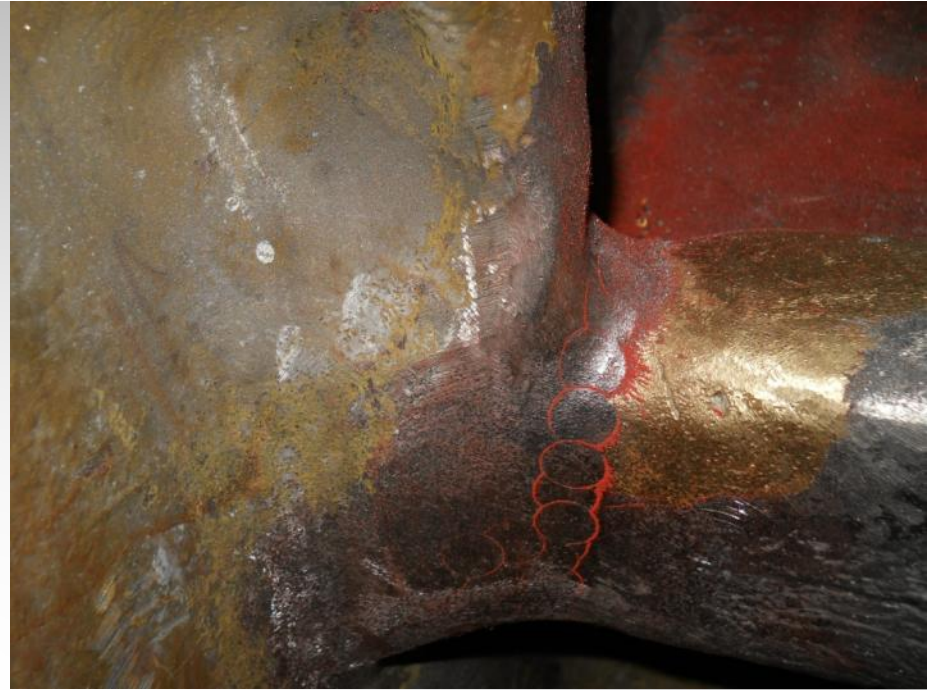
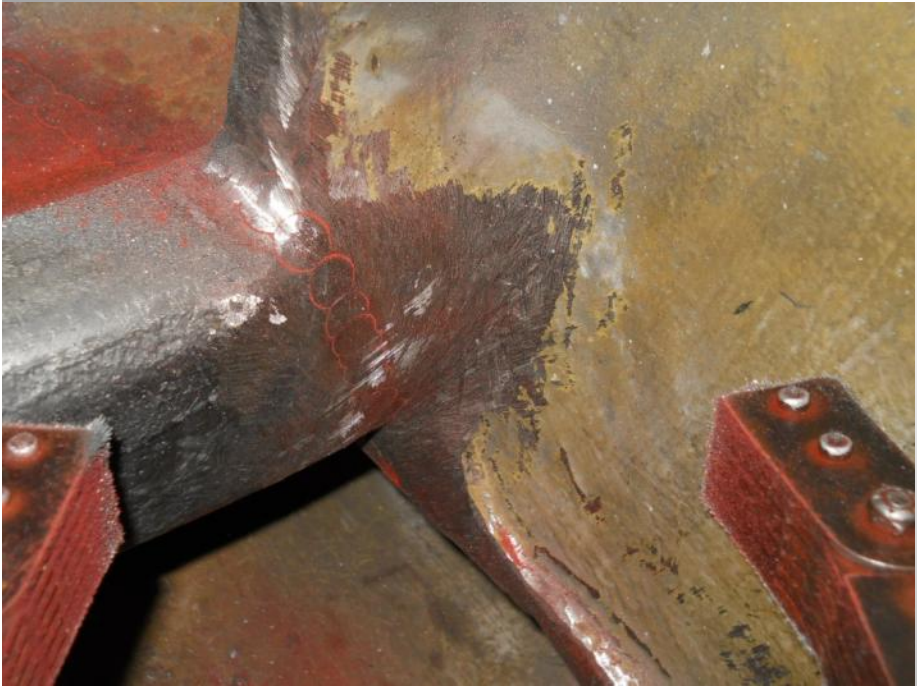
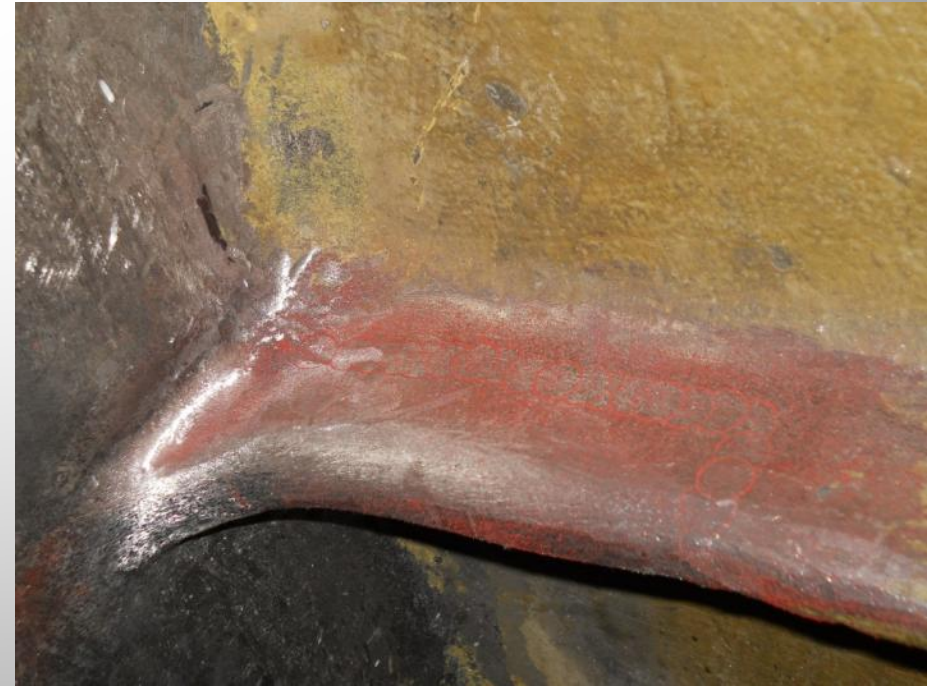
All repairs where Mag Checked to make sure that all damage was repaired
