Cruise ship damaged engine repair

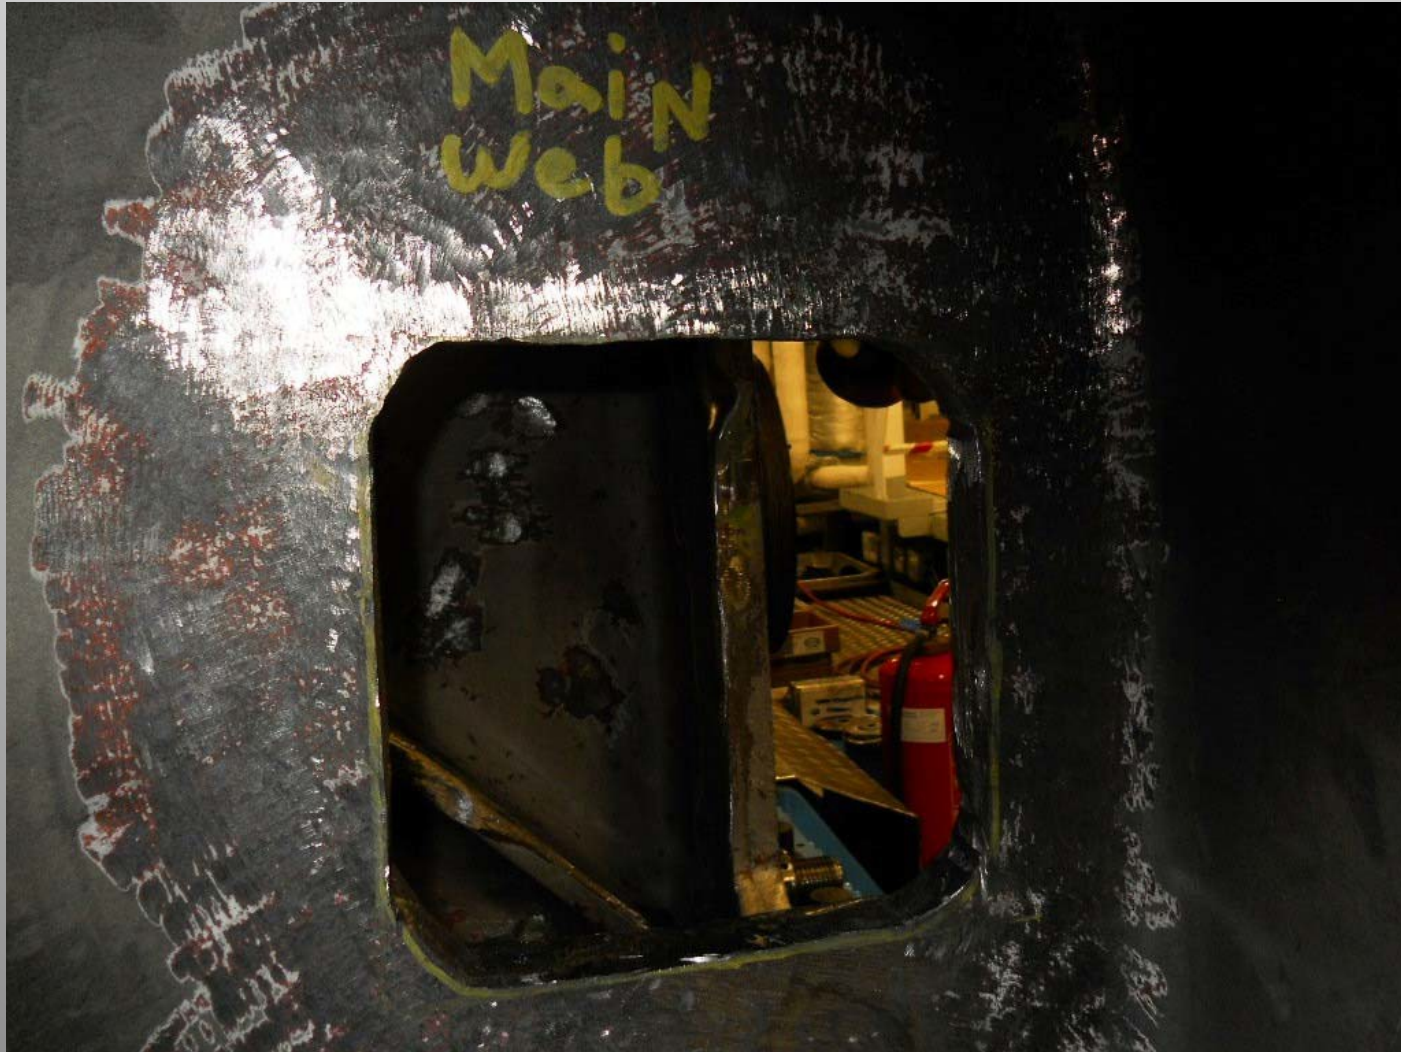
Damaged area removed

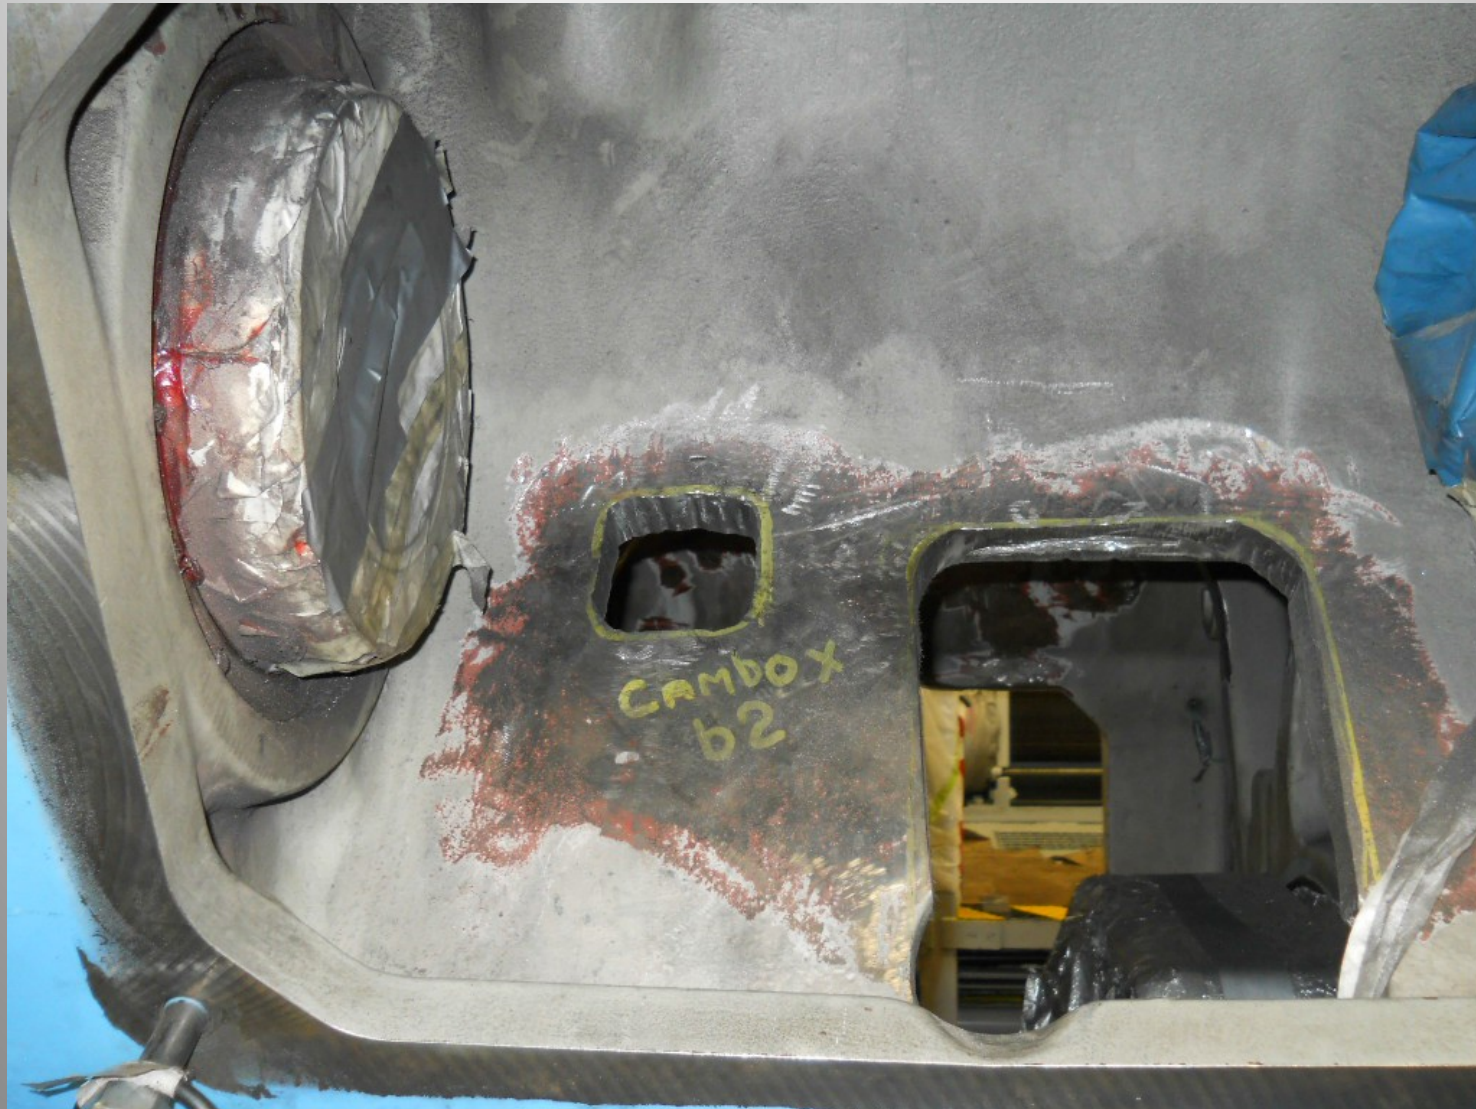
Ready to accept patches

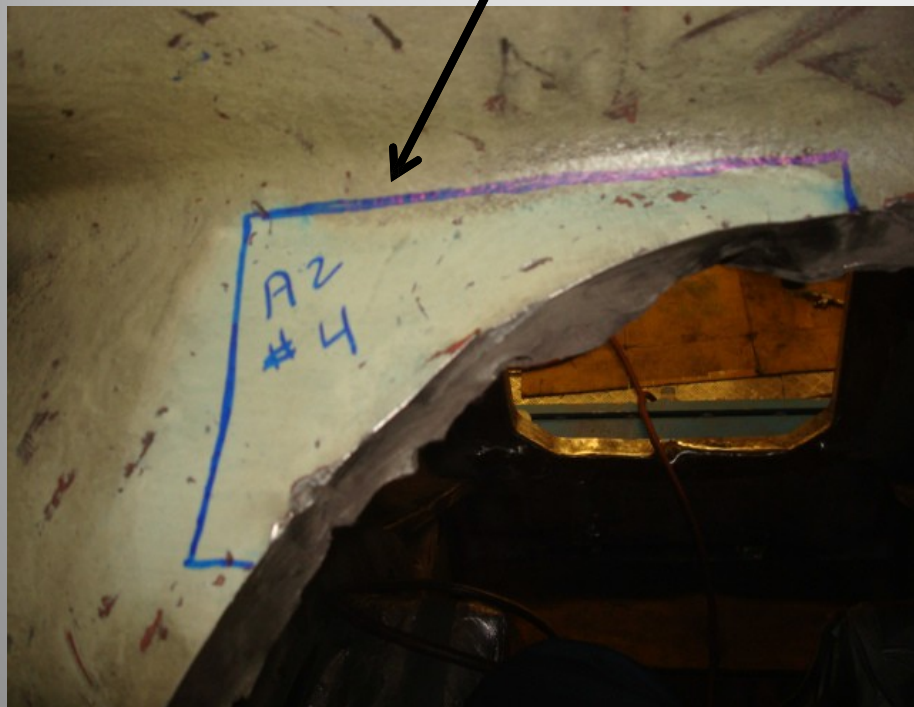
Patch four Lower Bore Side A2

Damaged area

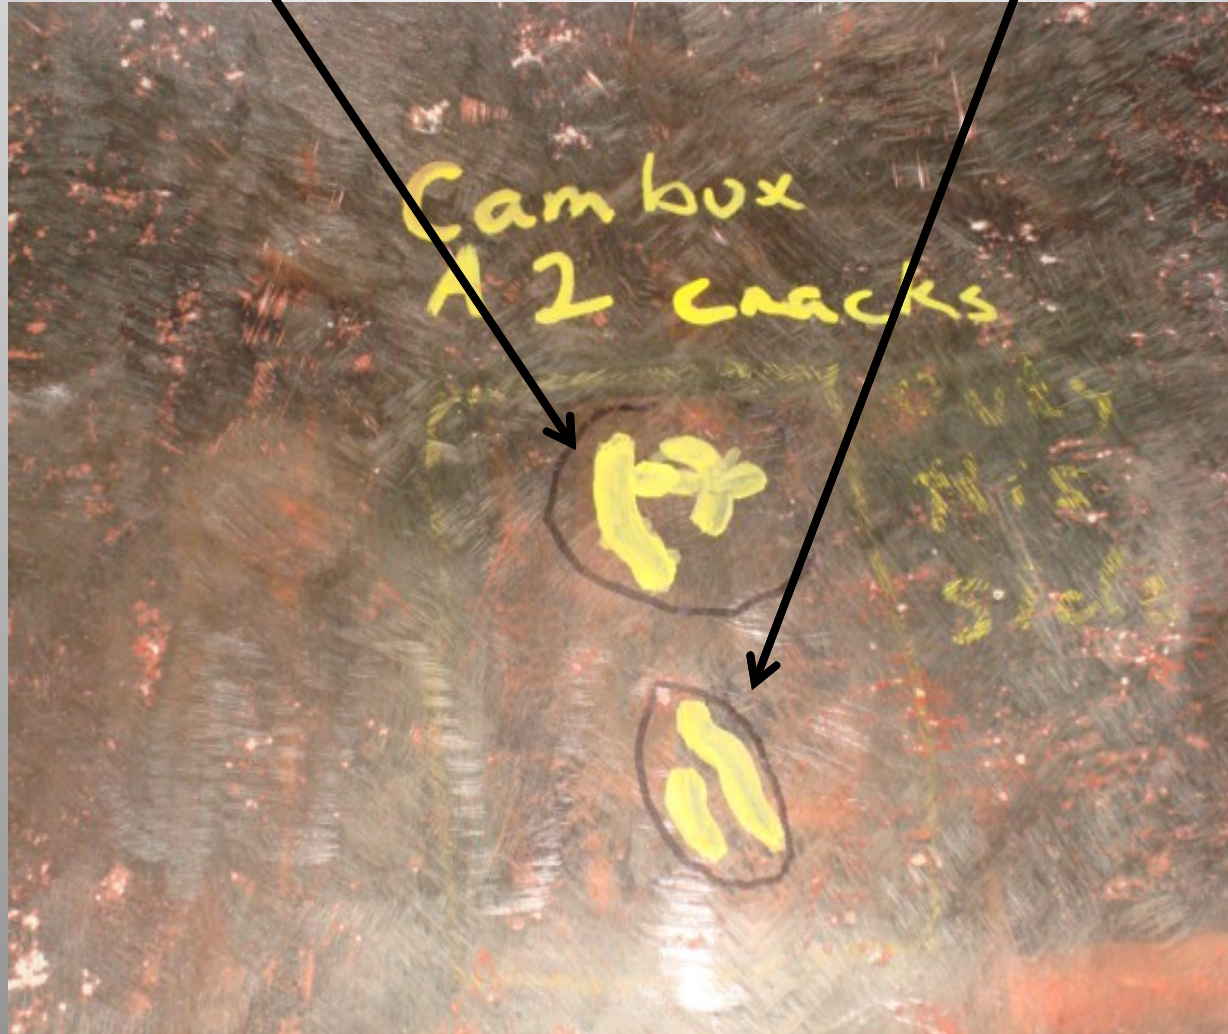
Damaged area in Cam Box A2
