Repair Final report

DIESEL GENERATOR # 4
CYLINDER UNIT # 3

Scope of work for metal stitching and machine work for GMT- Sulzer 8 ZAL 40 S

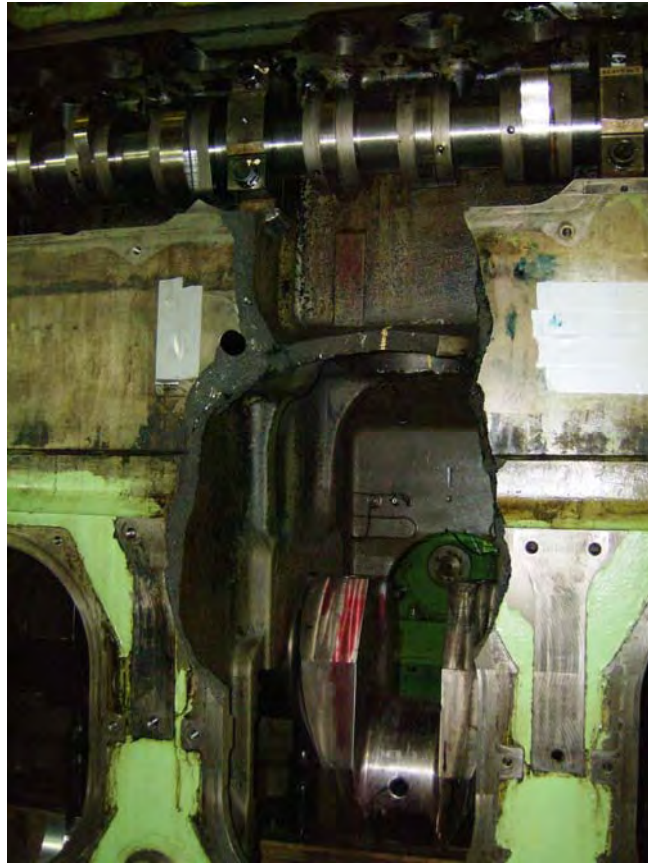
Large hole on sidewall of engine block

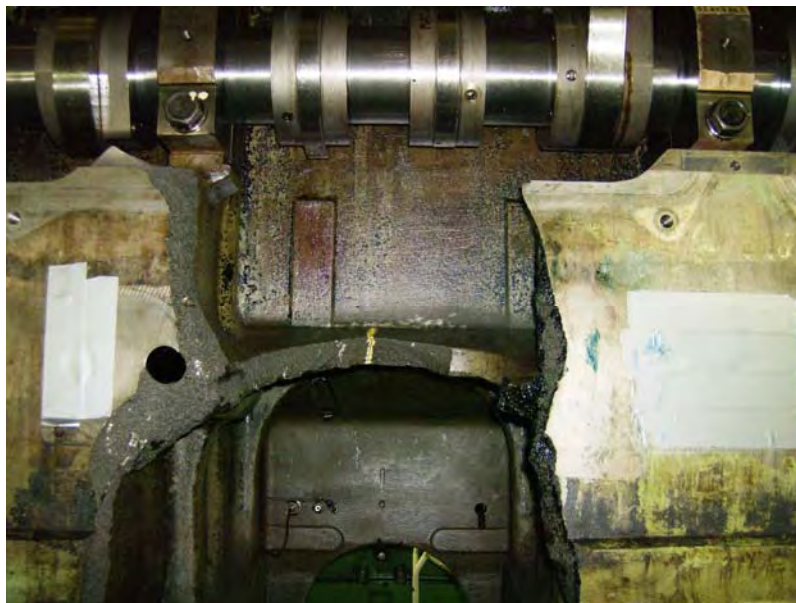
Cambox damage

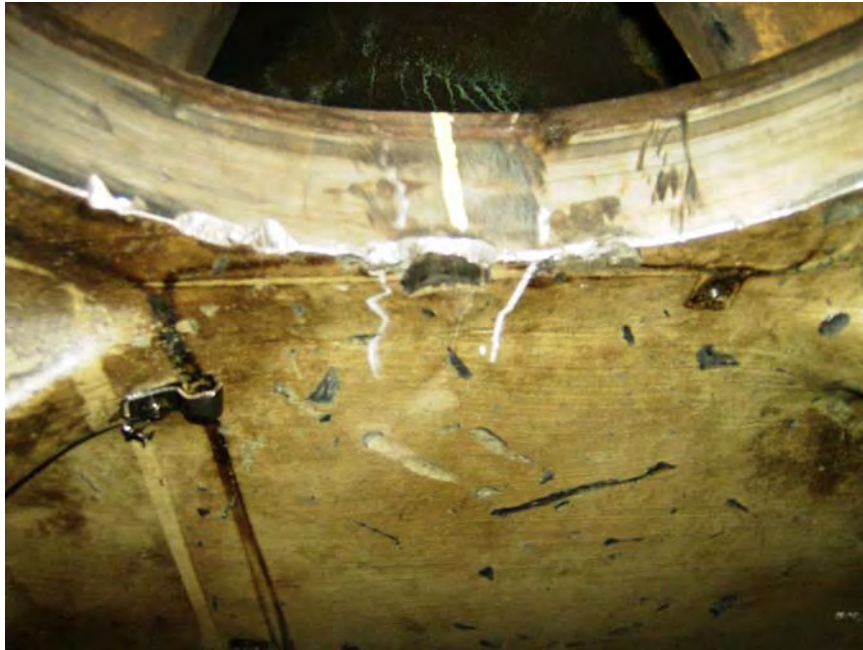
Lower bore damage

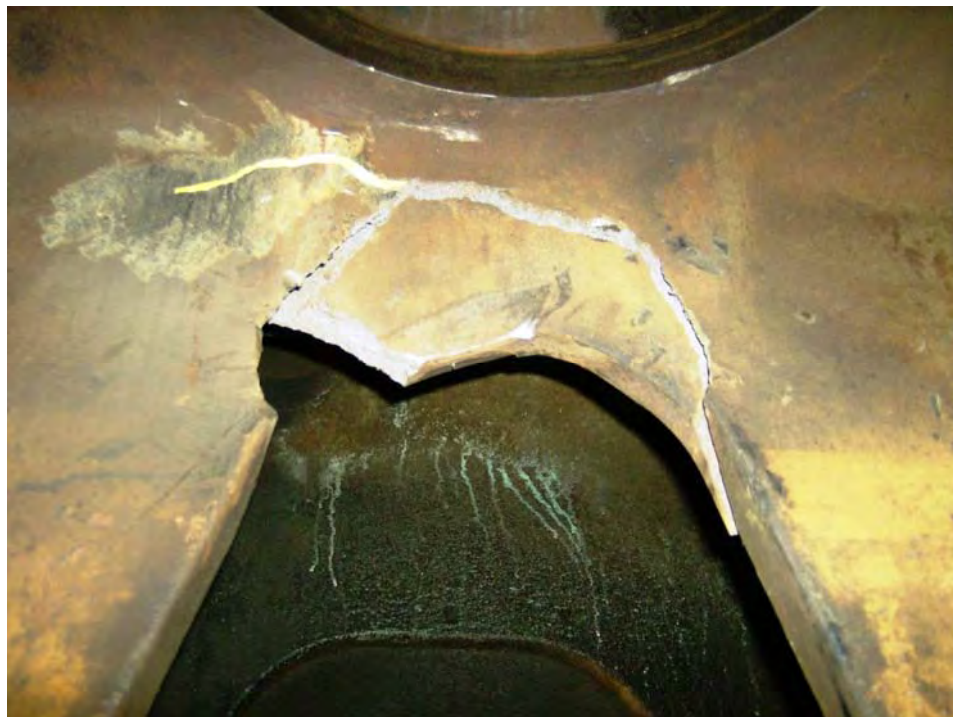
Scavenging trunk damage

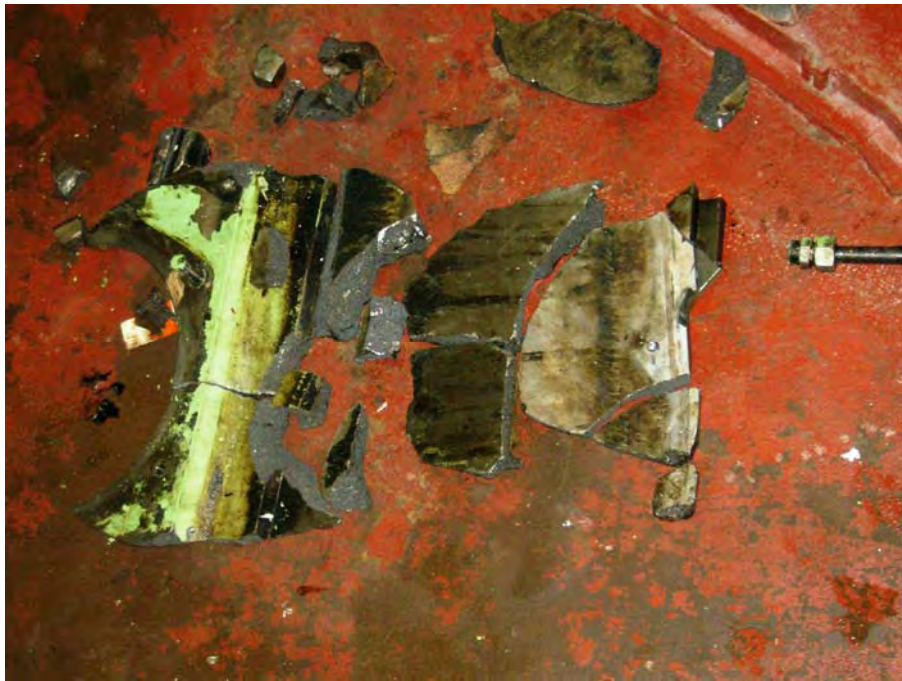
Broken pieces were shipped to LNS to make a template

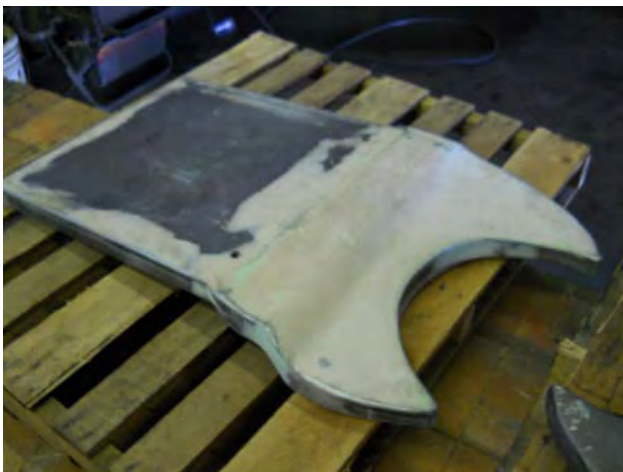
The pieces were welded together and missing sections were replaced to create a pattern. The pattern was used to make a mold for the new casting.

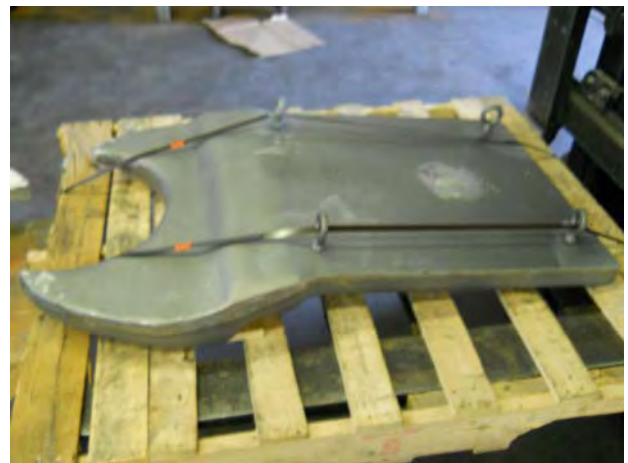
A new casting was cast by a local foundry to create the new sidewall. This casting was made slightly larger to provide excess for fitting into the engine block.

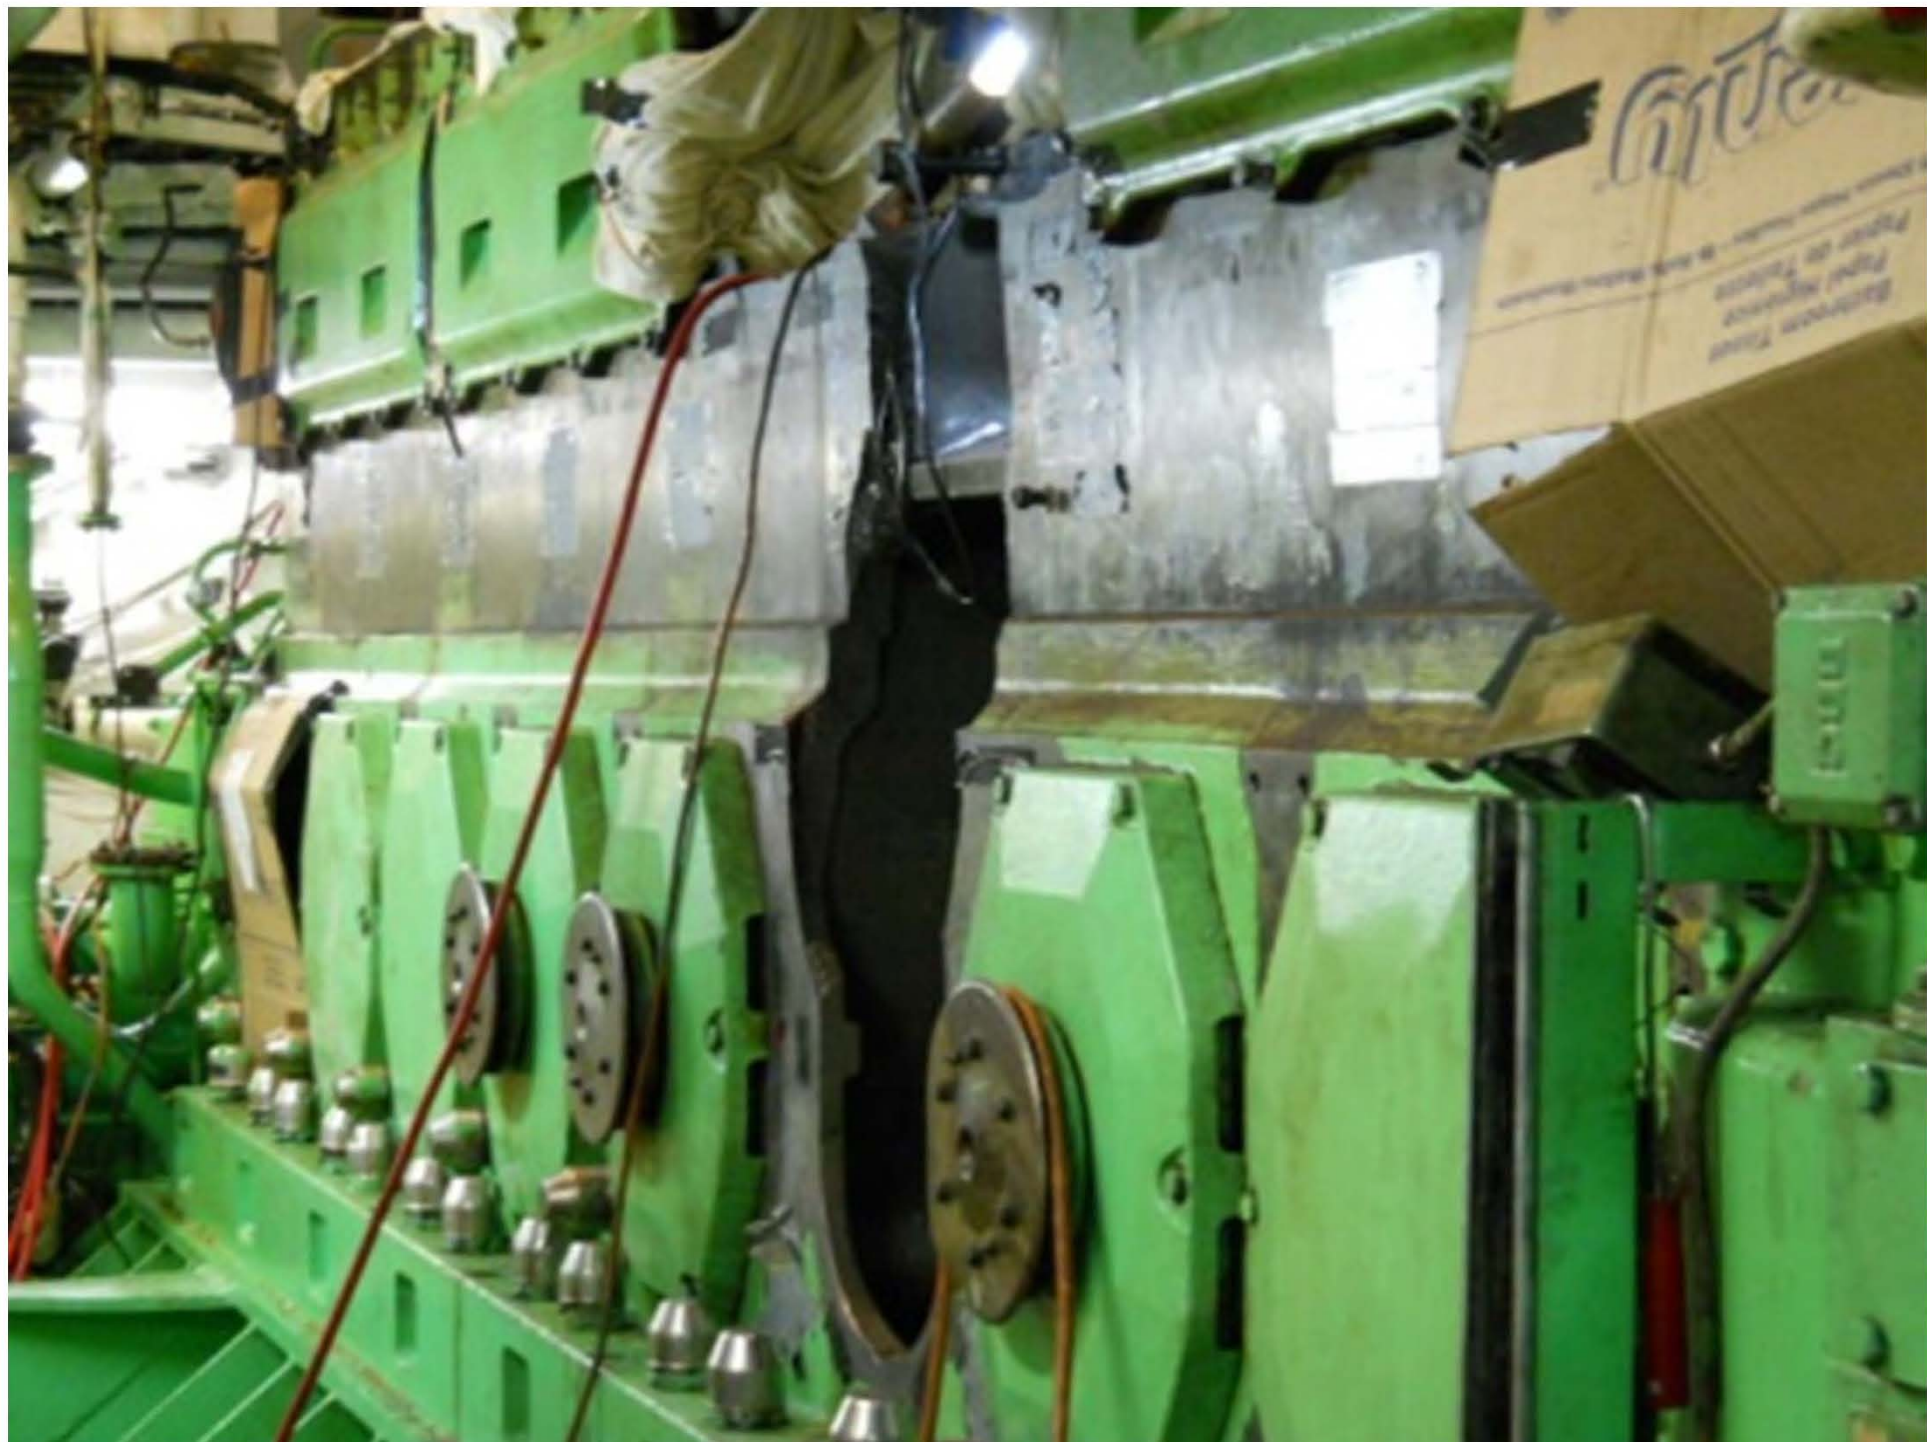
1. Cracks around the lower liner bore

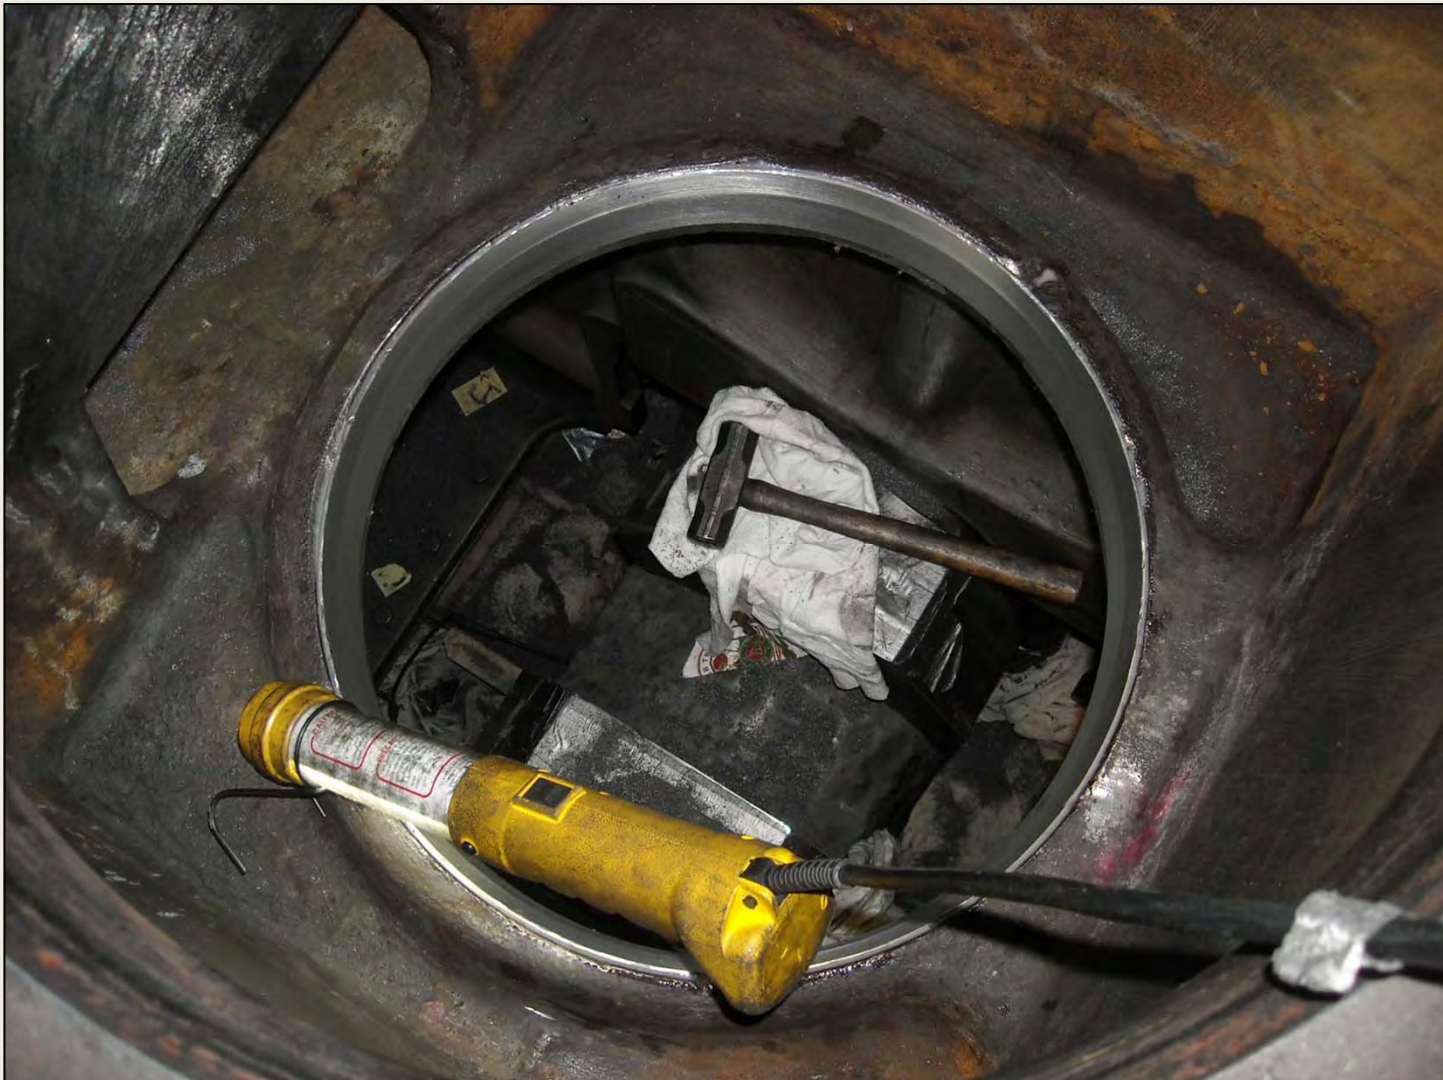
2. Broken out internal gusset

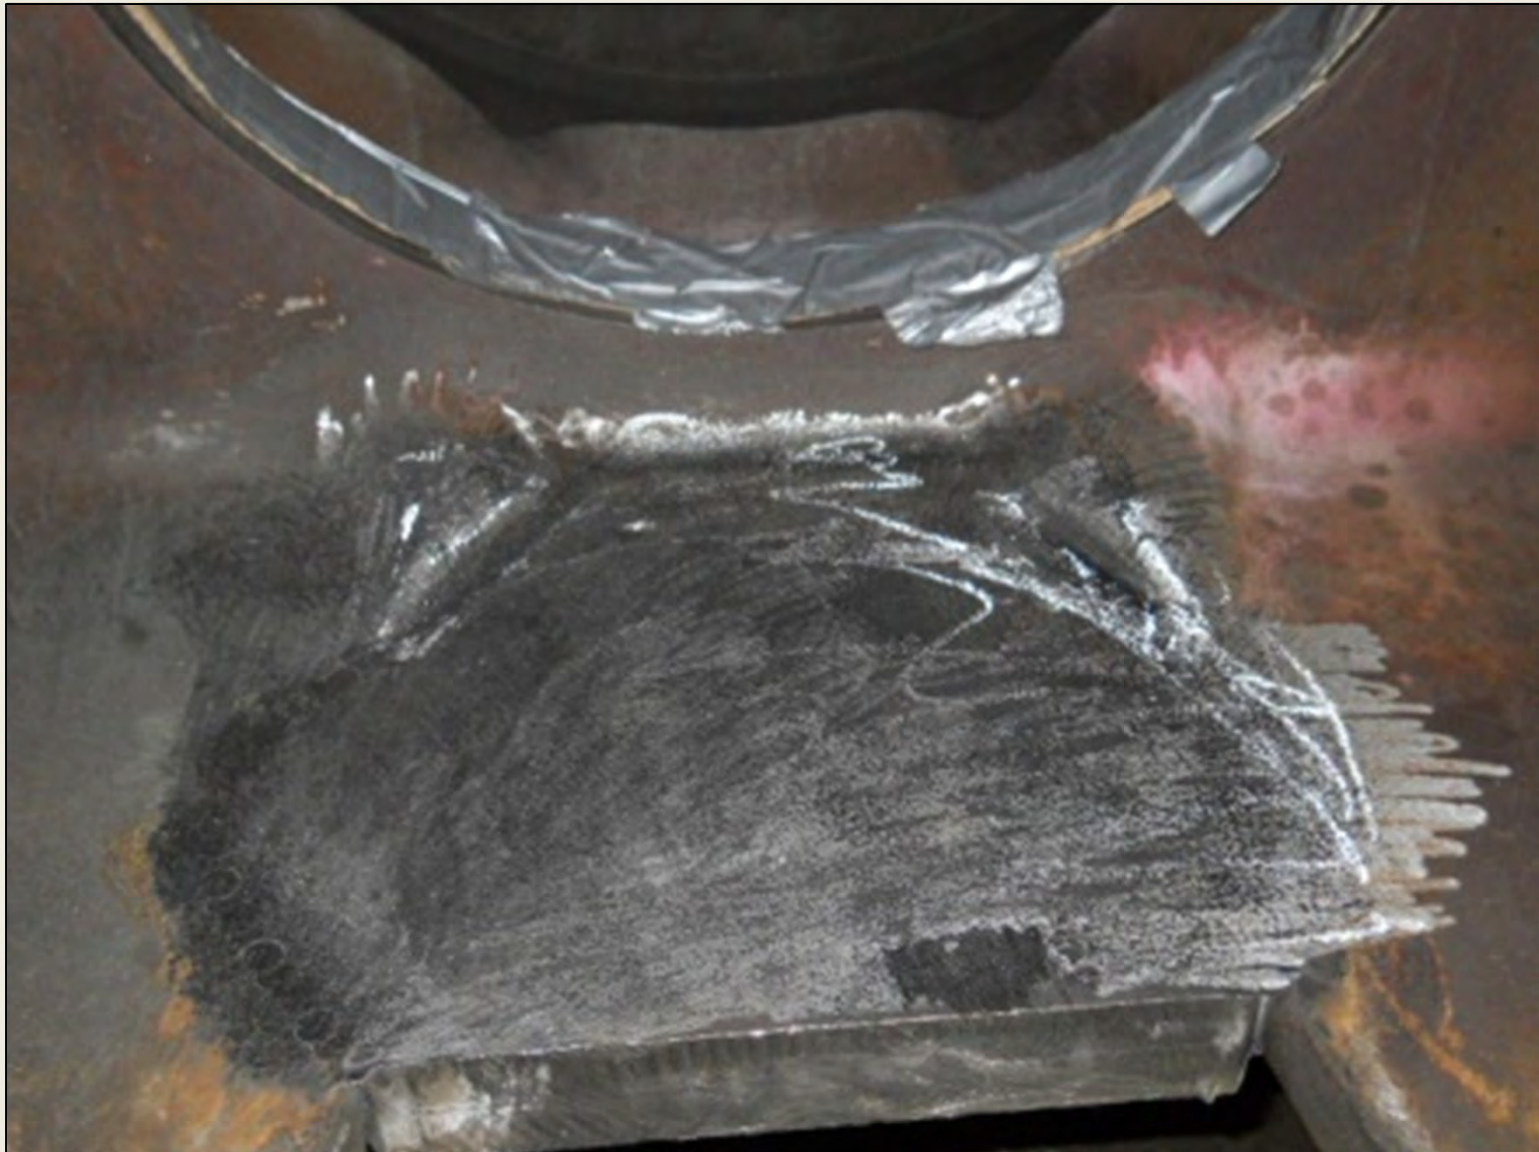
3. Cam Box floor missing

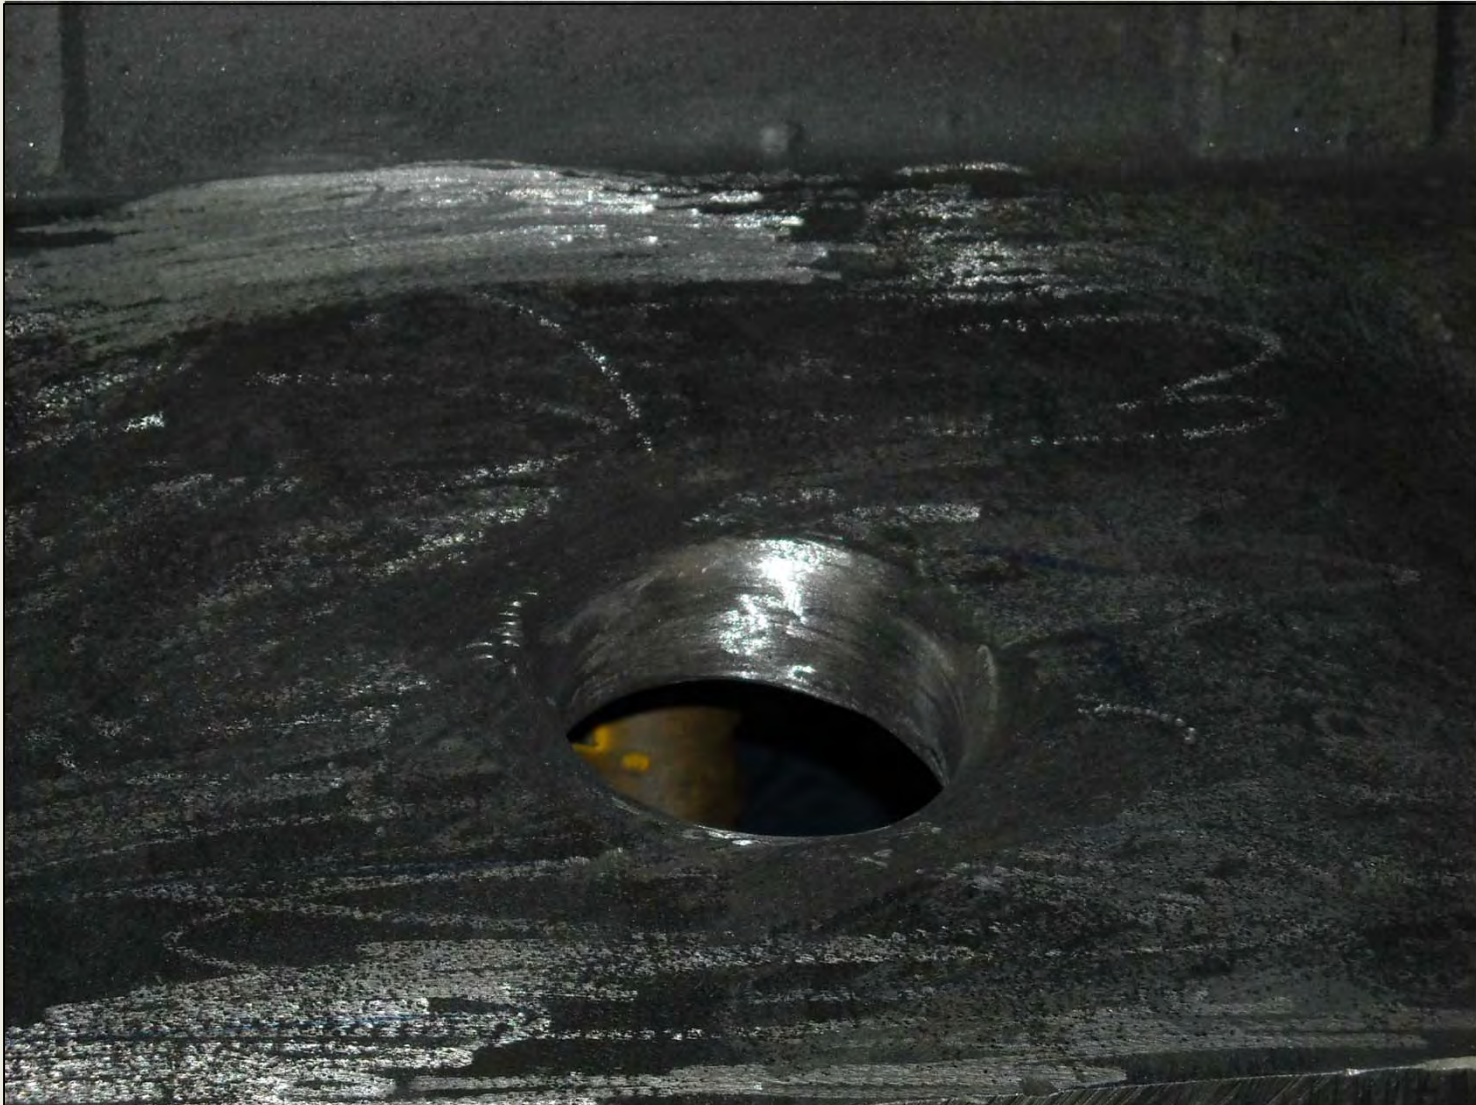
4. Broken connecting rod blew out the side of this engine
