Crusher Final Report

Date 12/18/2012

Part HP 300 Crusher

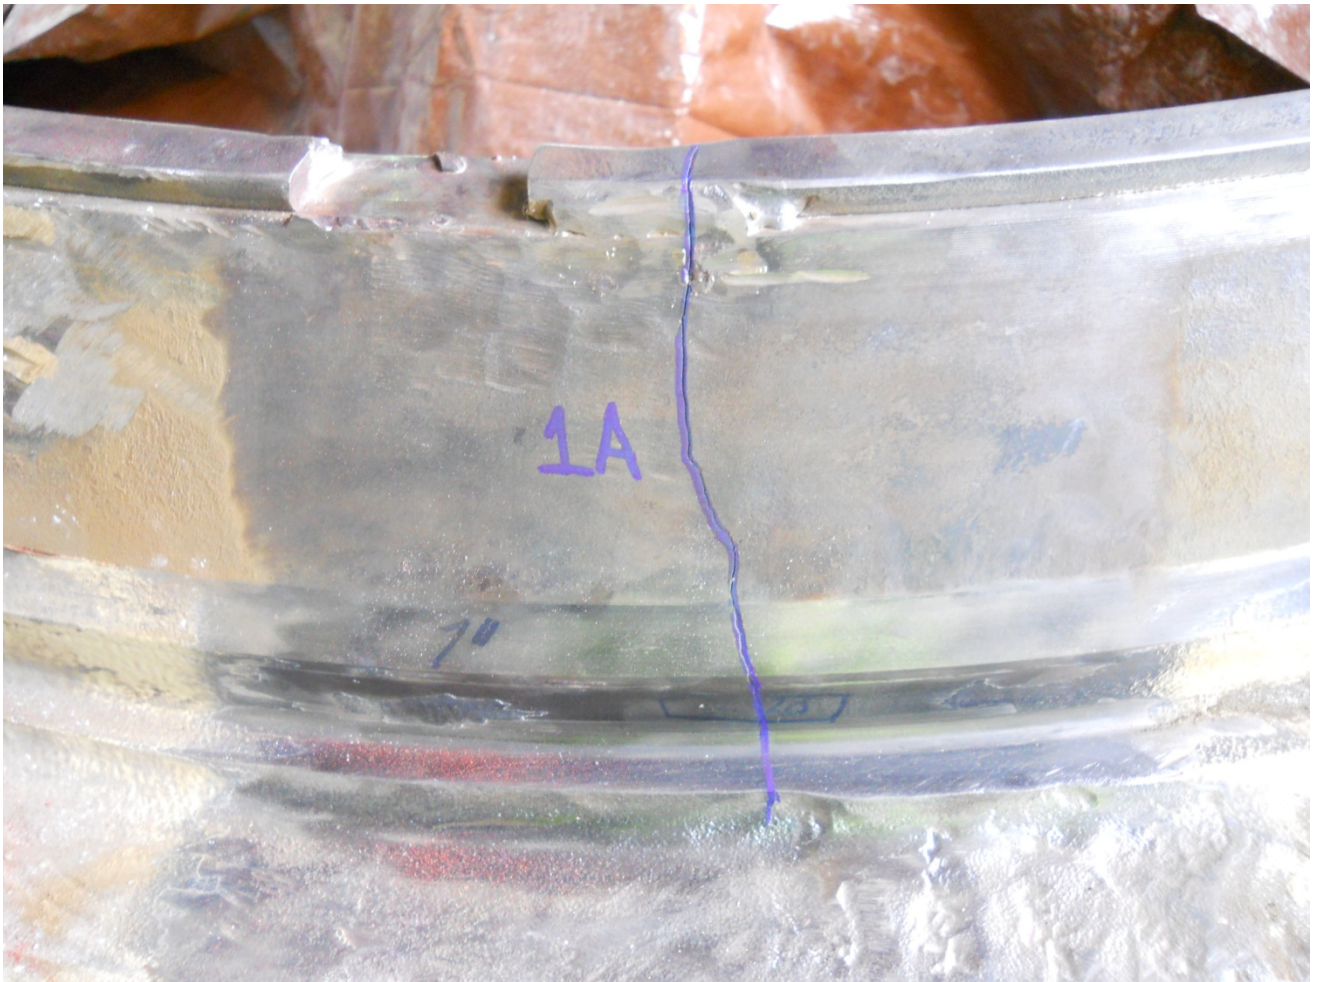
Exterior:

Found—Inspection shows 4 cracks on HP300 Crusher, totaling 26” of crack.
(interior & exterior)
