**LOCK-N-STITCH** Inc.  
 Casting Repair Specialists  
 1015 S. Soderquist Rd.  
 Turlock CA 95380

## **Final Report**

Customer Dresser-Rand Phone 801-295-2940  
 Contact Allen Bowers Alt phone 801-557-2447 cell  
 Address 25 N. 400 W. #6 Fax 801-295-0292  
 City, State, Zip N. Salt Lake City, UT. 84054 Date 10.15/2013

Part Large compressor frame  
 Serial number \_\_\_\_\_ Inspected by Customer

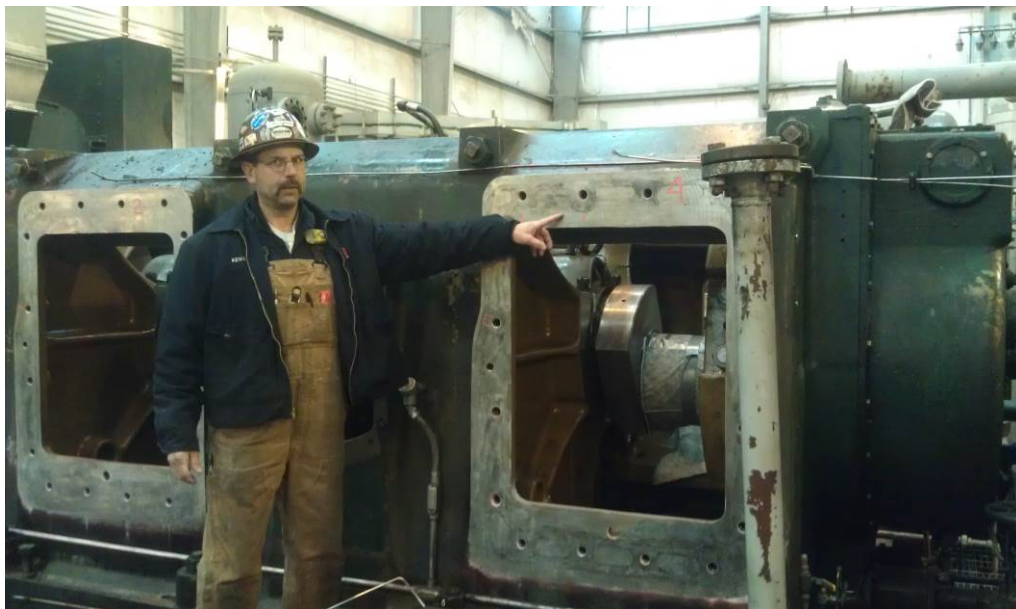
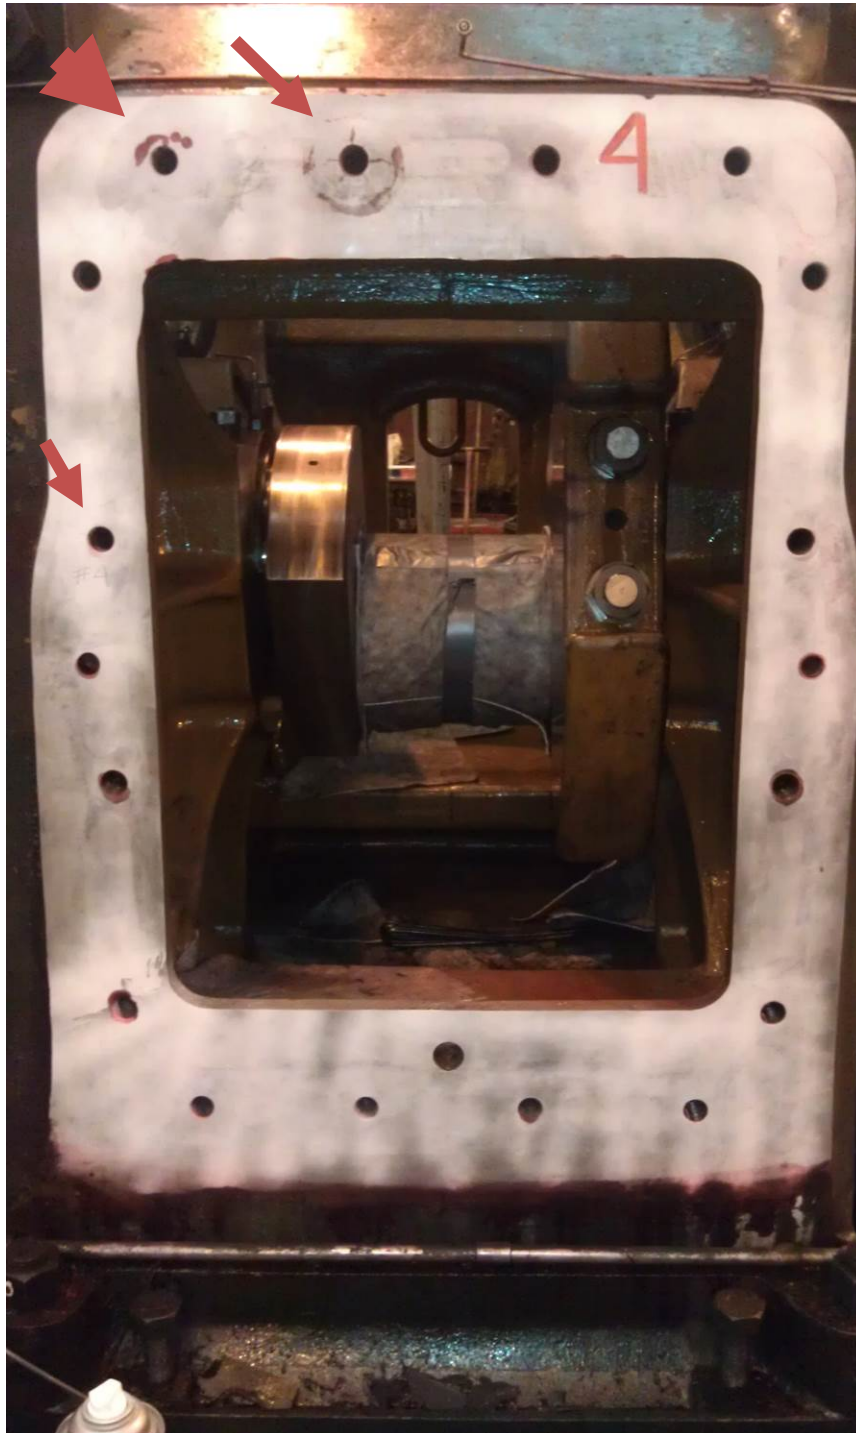
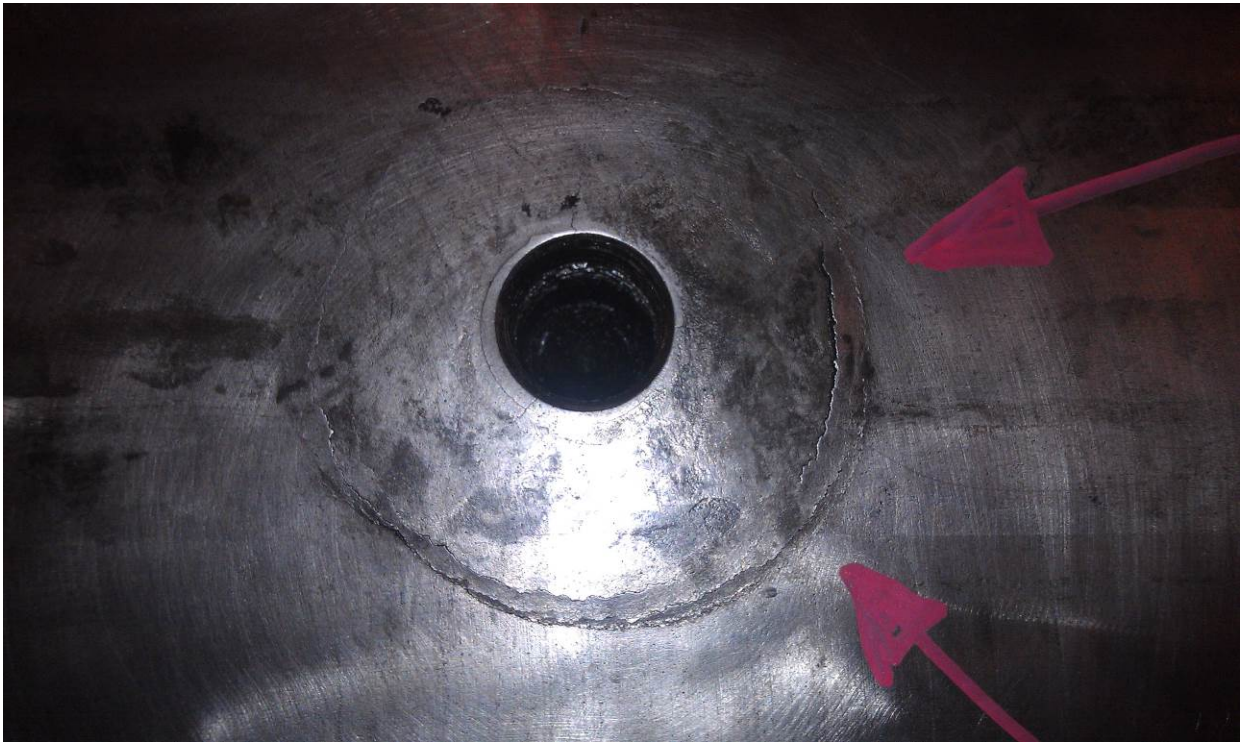
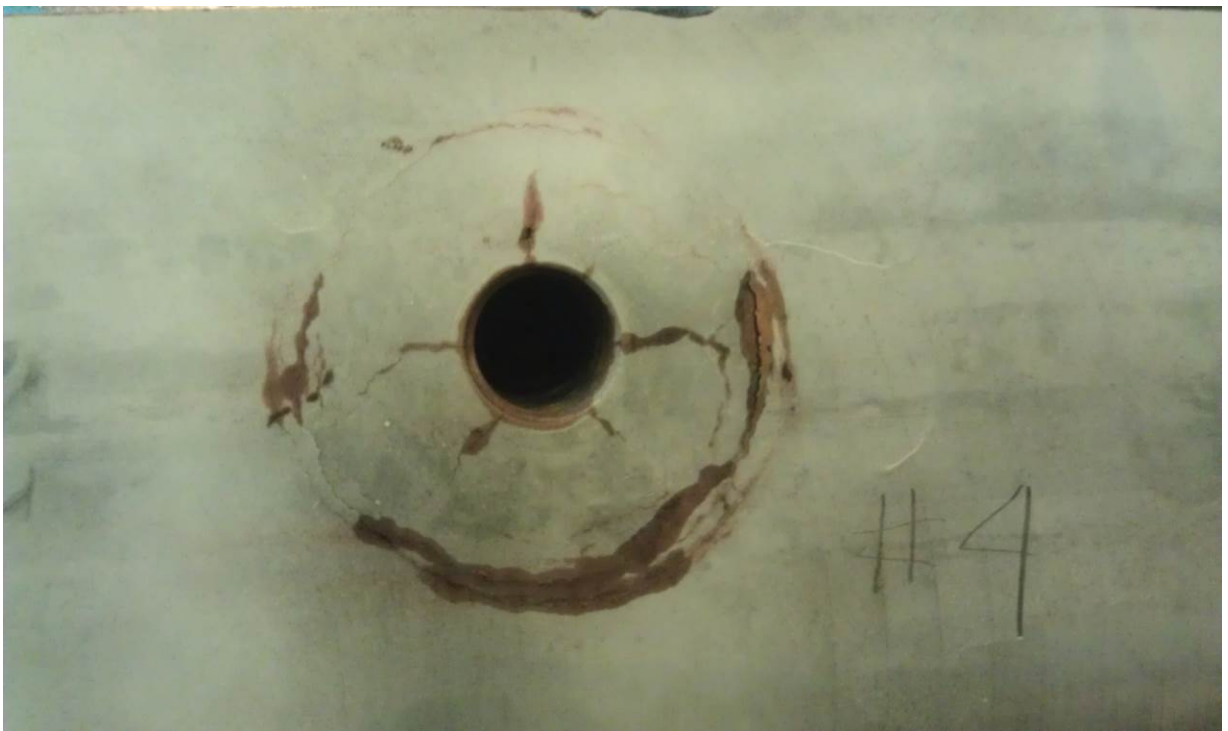
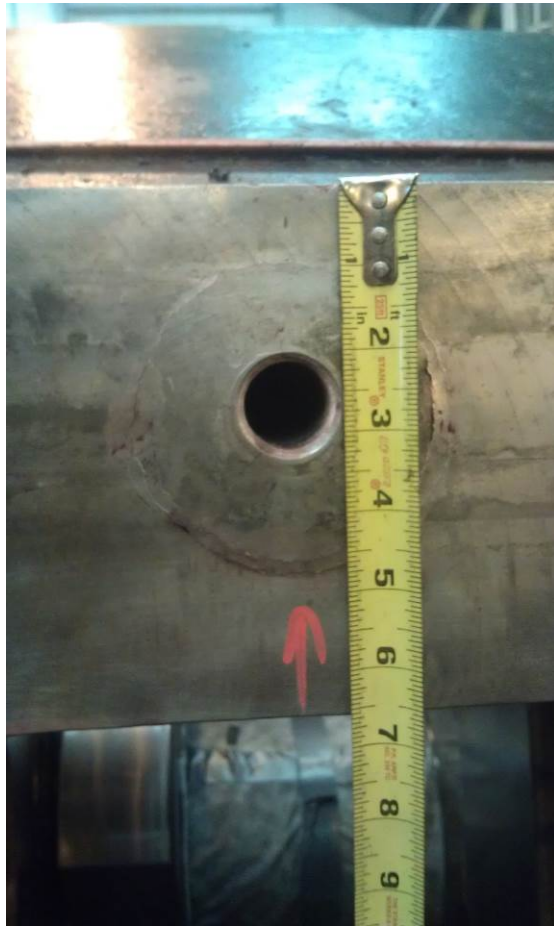
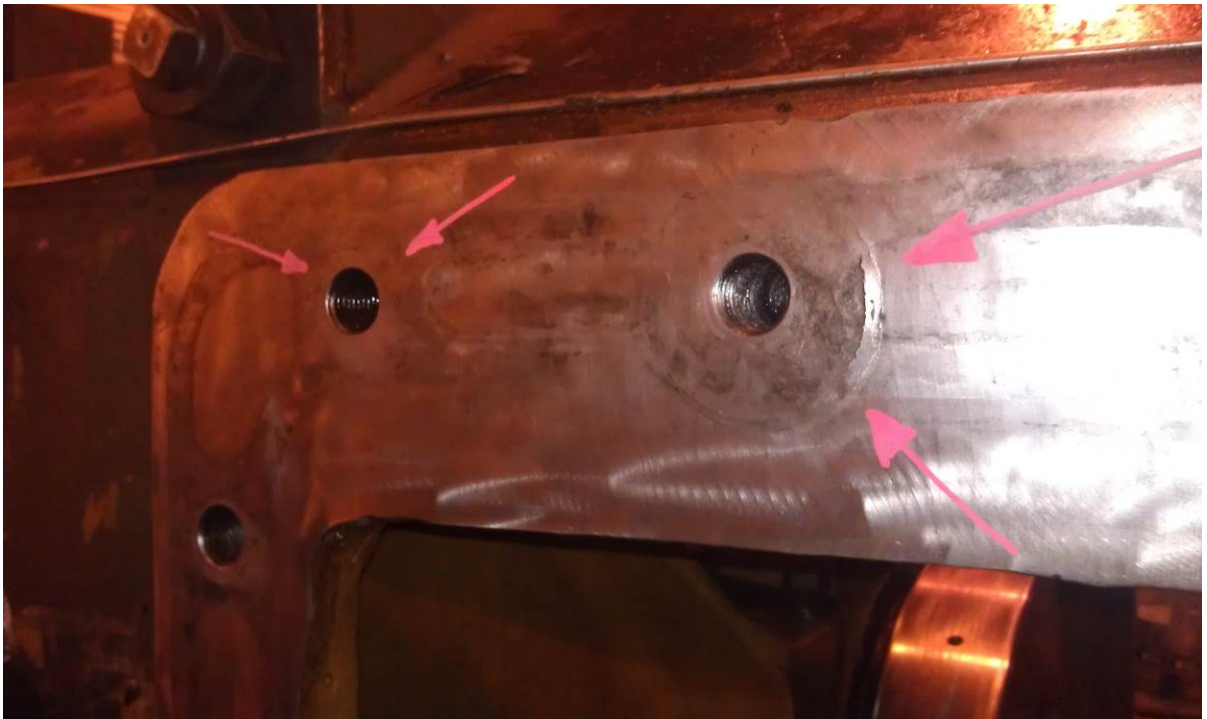
- impact
- heat
- freezing
- normal operation
- other Yielding studs

- #1 4.5" Diameter pull out
- #2 Partial Pull out
- #3 1" Crack from bolt hole
- #4 1" Raidial crack around bolt hole.

#1 Bolt hole has large pull out

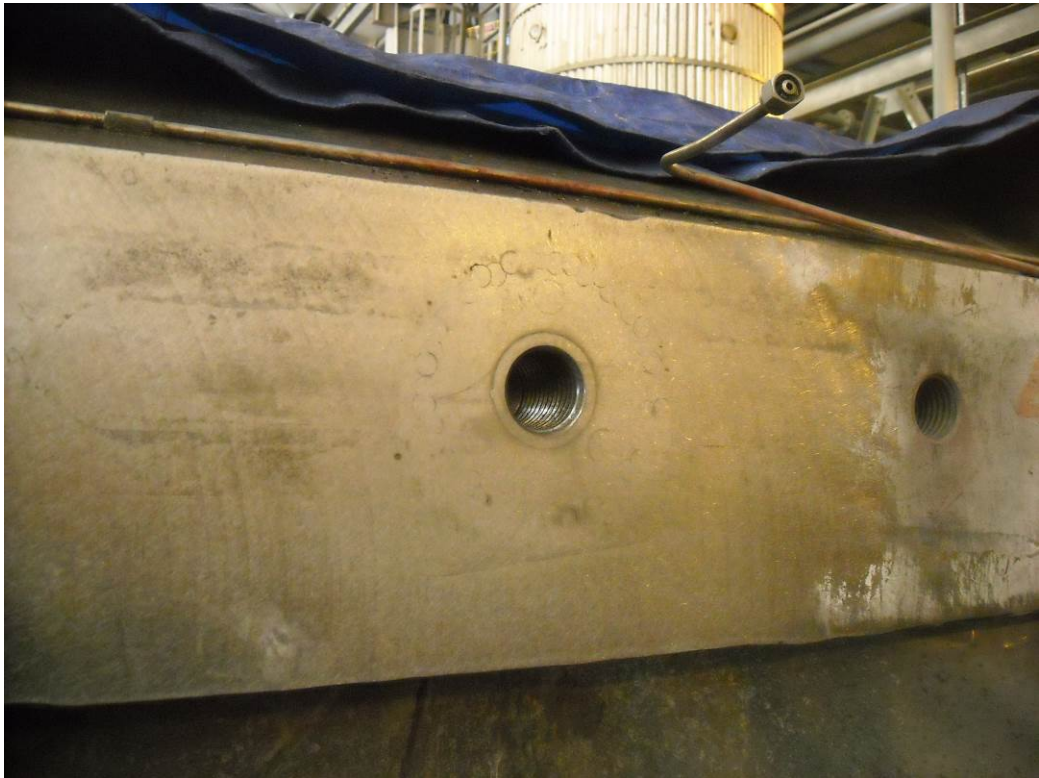
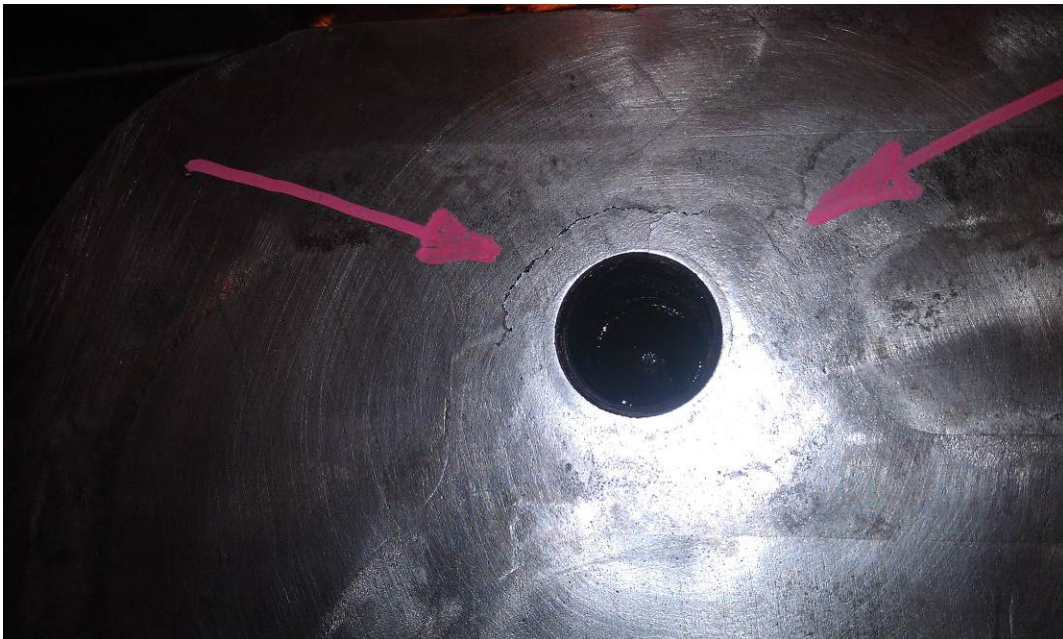
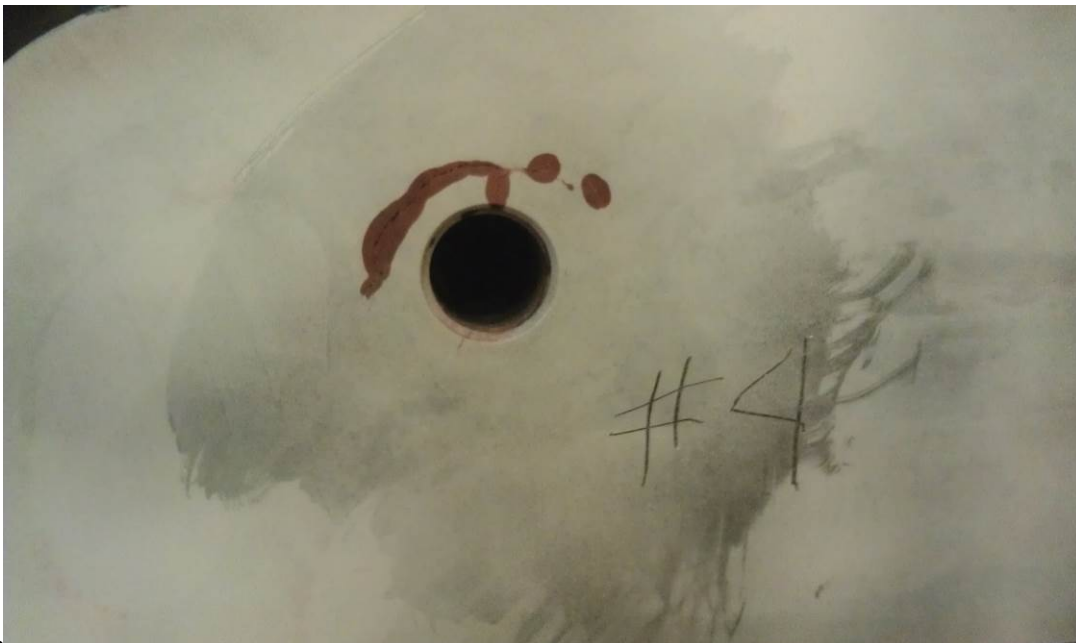
# 2 Pulled Bolt hole on cylinder # 4 bolt hole dim. 1 1/4-7 X 2.00"

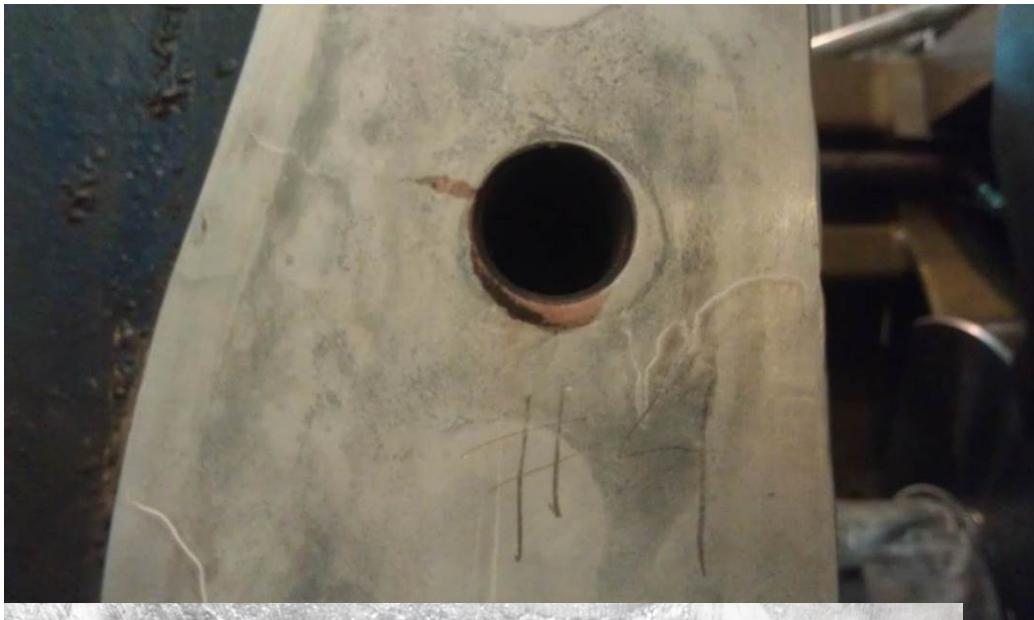
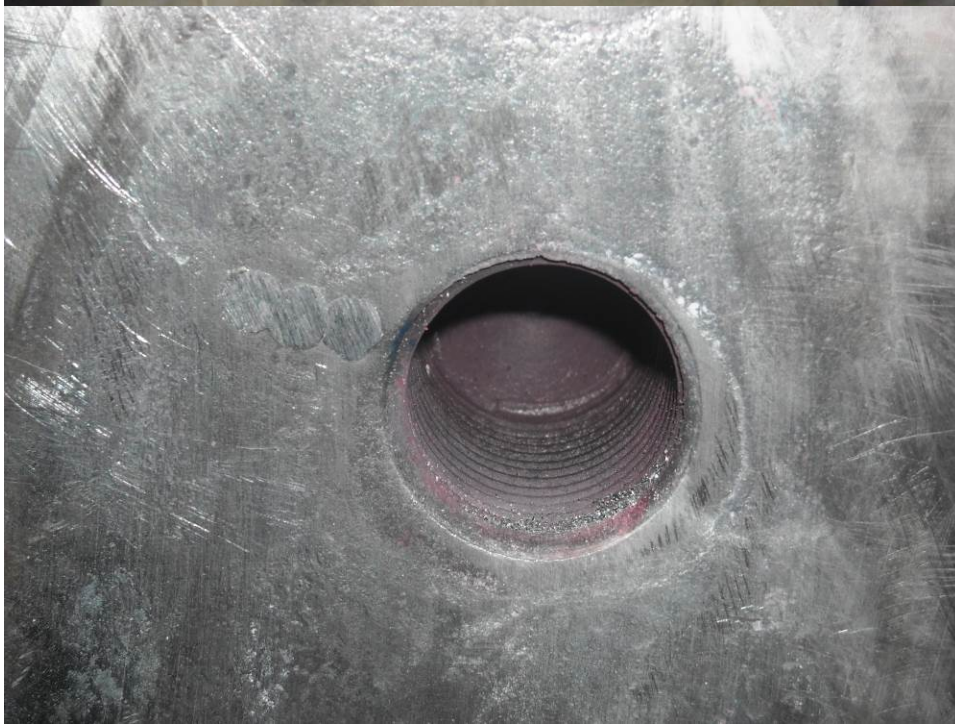
# 3 Cracked bolt hole on Cylinder # 4

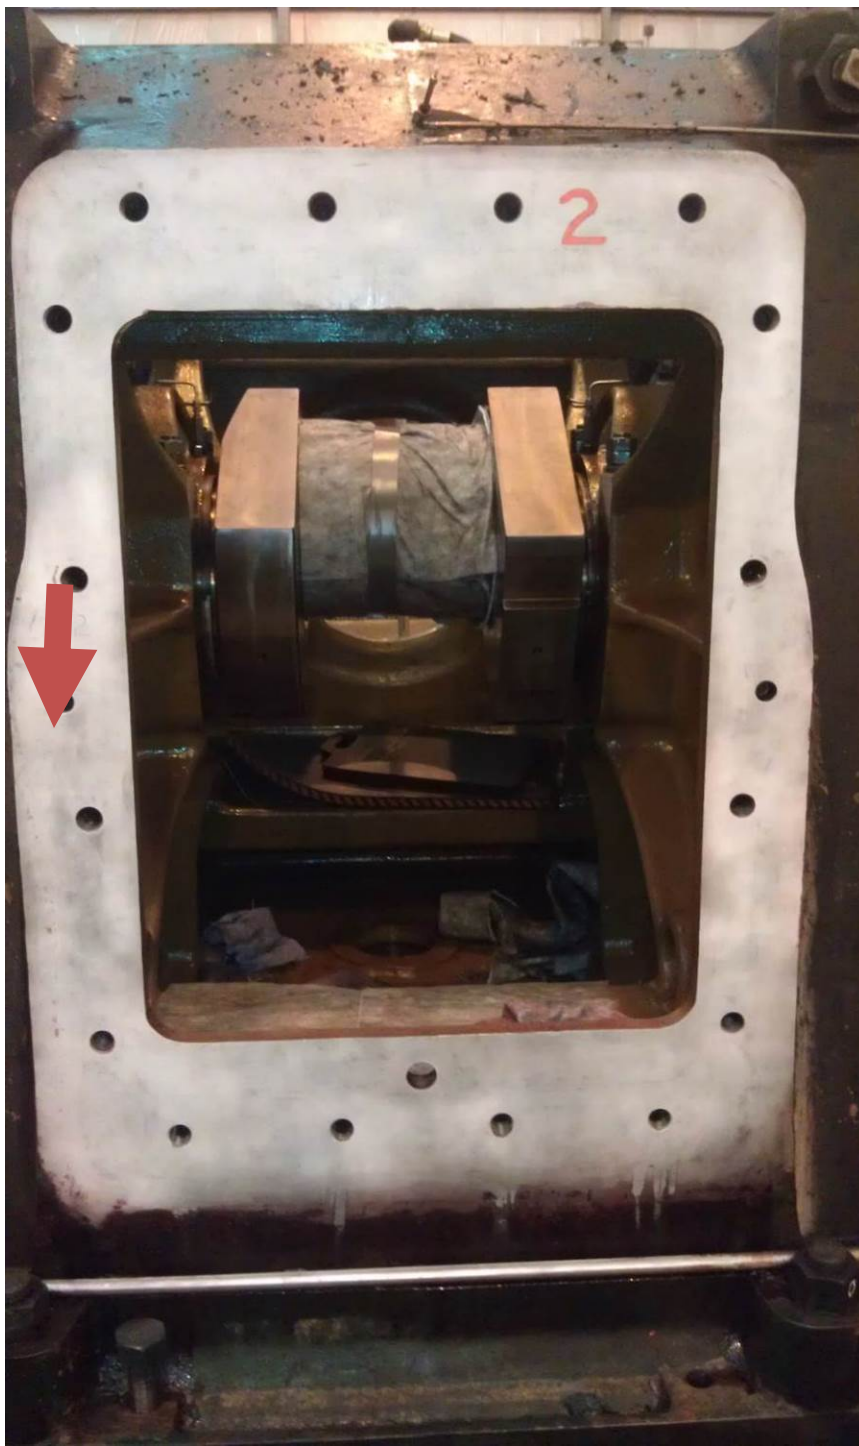
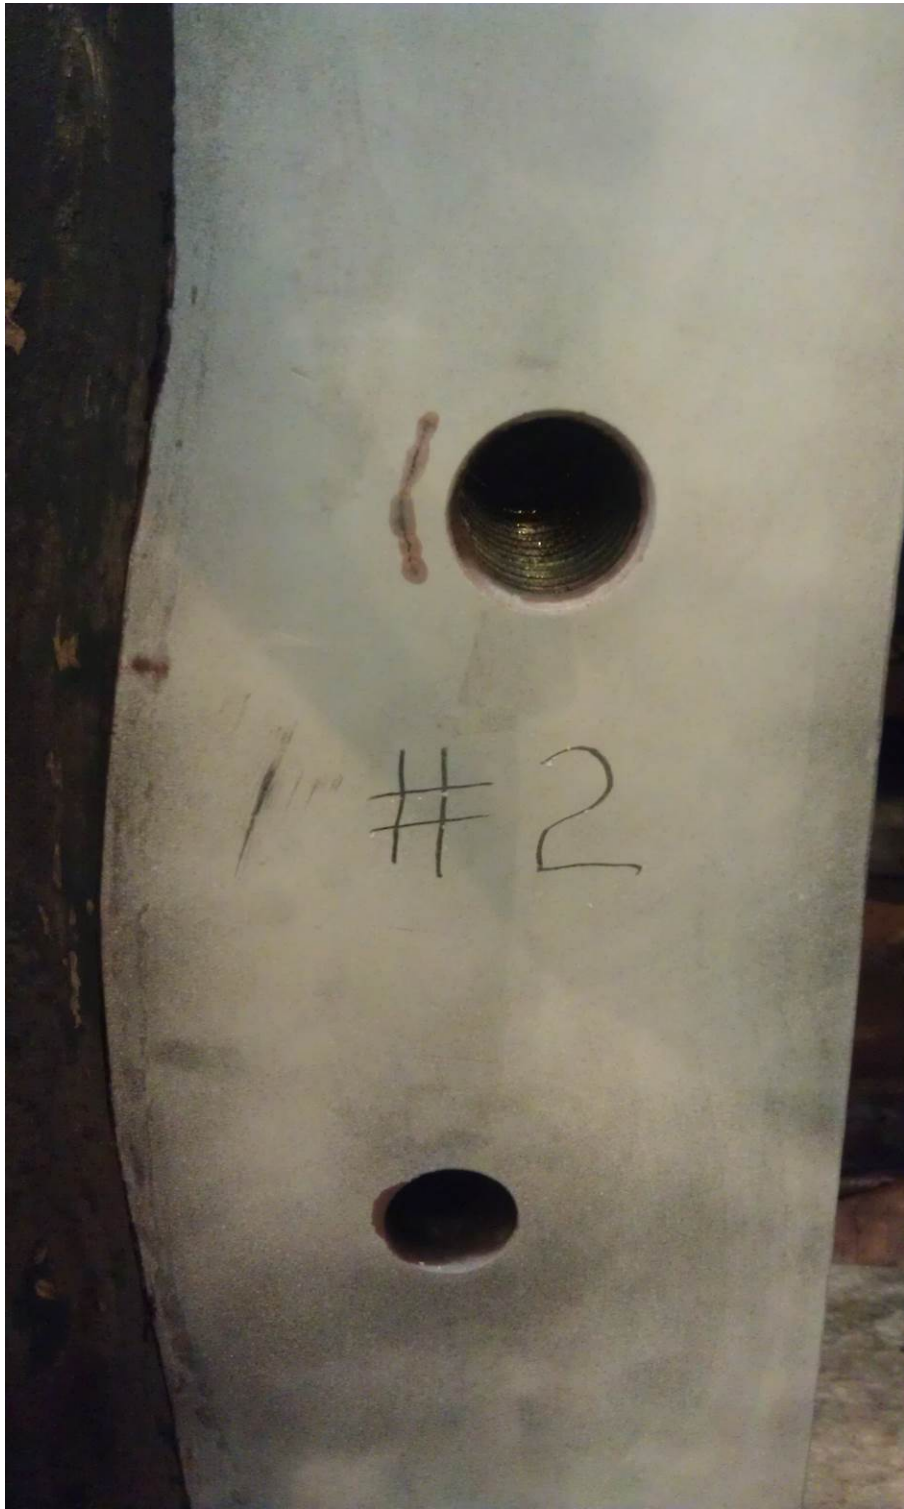
# 4  
hole on

Damaged Bolt  
cylinder # 2

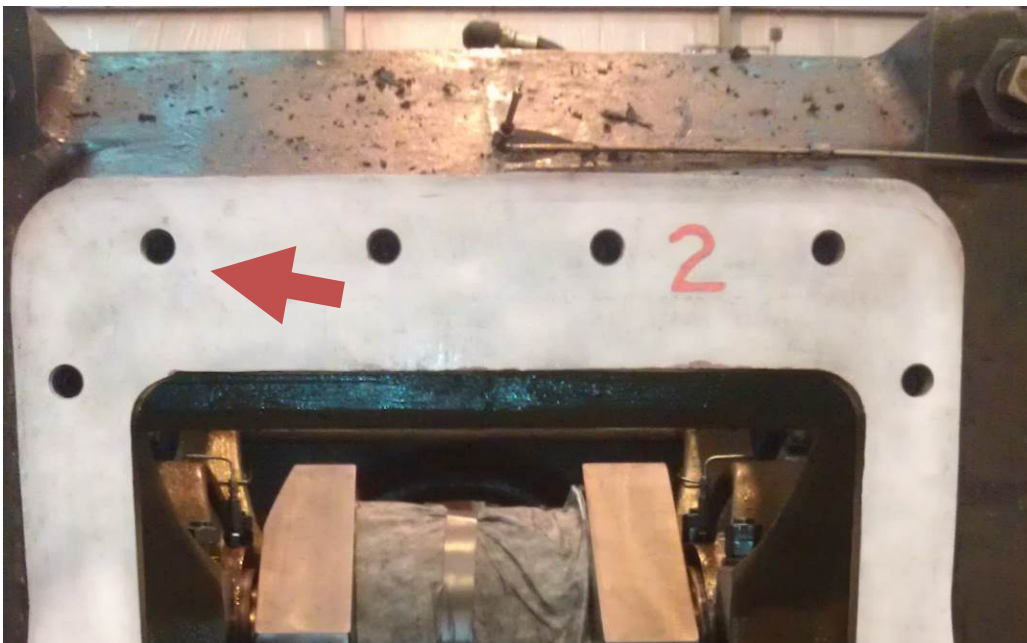
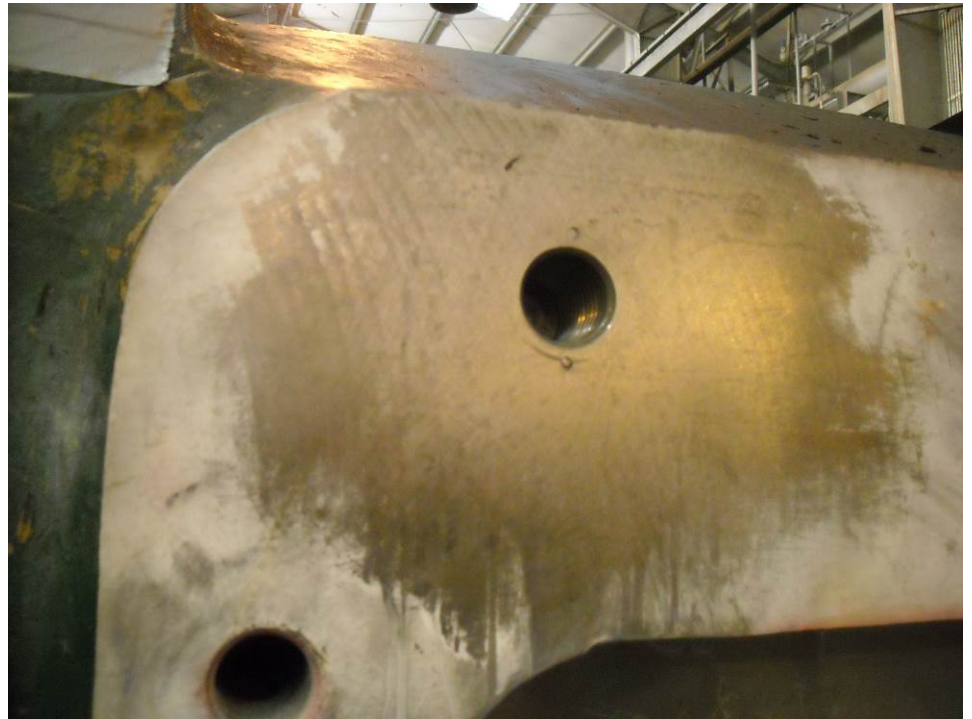
Bolt hole # 7 Had a very small crack in the top thread.

By installing the *FULL-TORQUE* Insert it removed the crack and completed the repair.

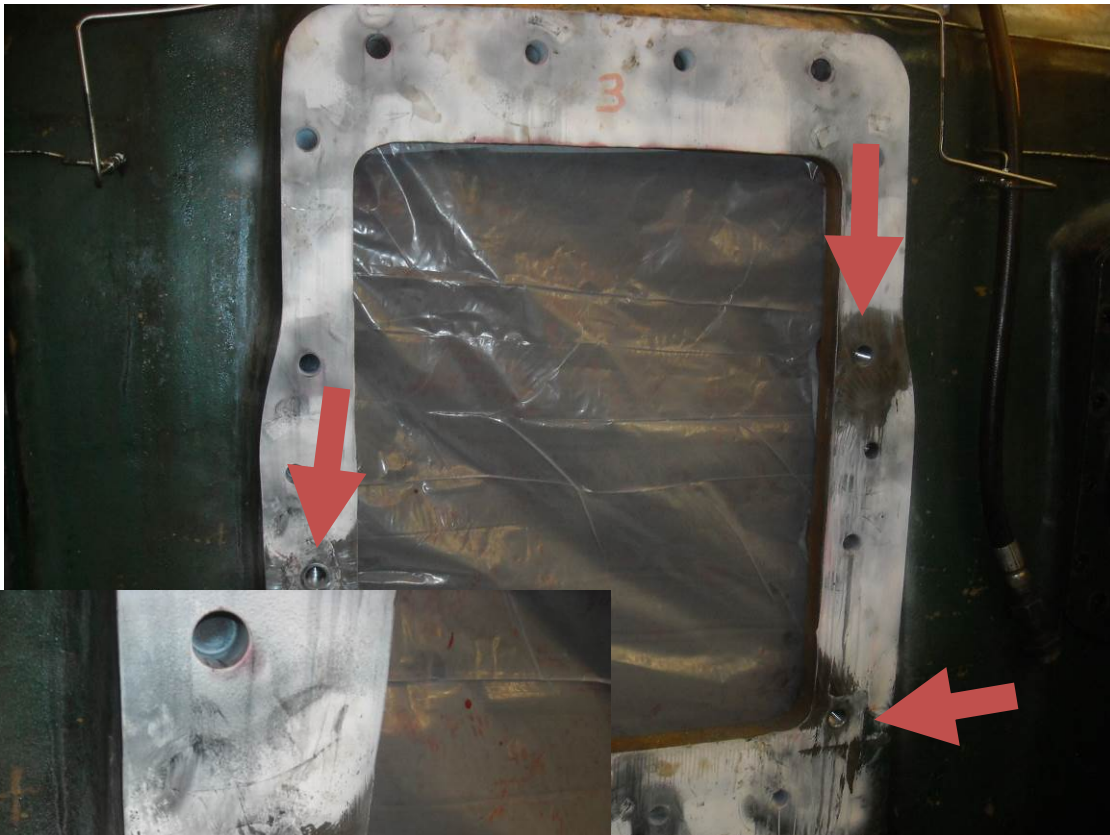
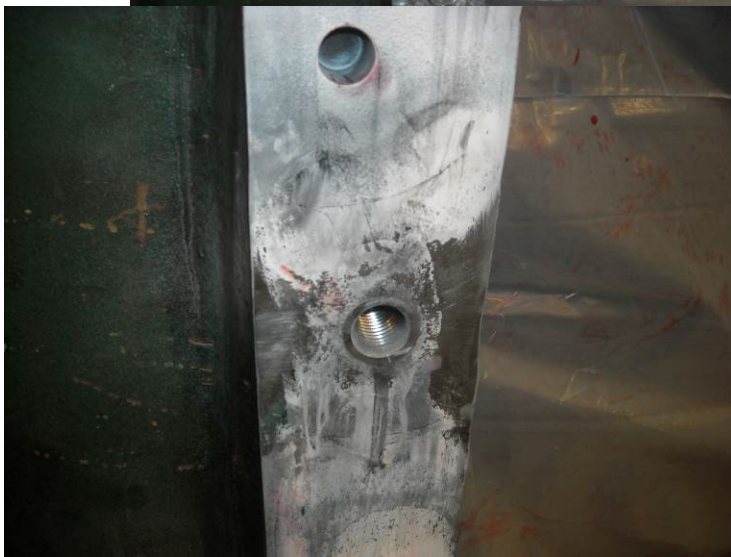
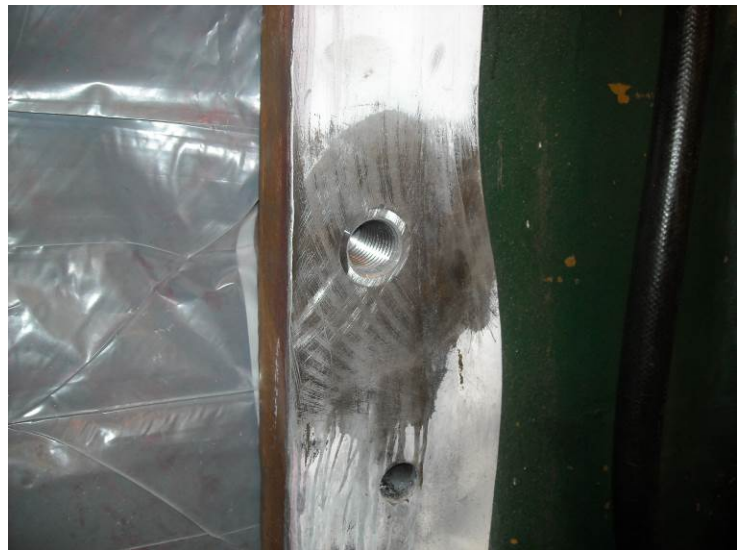
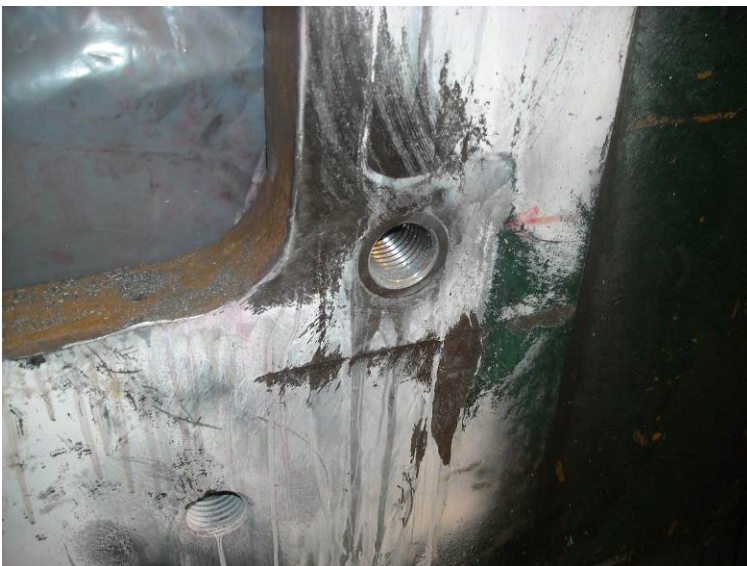
Bolt hole repairs # 8,9,10 on cylinder # 3 of the frame

#8 had a very small crack in the top thread and was repaired by installing a *FULL-TORQUE* insert to repair damage.

#9 bolt hole was repaired by just installing a *FULL-TORQUE* insert.

# 10 bolt hole was repaired by just installing a *FULL-TORQUE* insert.
