Drilling ship

Repair completed by *LOCK-N-STITCH* Inc.

September 2012

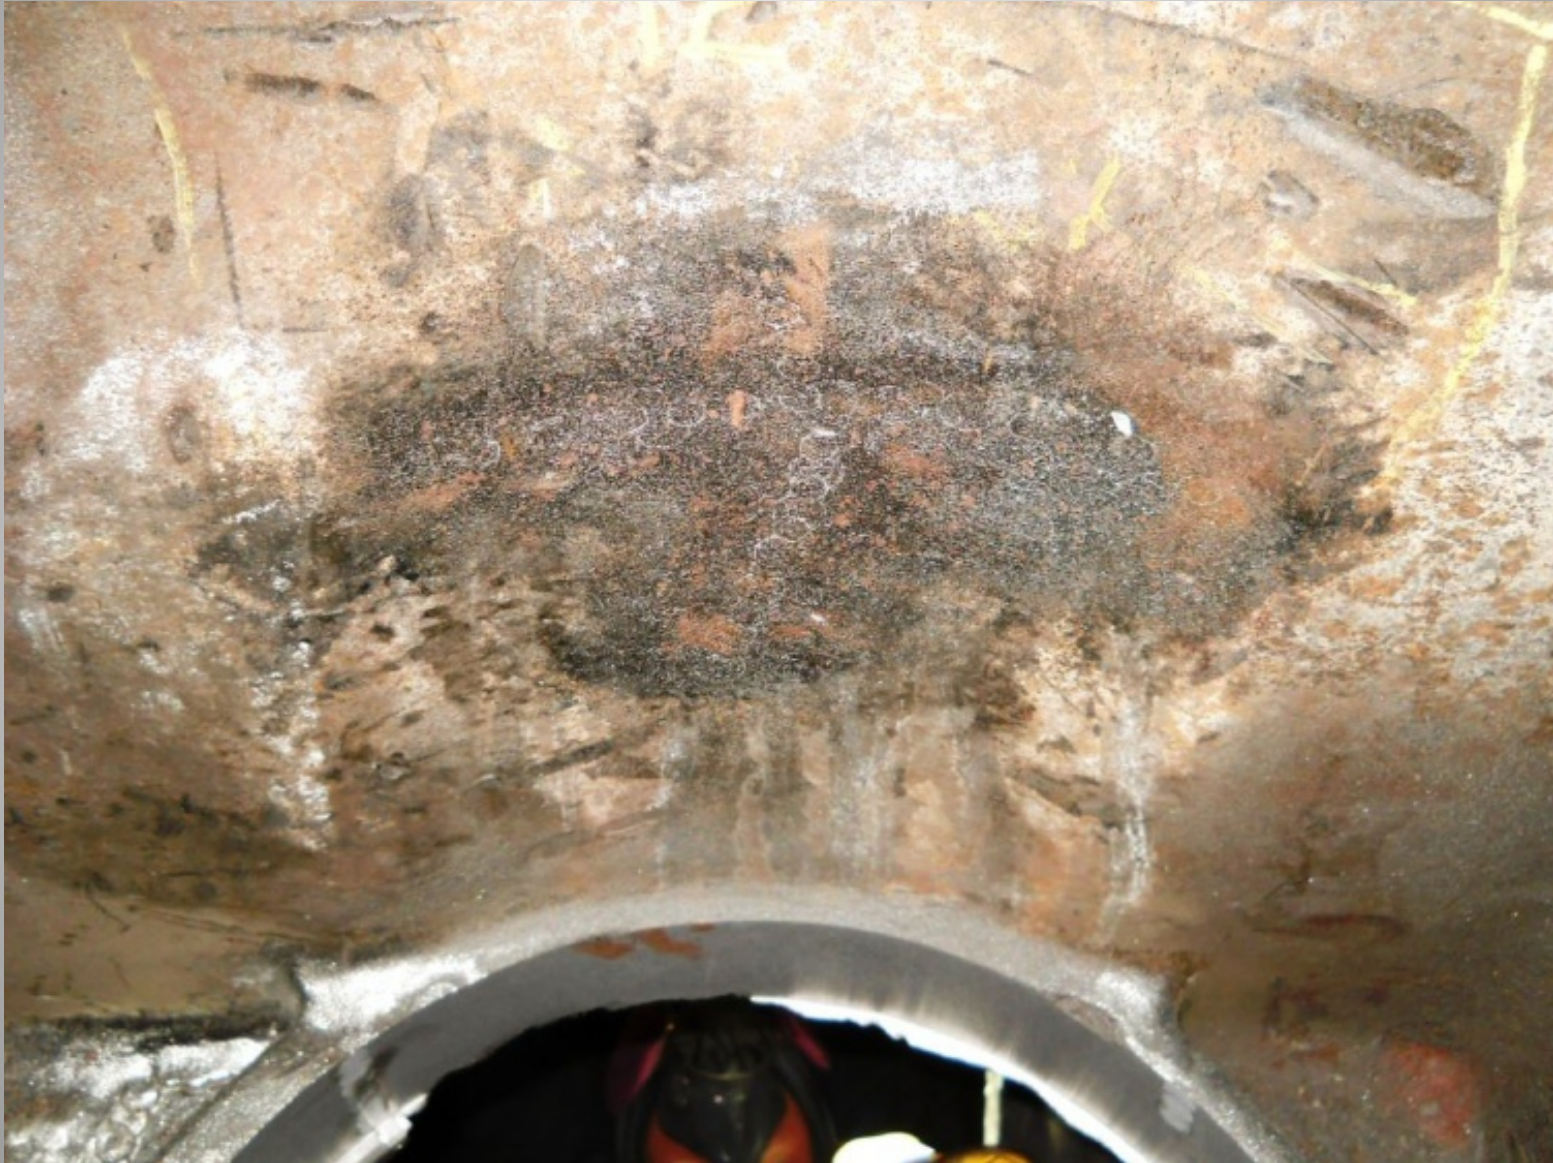
Lower bore repair side A2 needs two more pins and finish work

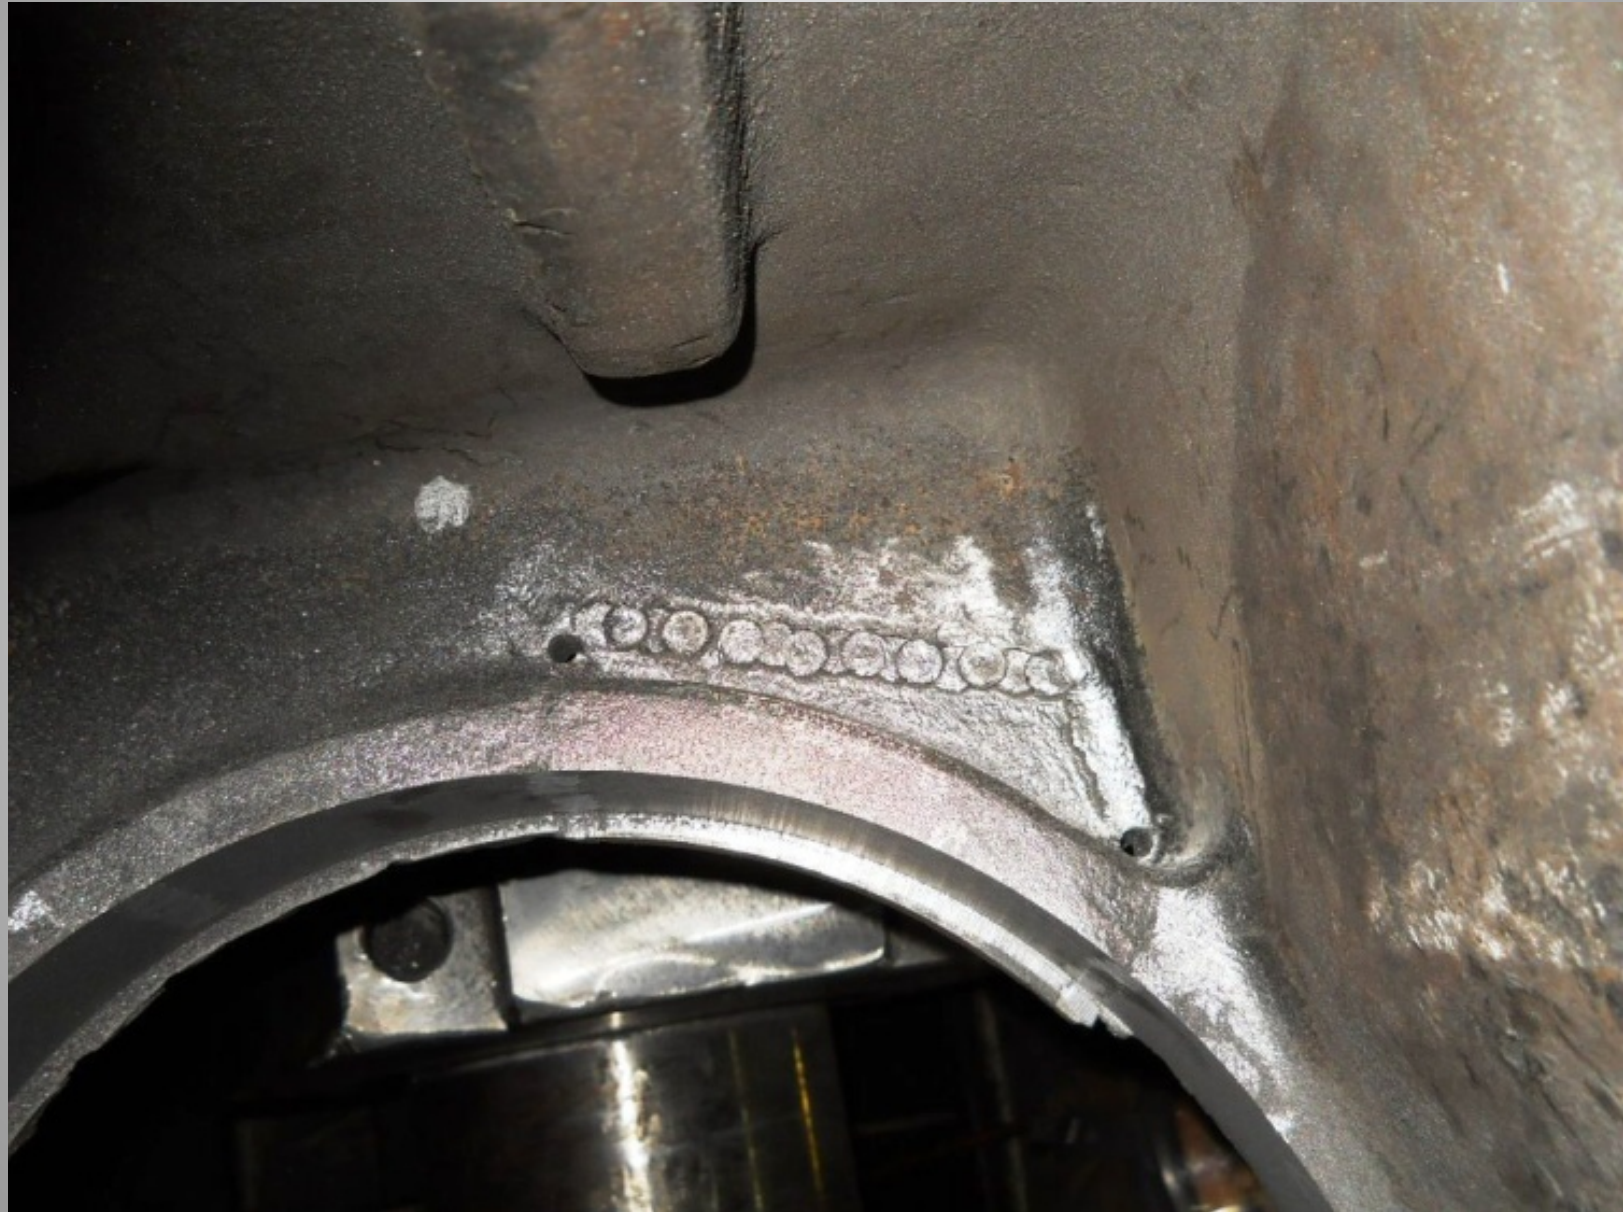
Bores A2 and B2 are bored and ready to accept repair sleeves

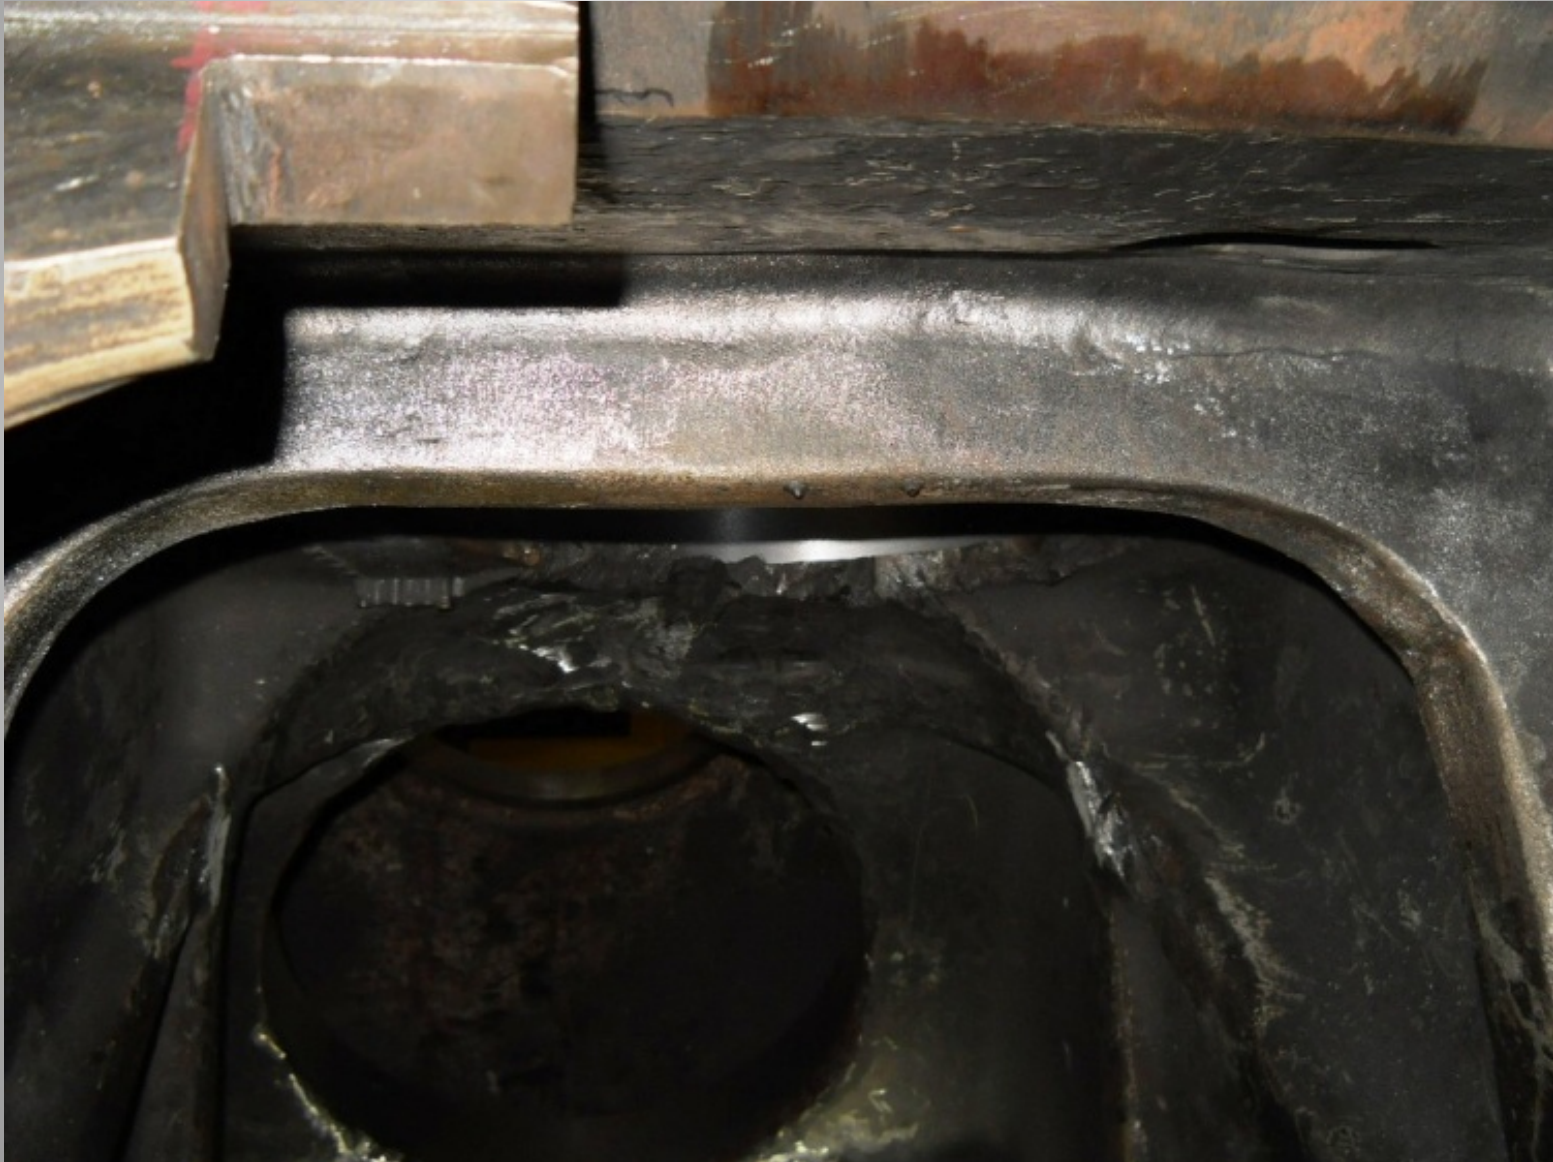
Stiffening bracket side B2 is stitched and ready for finish work

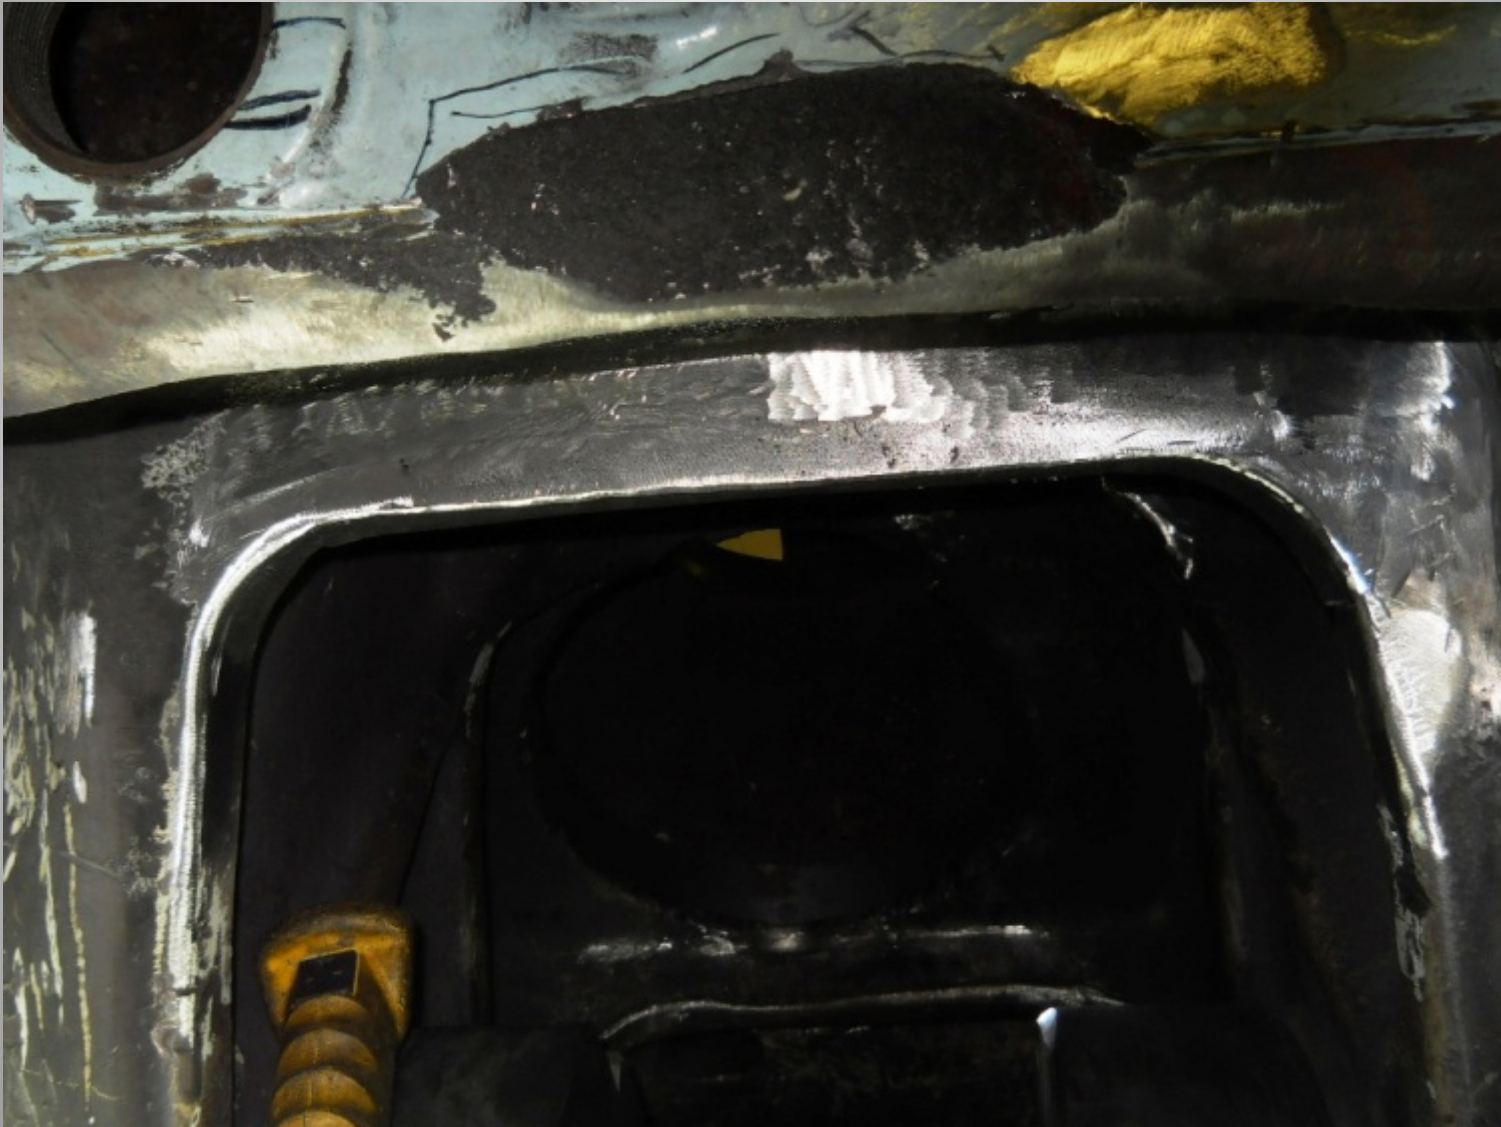
Side B2 main bearing web damage removed and ready to be stitched

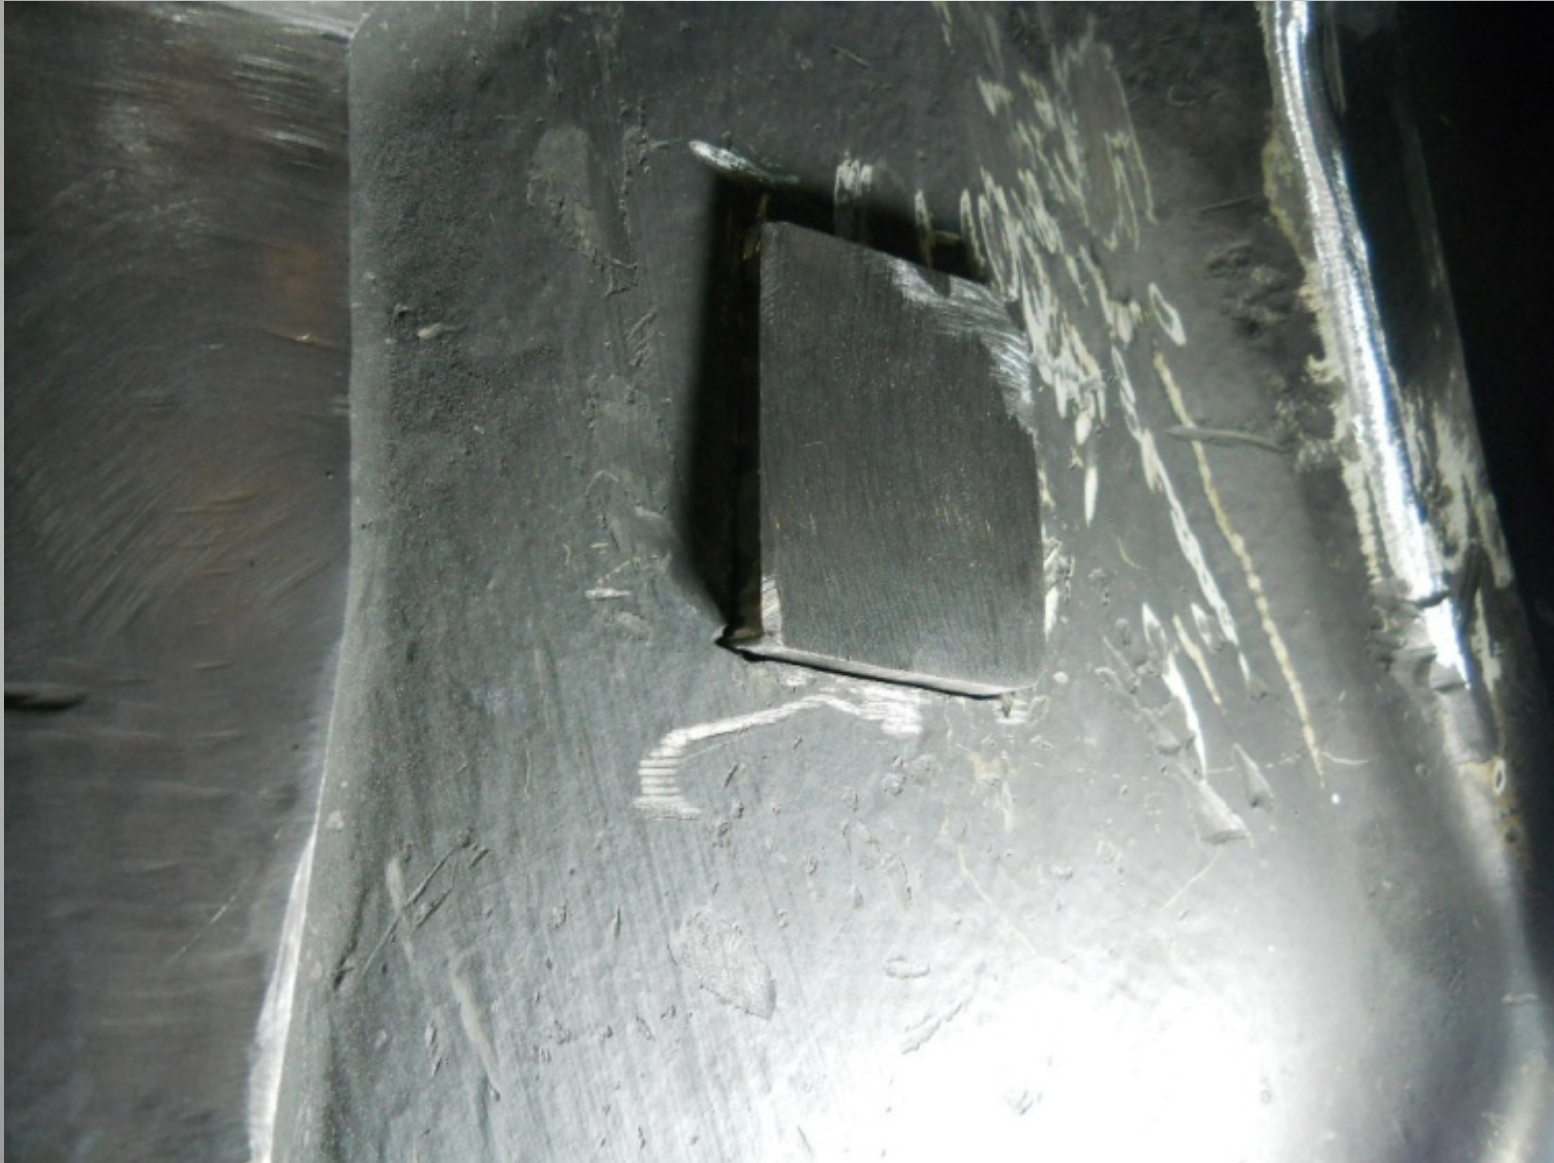
B Side Main Bearing Wall damage casting metal stitching completed and ready to be hand finished

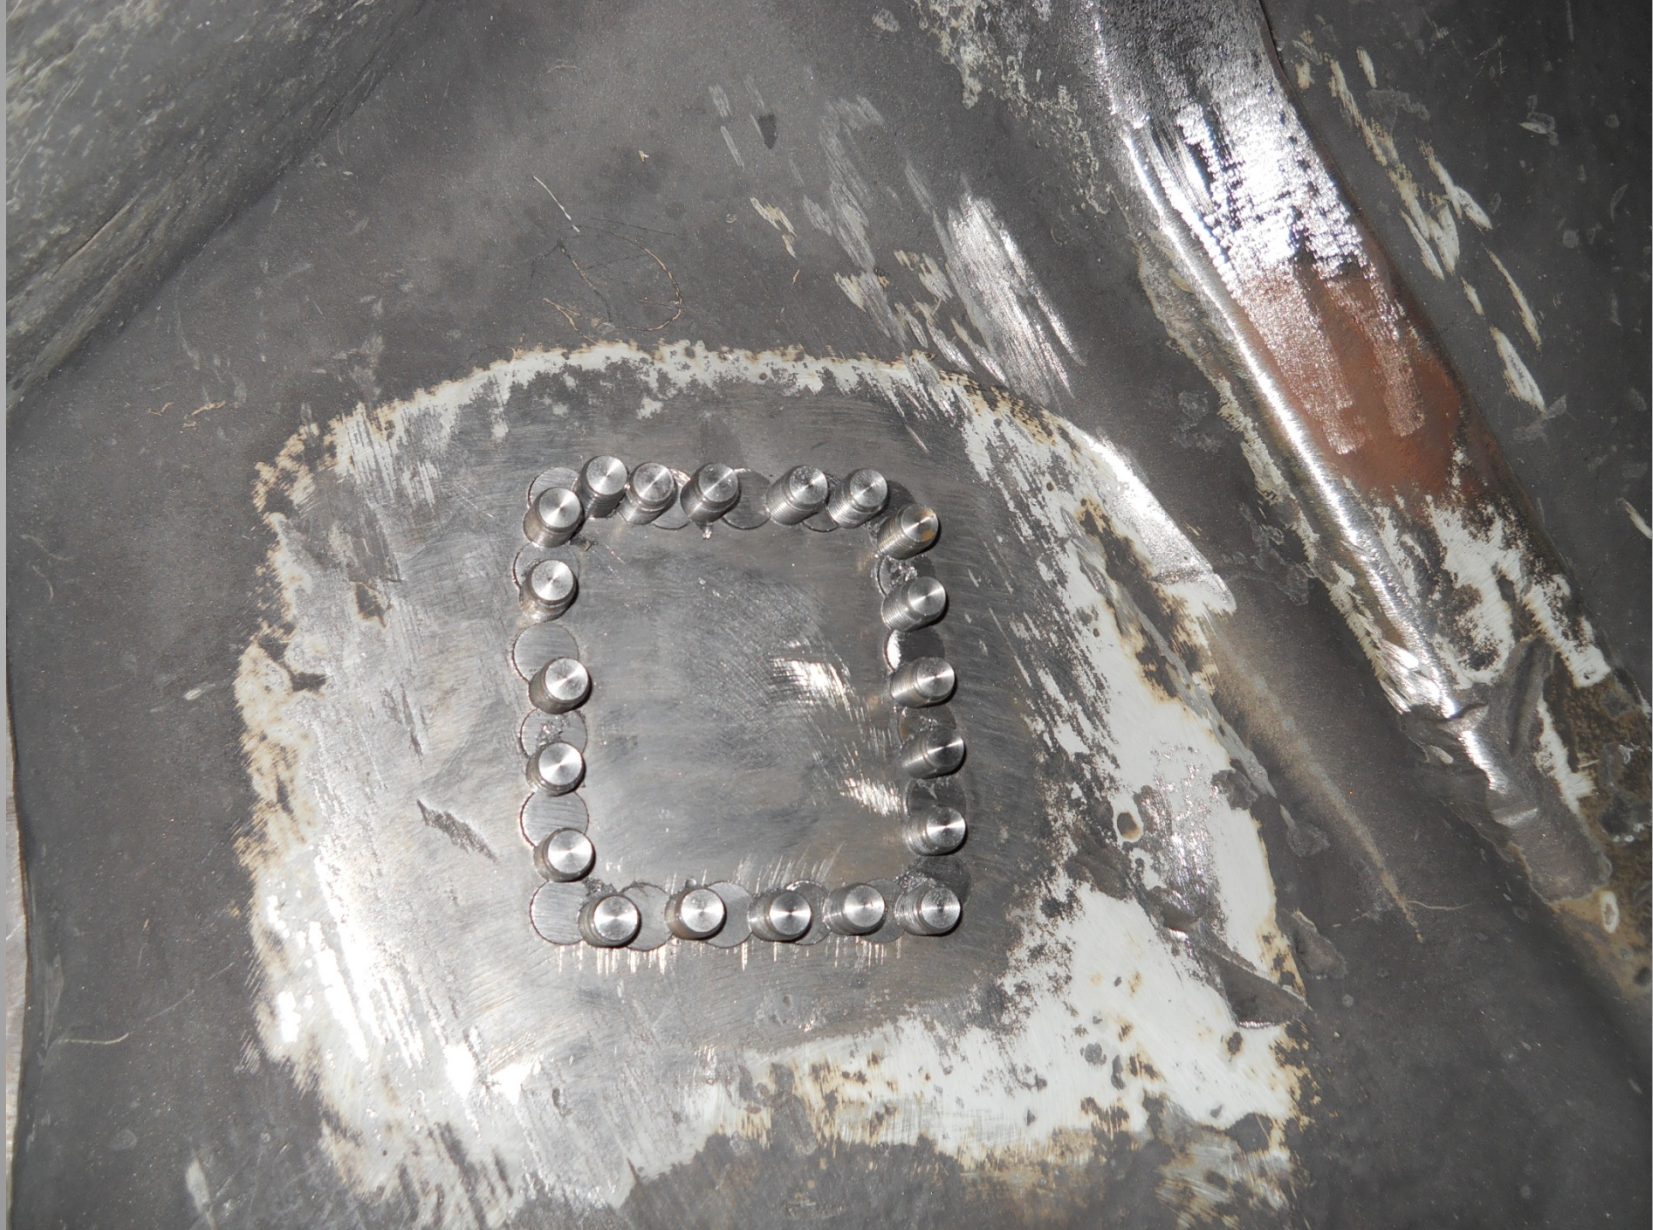
Inspection door side A2 damaged cut out and ready for new casting

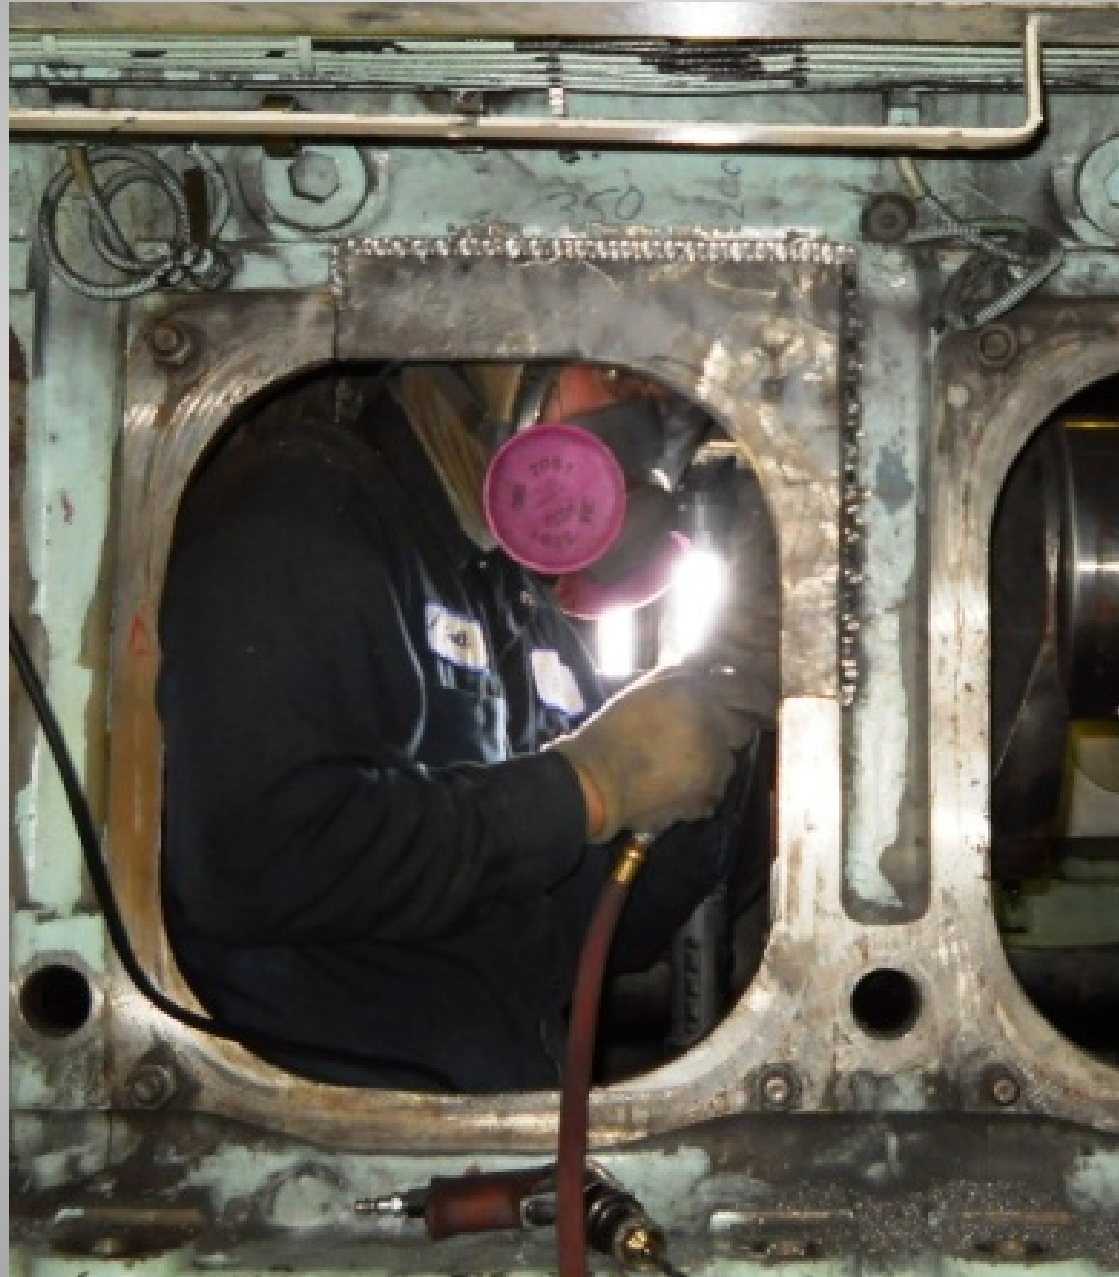
A side inspection door gasket surface repaired and machined

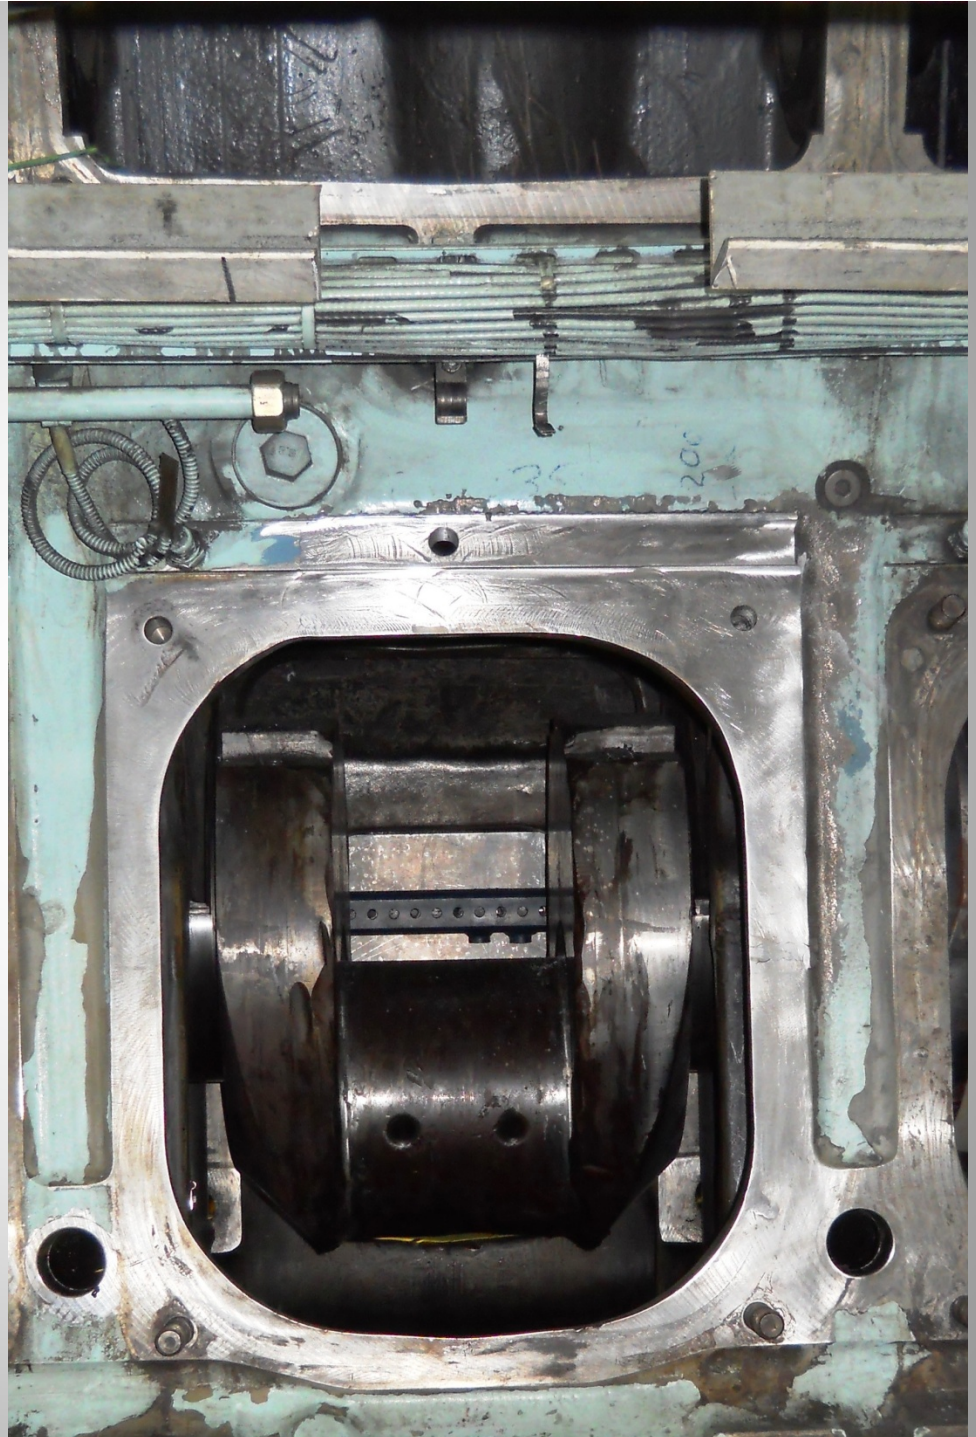
Inspection door B2 damage cut out and still need to cut damaged pocket above door

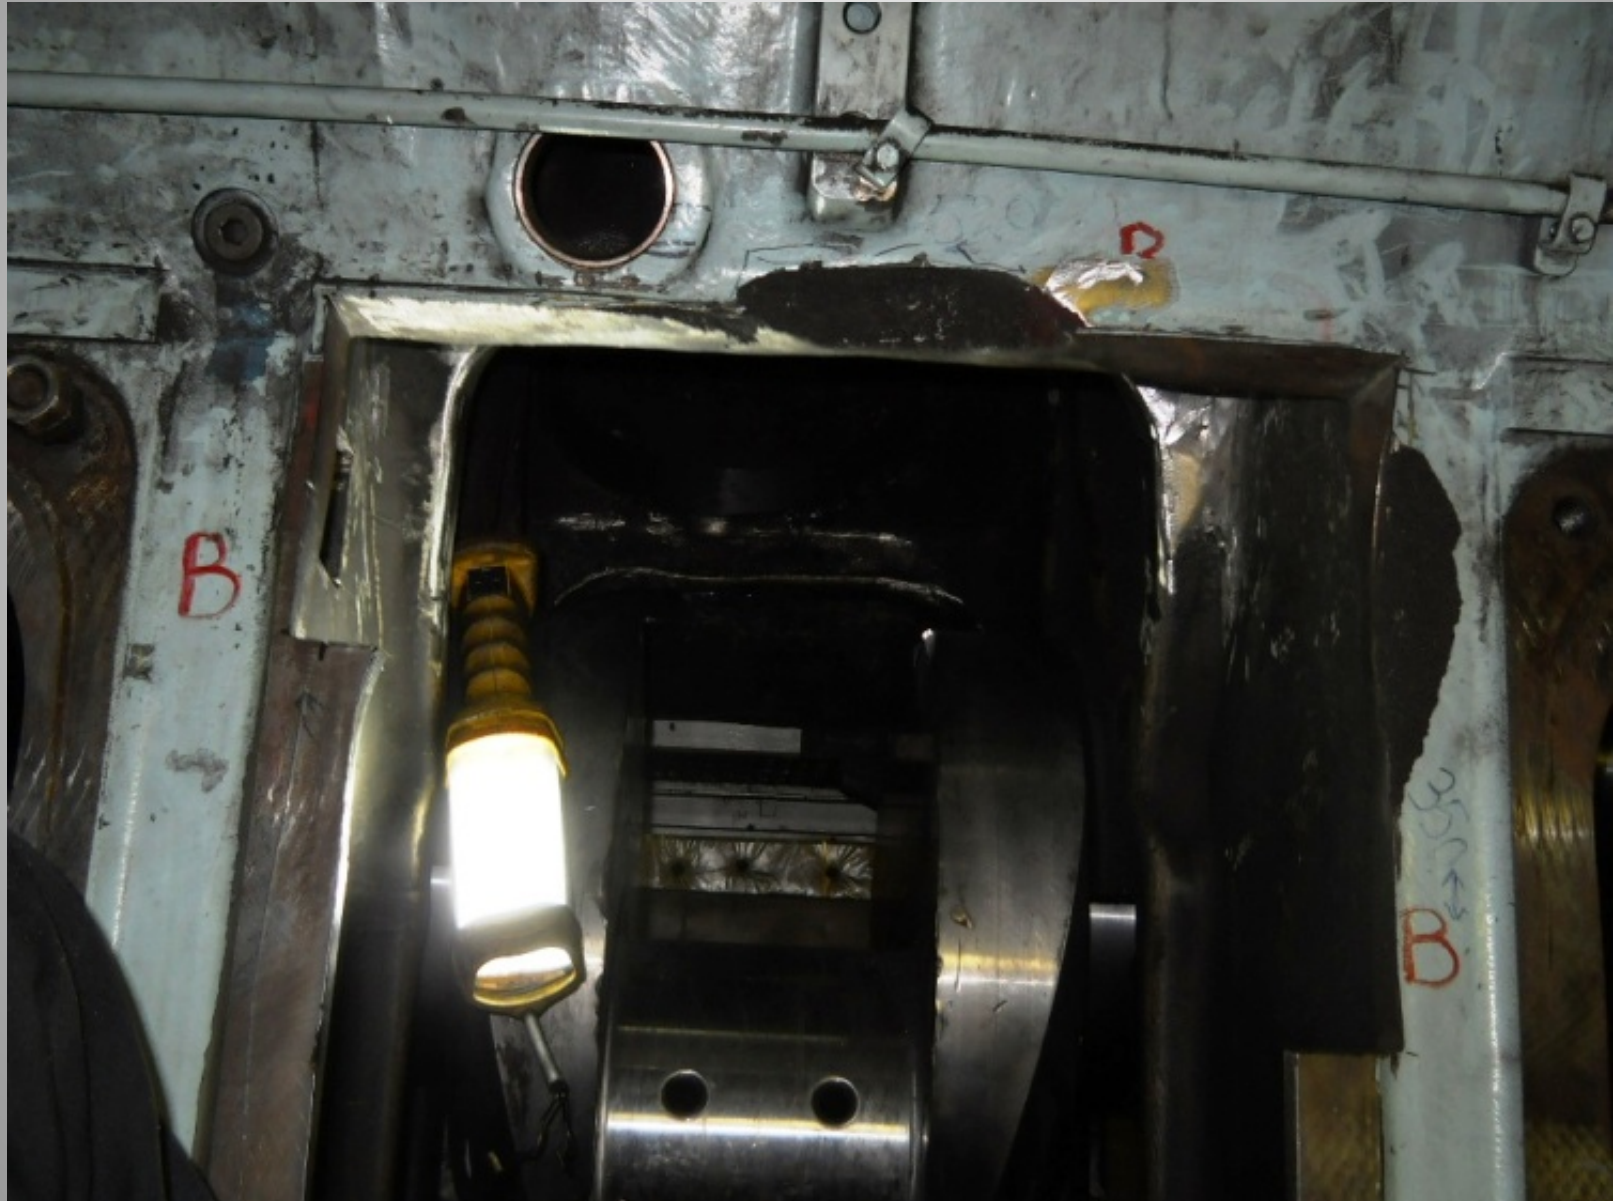
B side inspection gasket surface casting fitted and ready to be metal stitched

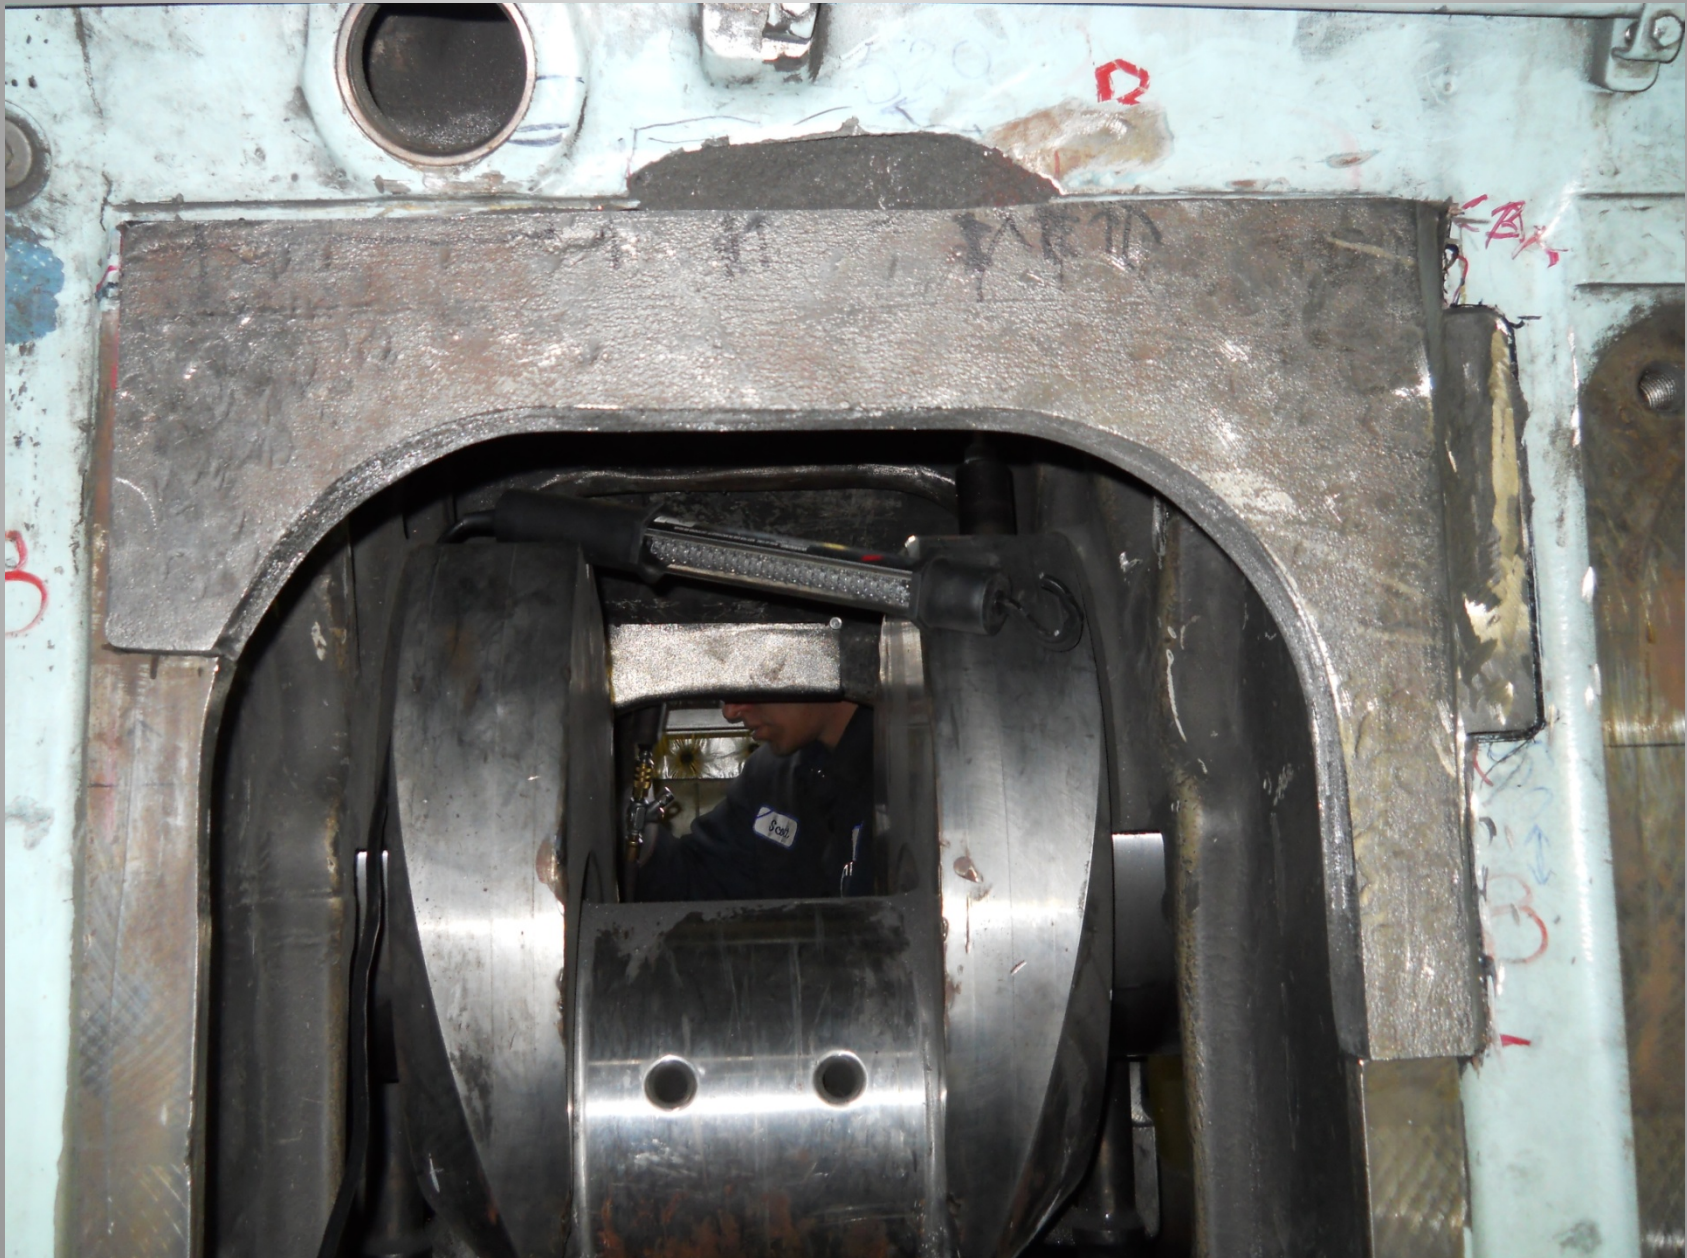
Metal stitching in process on the B side Inspection Door Gasket Surface

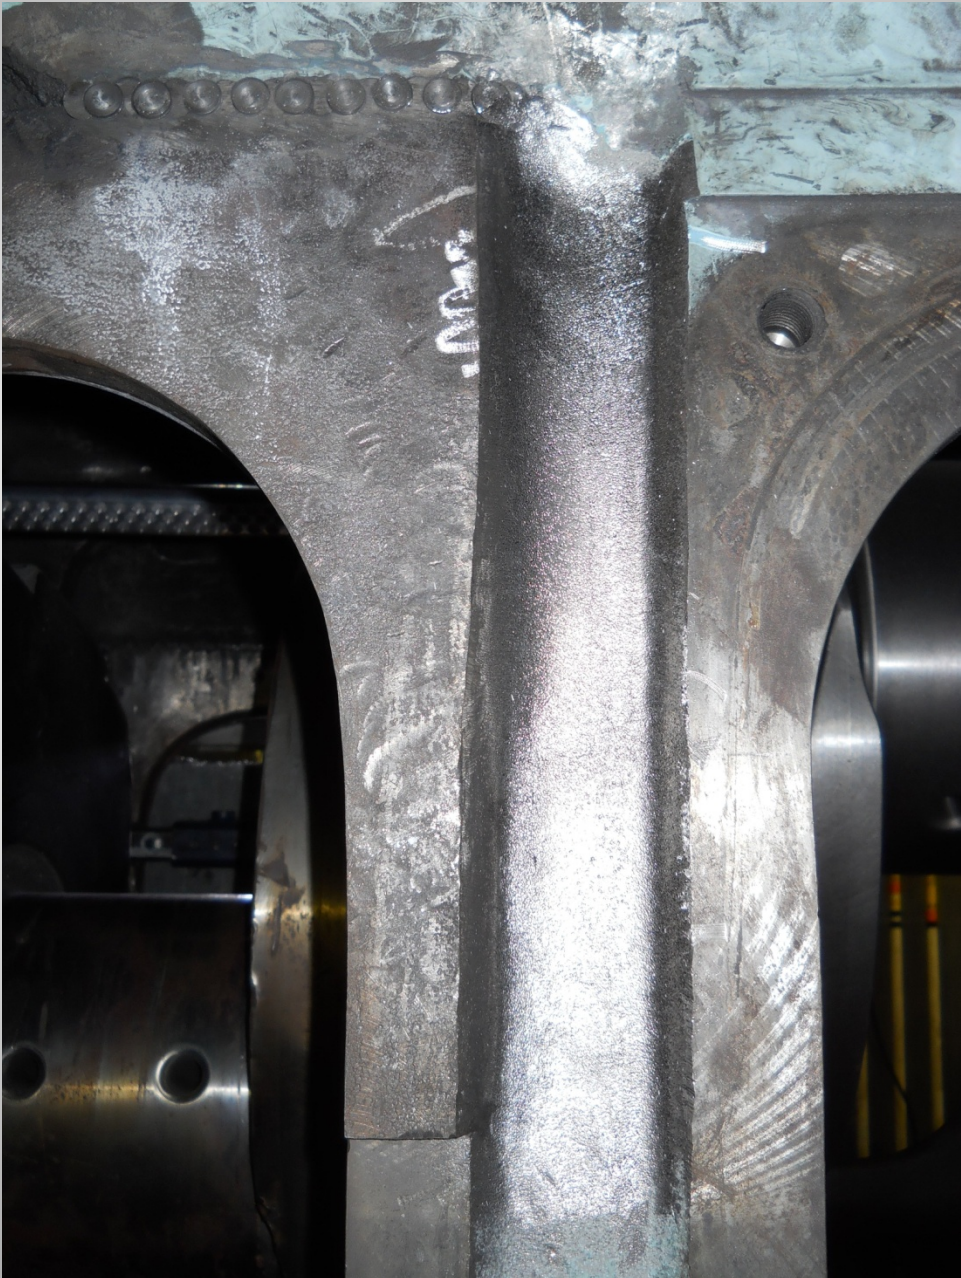
7' Climax bed Mill machining the gasket surfaces on the inspection door

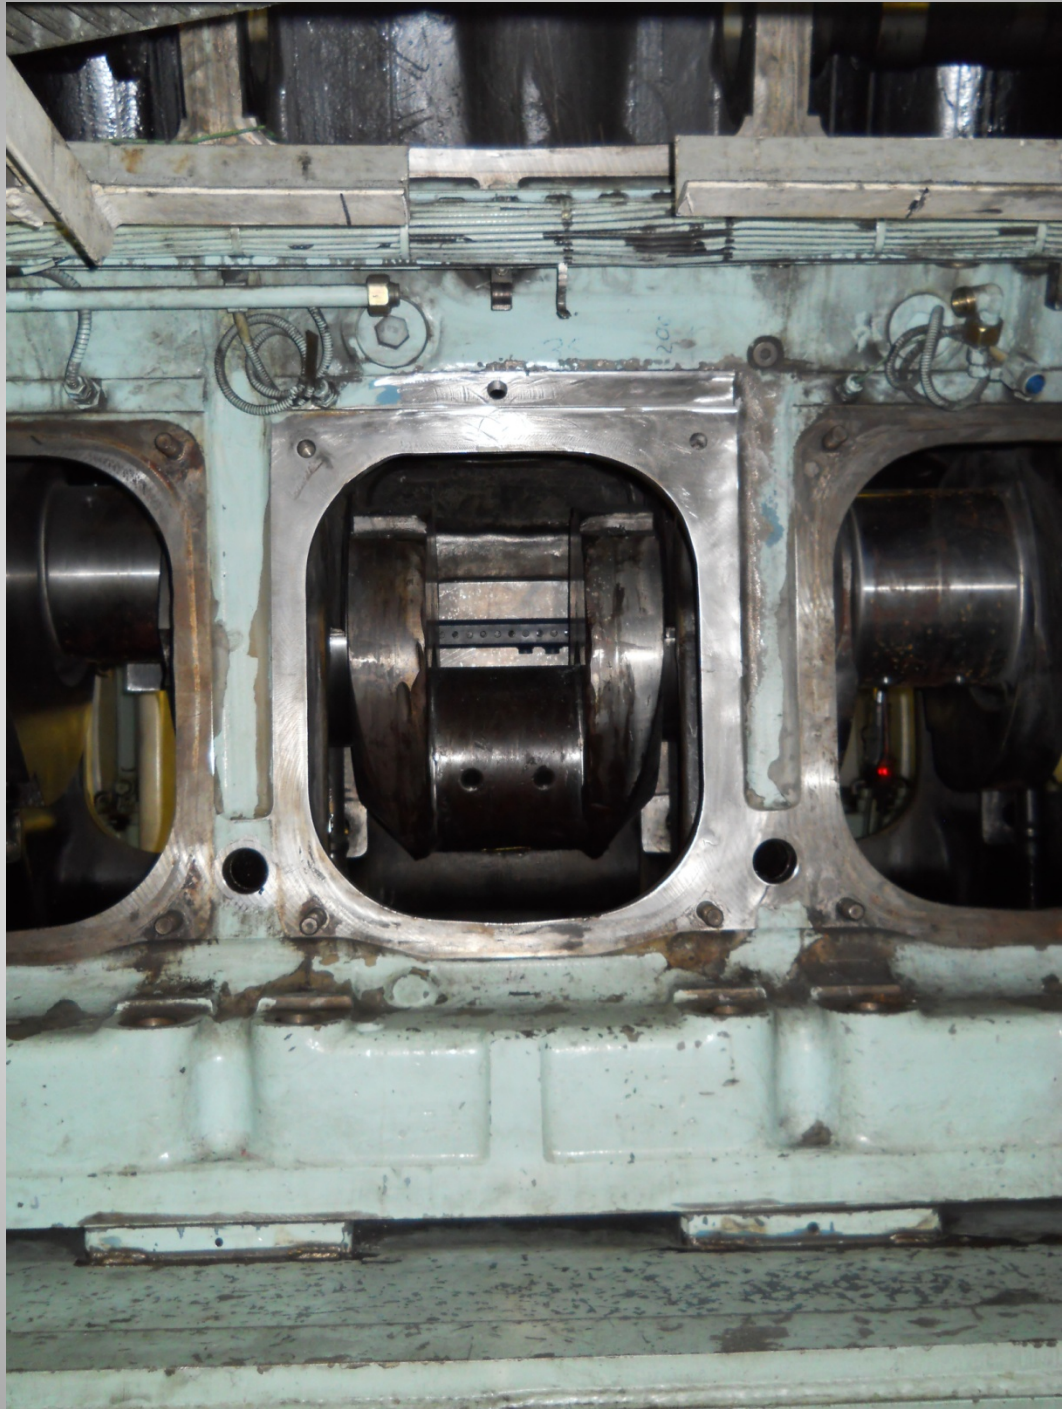
Final repair inspection process

1. LNS technicians performed in-process and final inspections of each repair site once the metal stitching process for that area was concluded.
2. The process involved using a magnetic particle inspection process with either dry powder or wet particle methods.
3. The metal stitching locks and stitching pins have magnetic properties that are slightly different from the cast iron so the outline of the repairs attracts the magnetic powder when a special magnet is placed on the part with the North and south poles spanning the repair.
4. This method quickly and easily shows any gaps between the pins or any crack that may have been missed.
5. If a gap is detected on either side of the repaired wall, additional stitching pins could have been added to the repair.
6. The final inspection showed no spaces, gaps or cracks at or around the metal stitching repairs that were repaired.
