Ingersol-Rand KVS Compressor Repairs for Brown& Root Elk Hills, California 2003

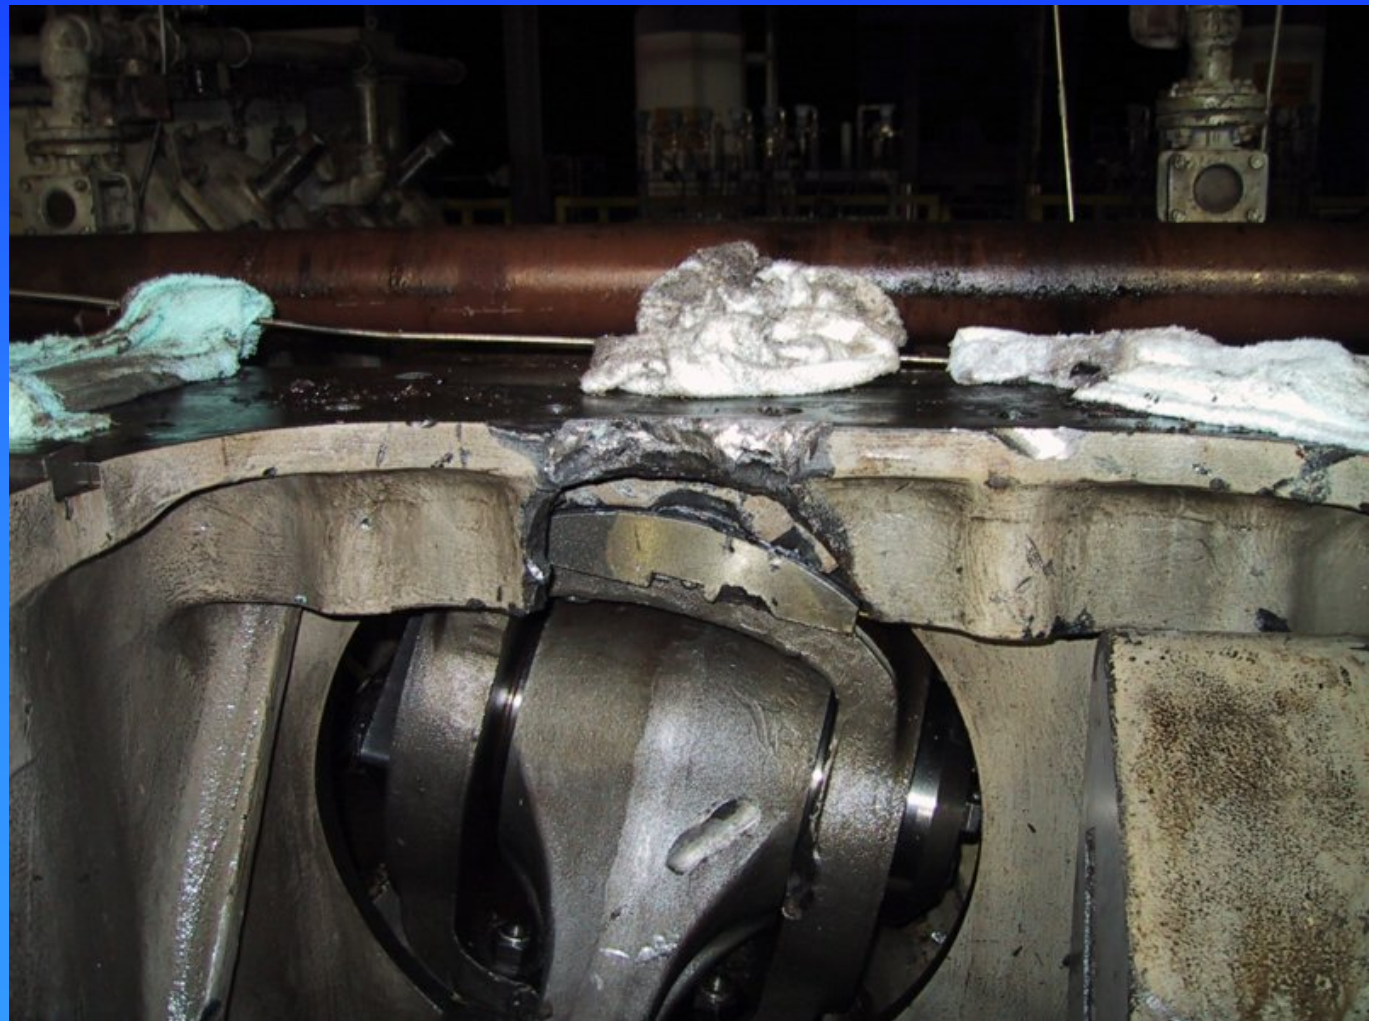
Serious damage occurred due to a connecting rod failure

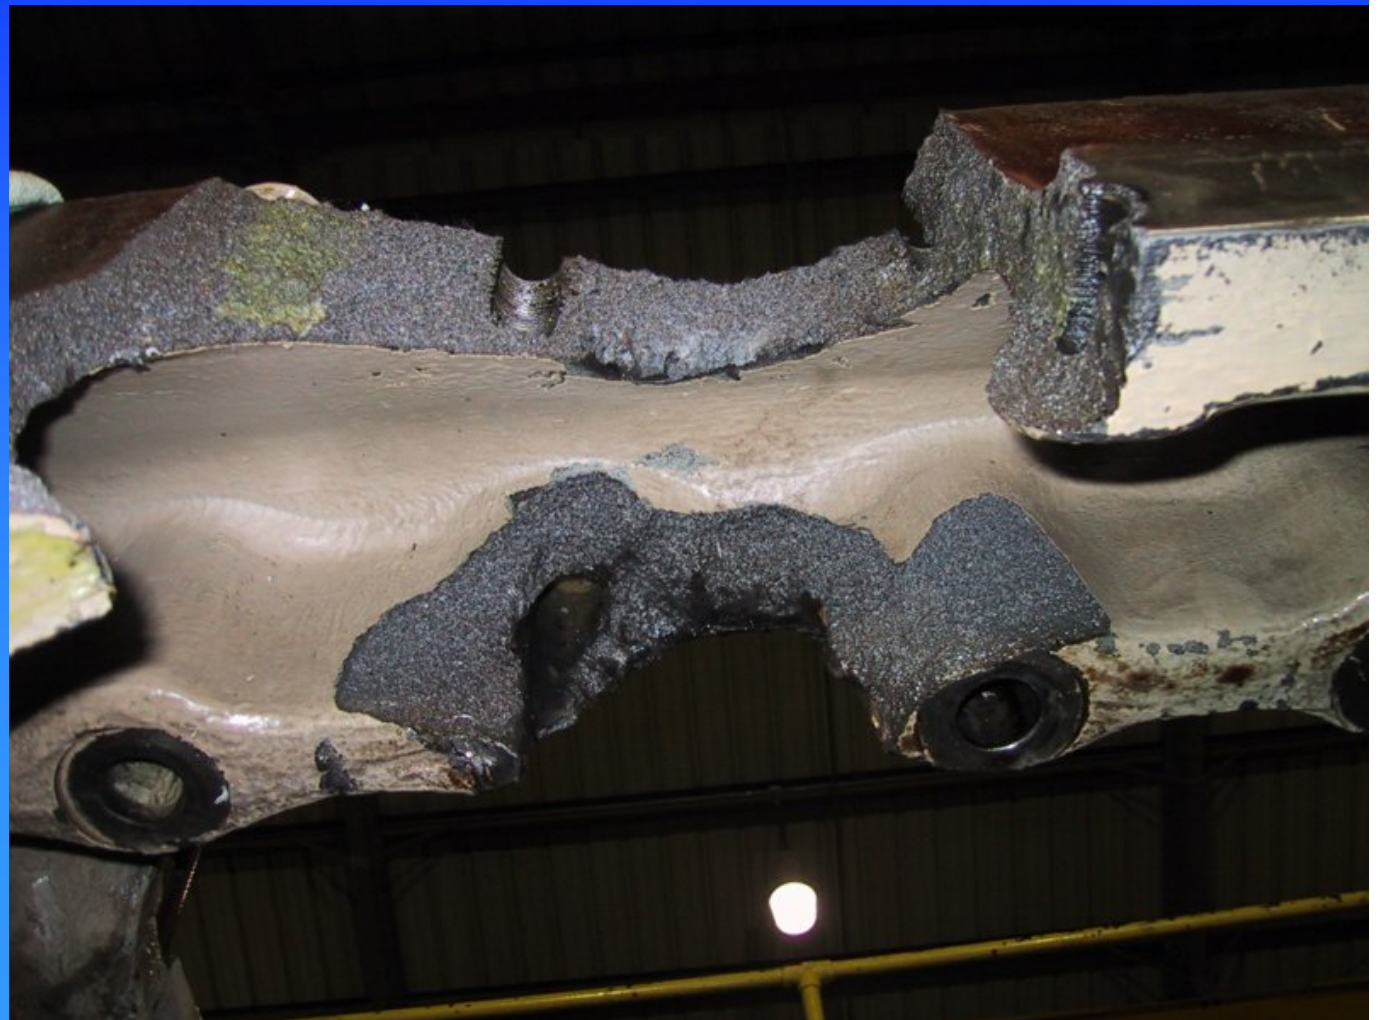
Both sides of the frame suffered damage

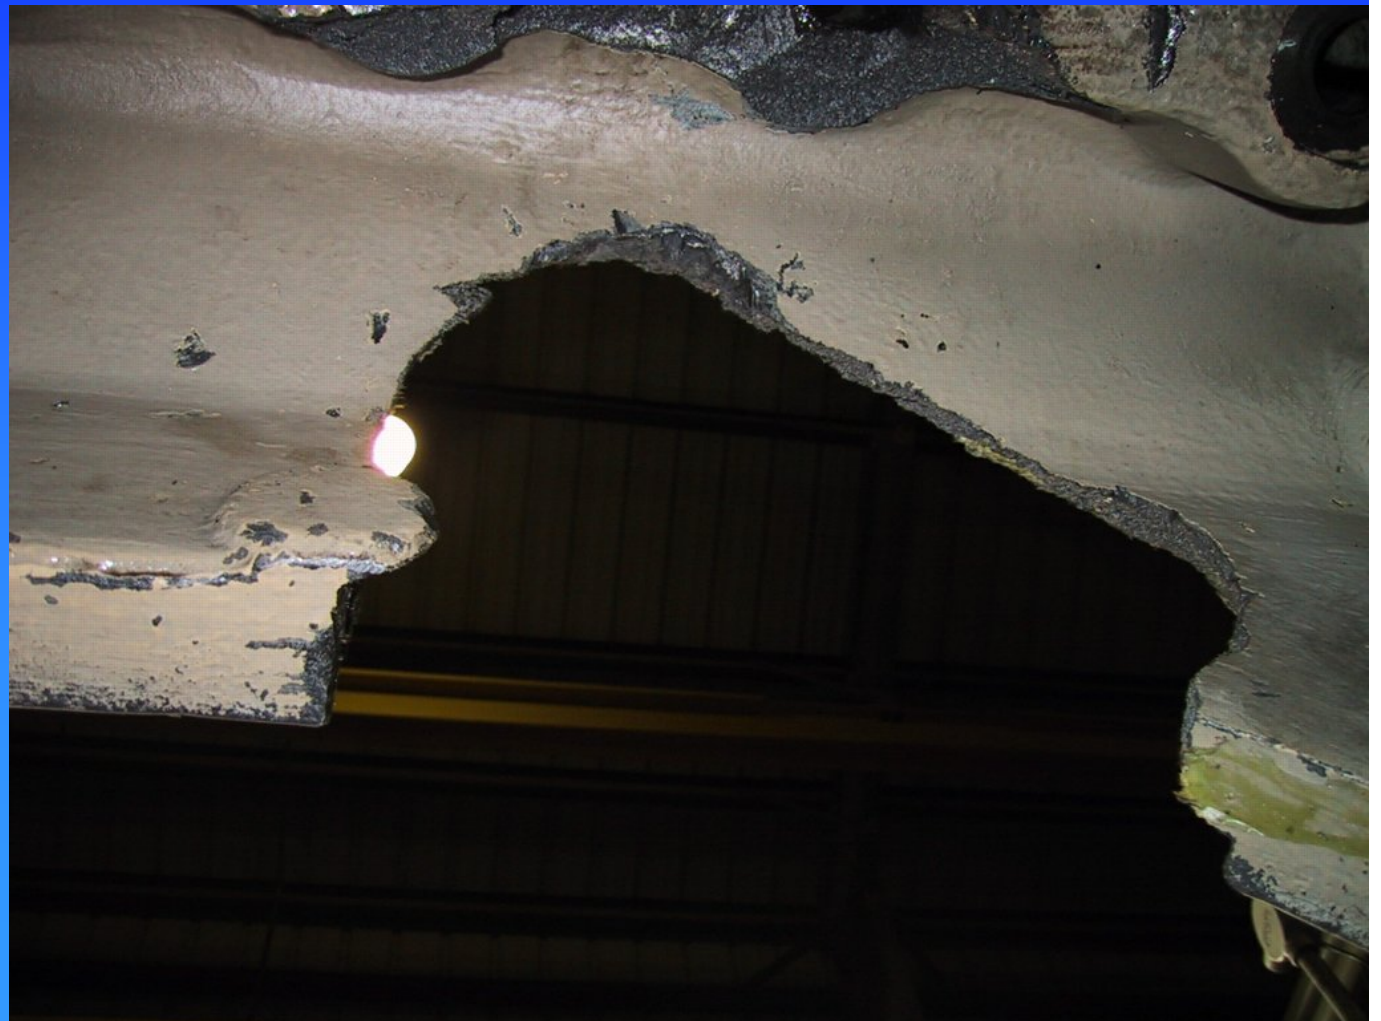
Inside view of the large hole on
the side of the frame

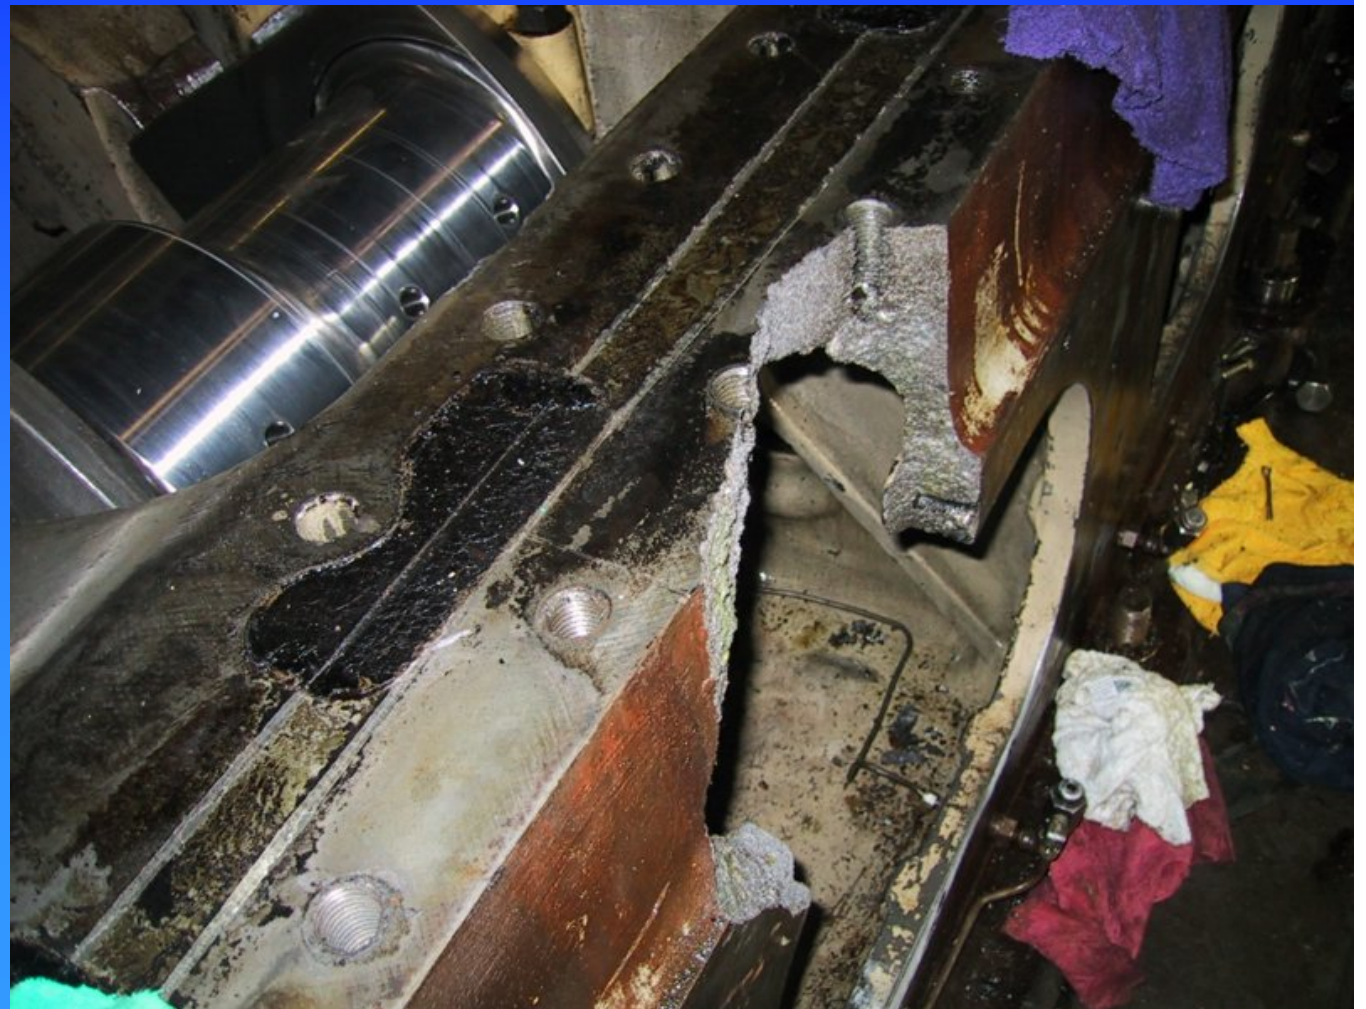
Top view of the same large hole
on the side of the frame

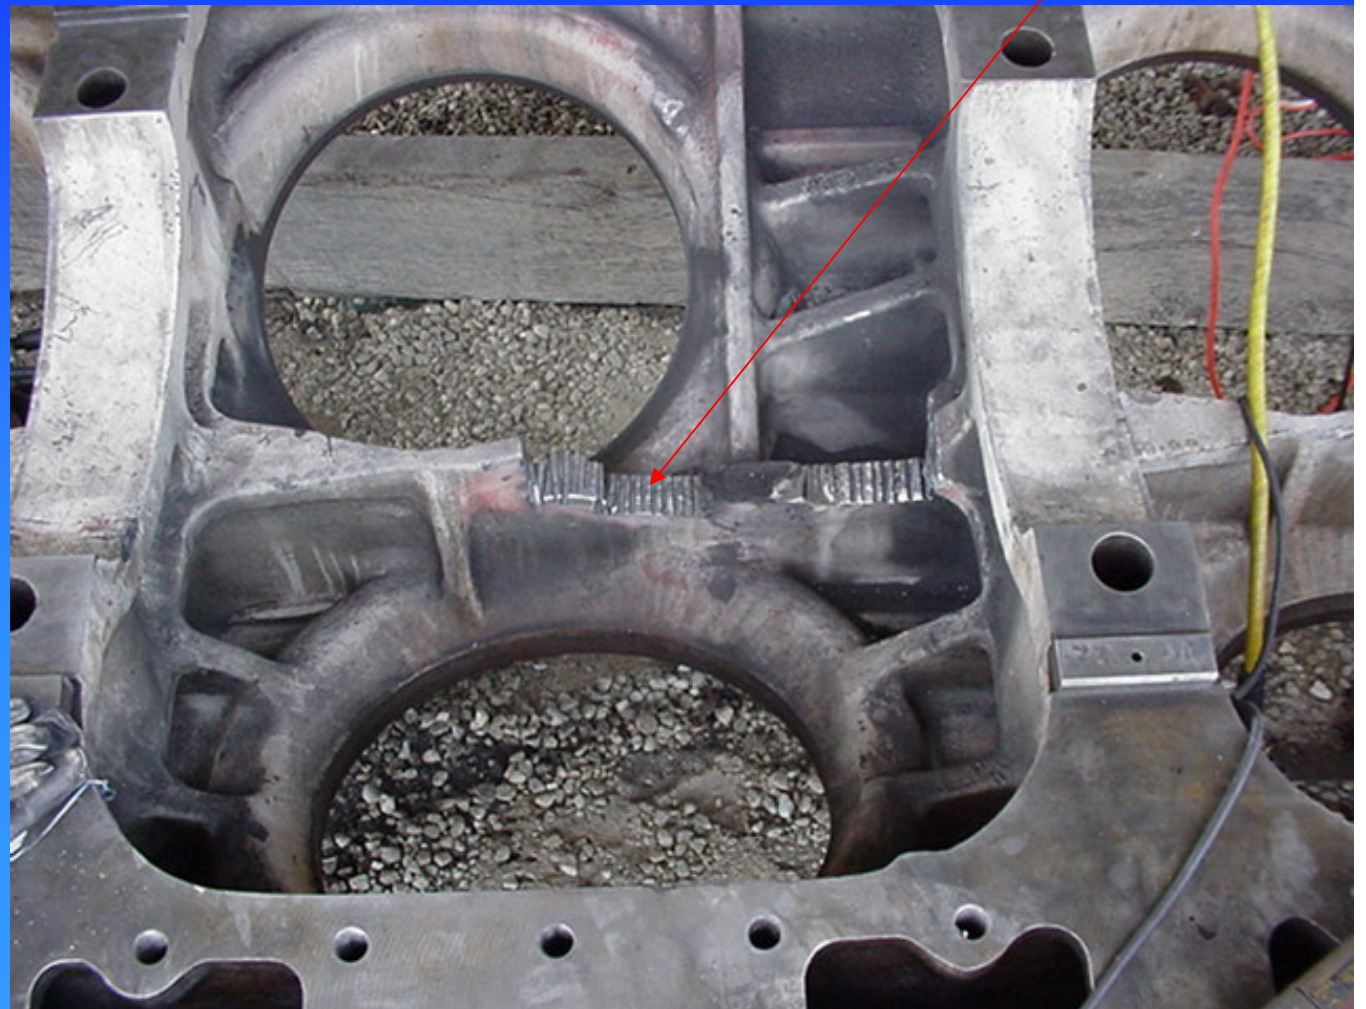
The underside of the top half of the frame was also damaged

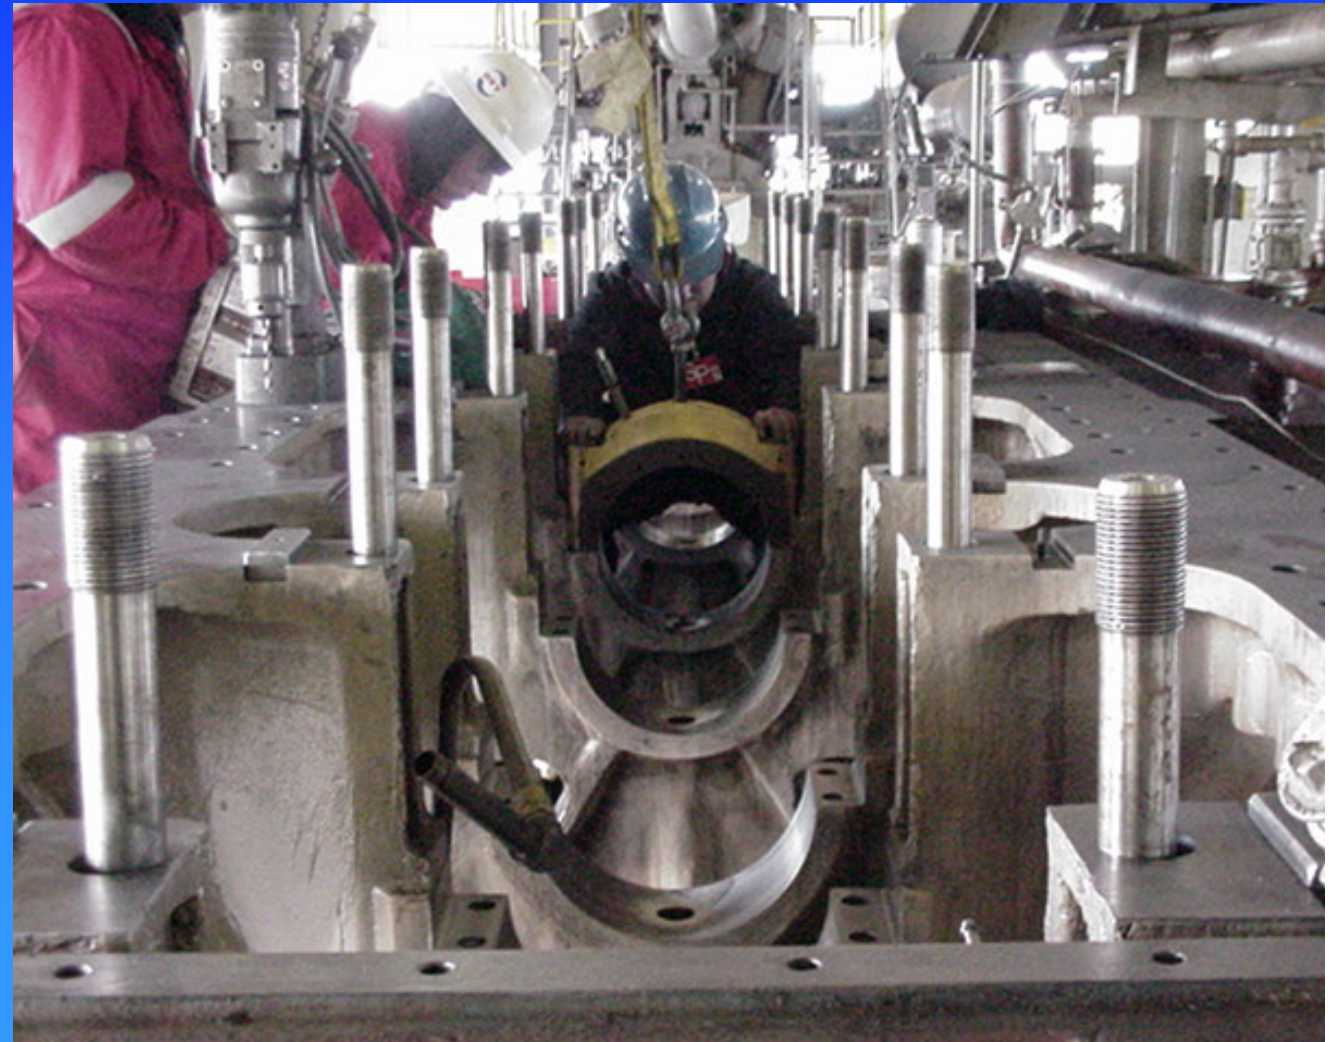
Main bearing caps are inspected for fit

The jaw fit on all caps were loose and required oven fusion welding and machining to reestablish the correct fit.

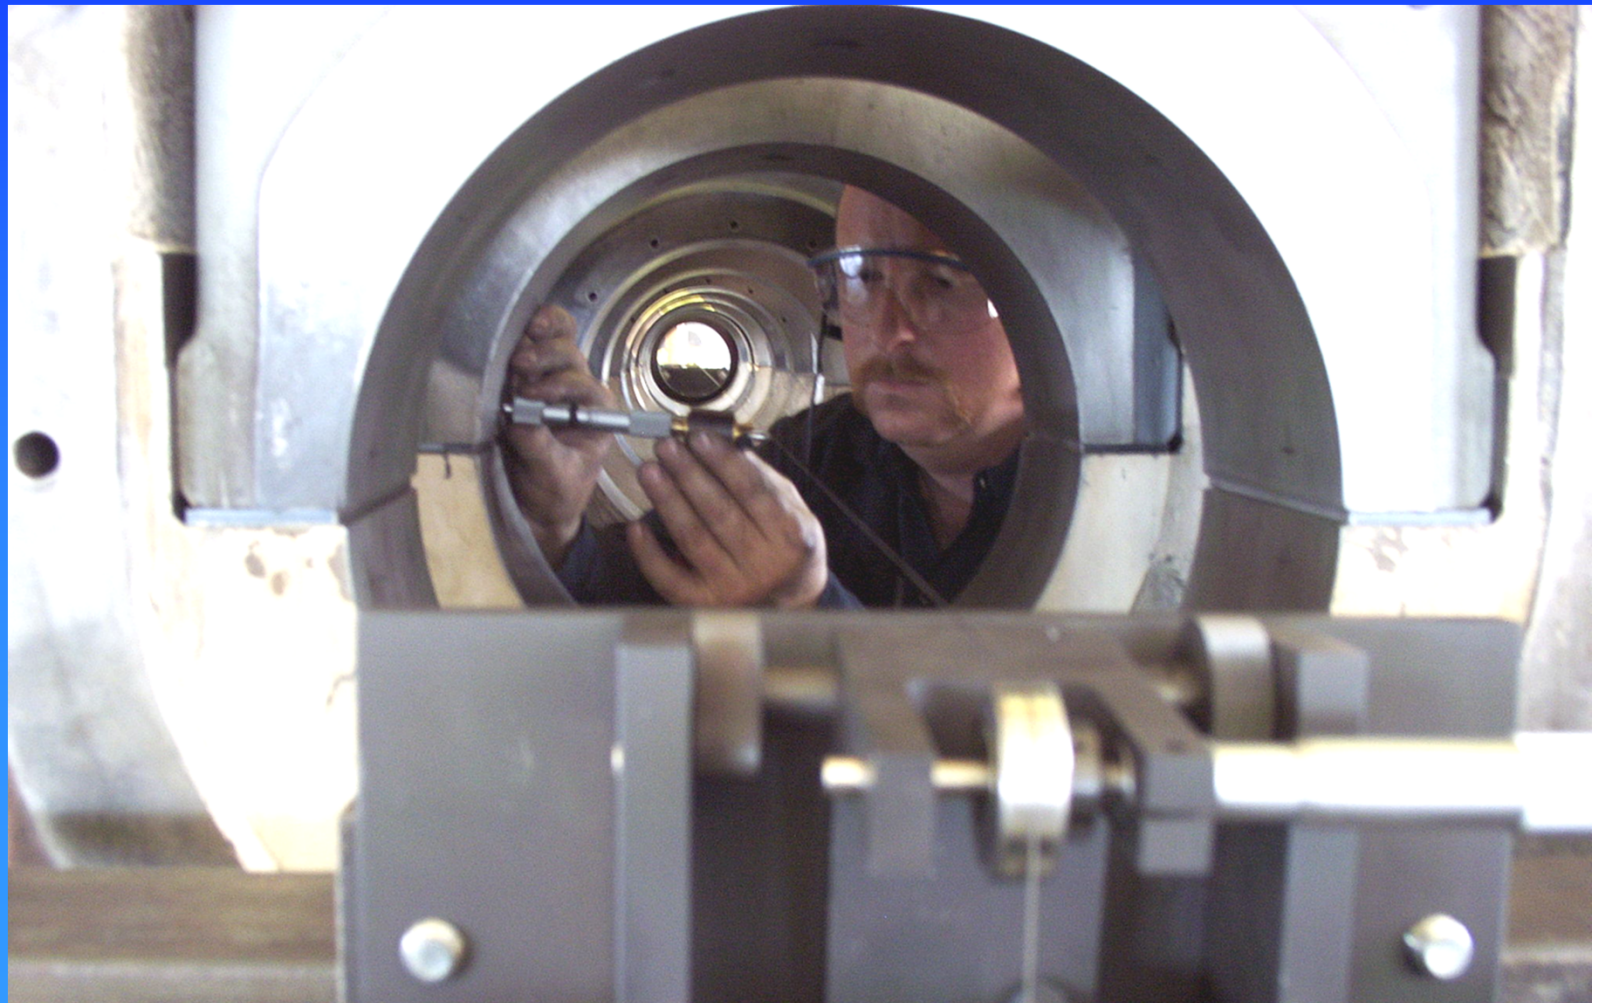
The line bore was checked with a wire line to map the straightness of the bore.

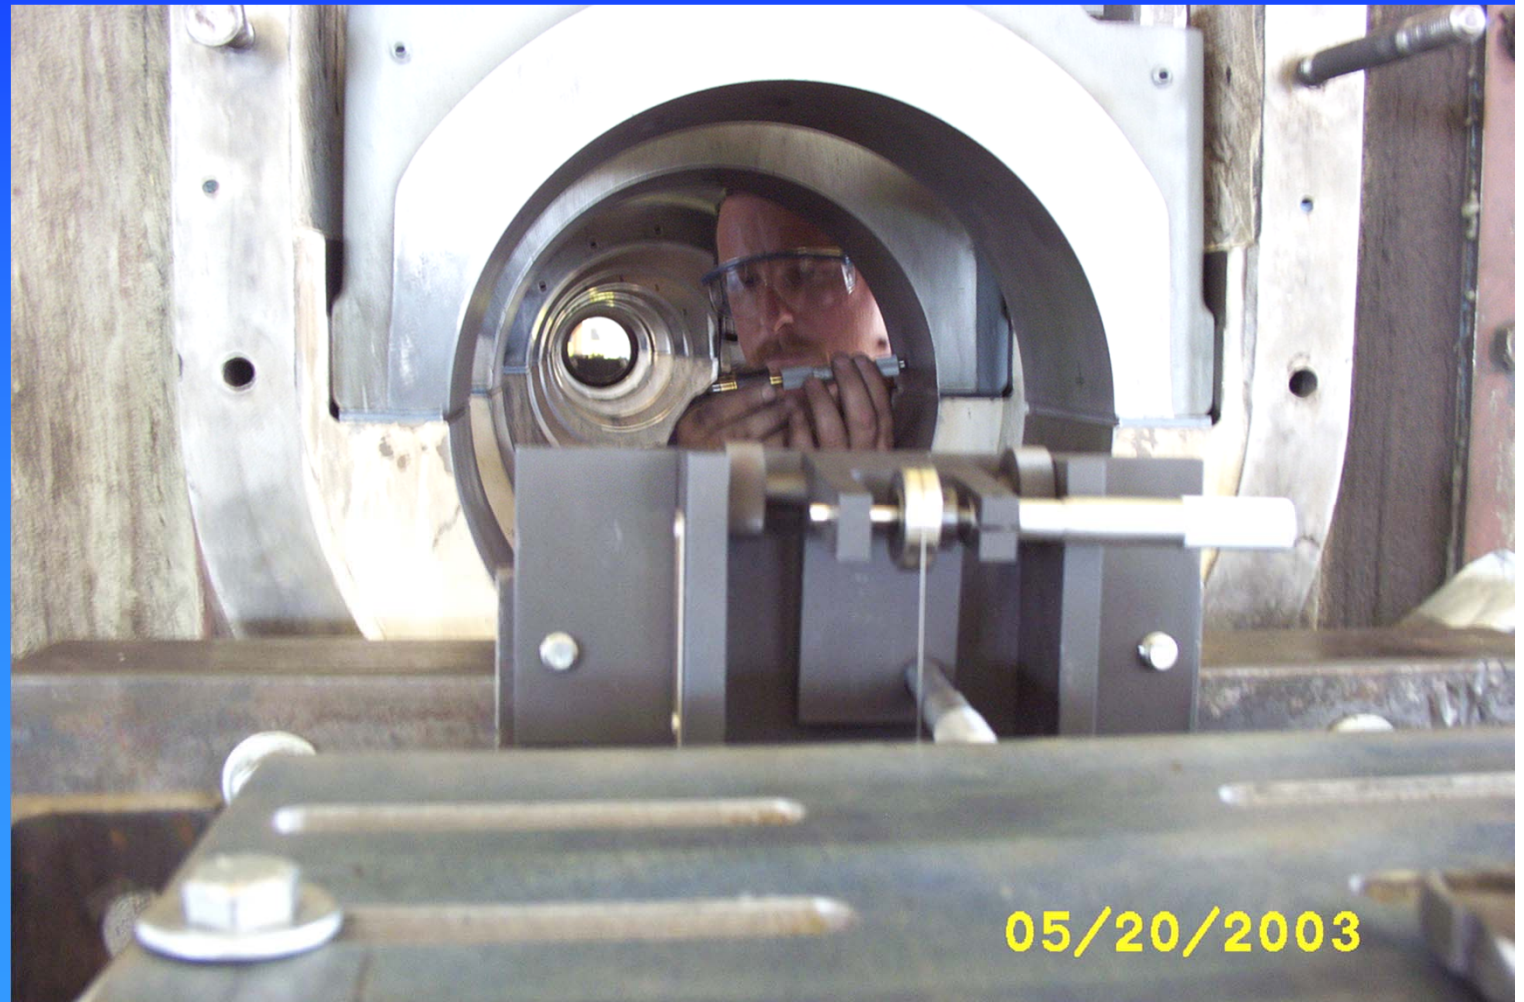
After boring, the bore is inspected by wire line to measure the diameter and straightness of the bores
