LNG tanker Wartsila Engine repair

Repair completed by *LOCK-N-STITCH* Inc.

July 2012

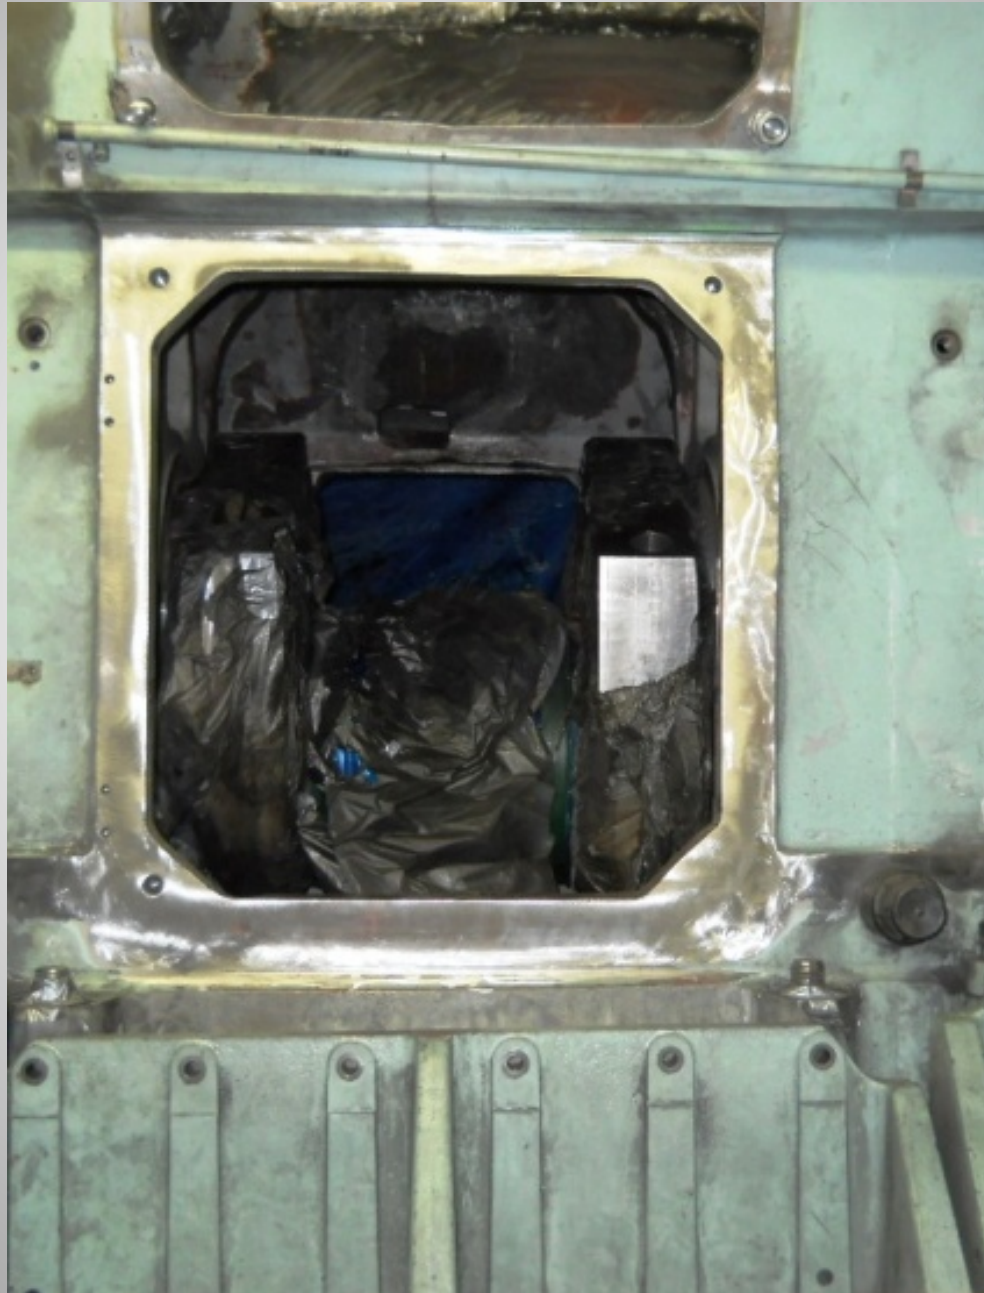
Damaged A side inspection door

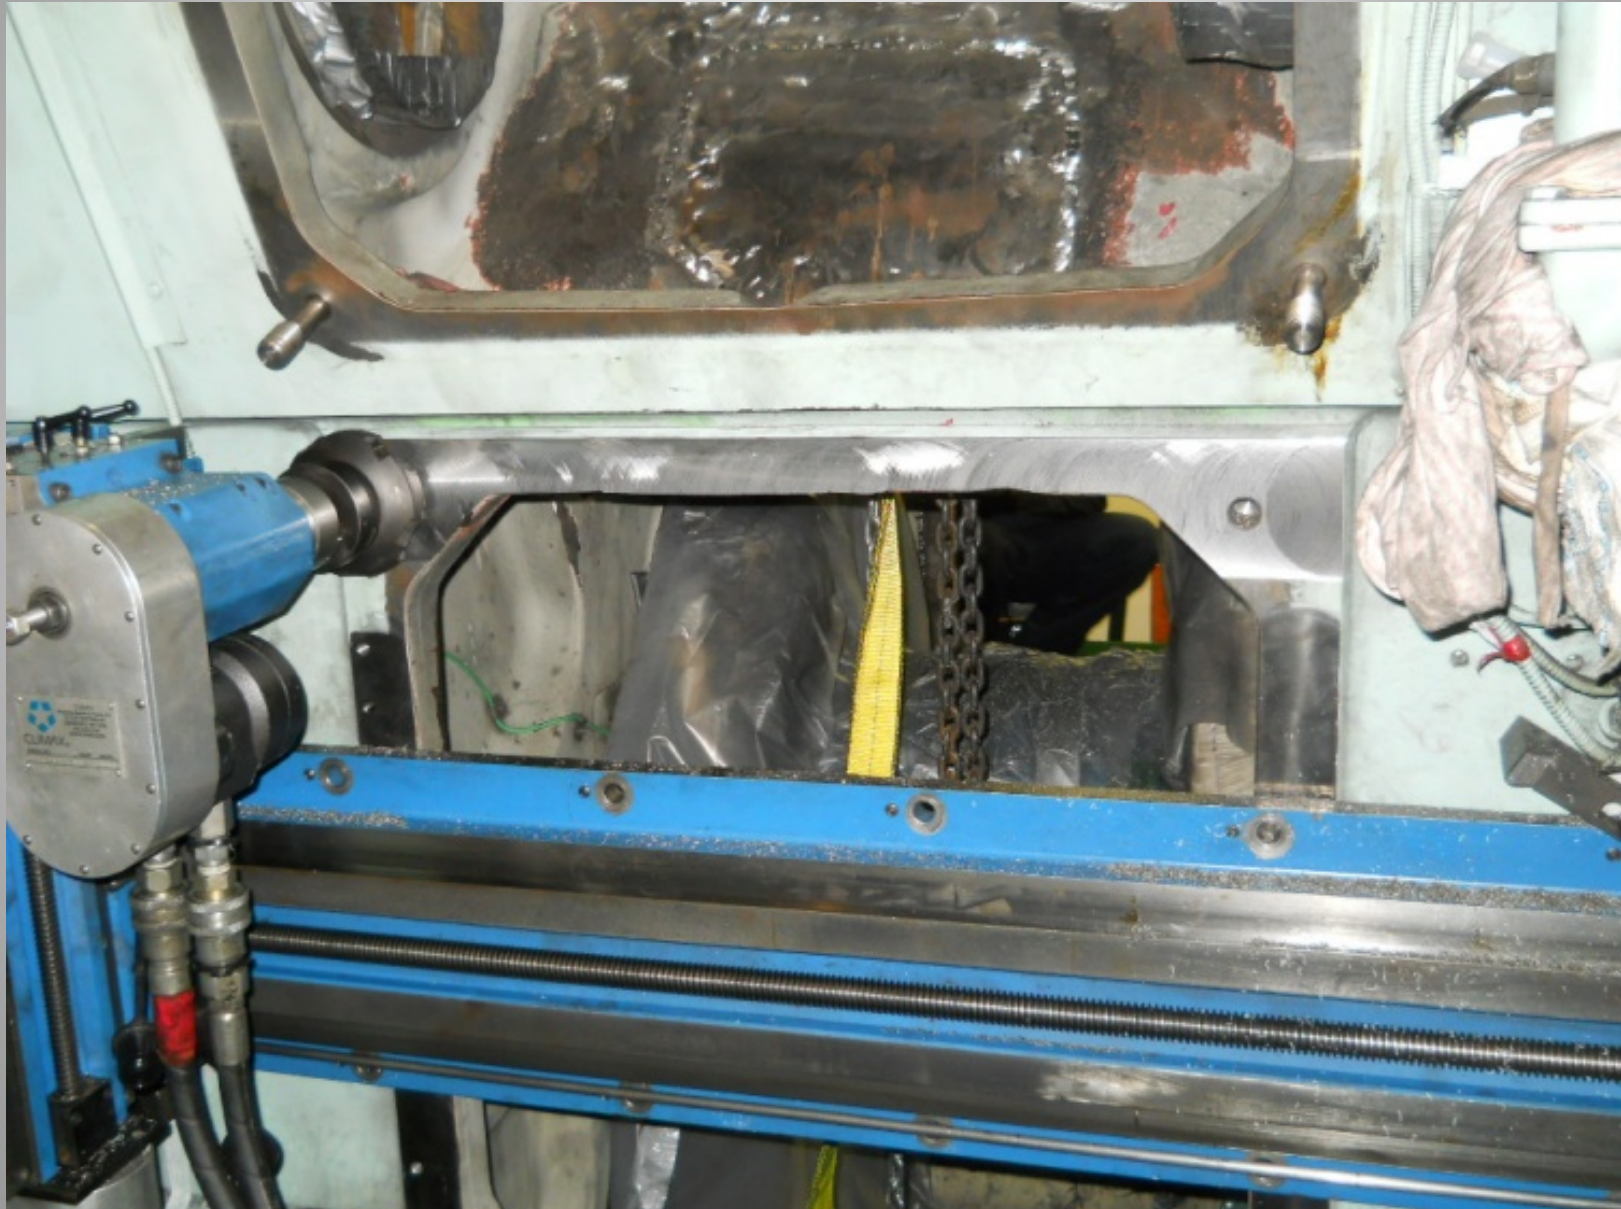
Damaged area on the inside of the water channel

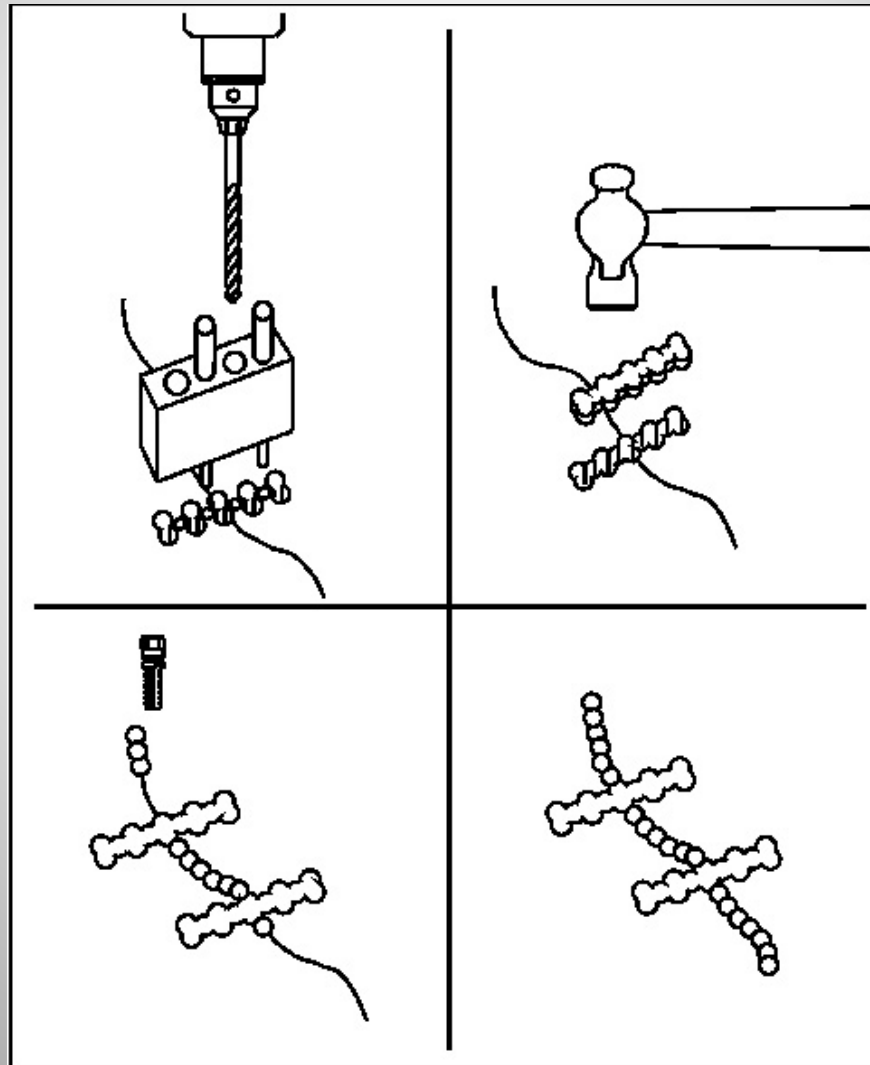
Final repair inspection process

1. LNS technicians performed in-process and final inspections of each repair site once the metal stitching process for that area was concluded.
2. The process involved using a magnetic particle inspection process with either dry powder or wet particle methods.
3. The metal stitching locks and stitching pins have magnetic properties that are slightly different from the cast iron so the outline of the repairs attracts the magnetic powder when a special magnet is placed on the part with the North and south poles spanning the repair.
4. This method quickly and easily shows any gaps between the pins or any crack that may have been missed.
5. If a gap is detected on either side of the repaired wall, additional stitching pins could have been added to the repair.
6. The final inspection showed no spaces, gaps or cracks at or around the metal stitching repairs that were repaired.
