**LOCK-N-STITCH Inc.**  
Casting Repair Specialists  
1015 S. Soderquist Rd.  
Turlock CA 95380

## **Final Report**

Date 12/18/2012

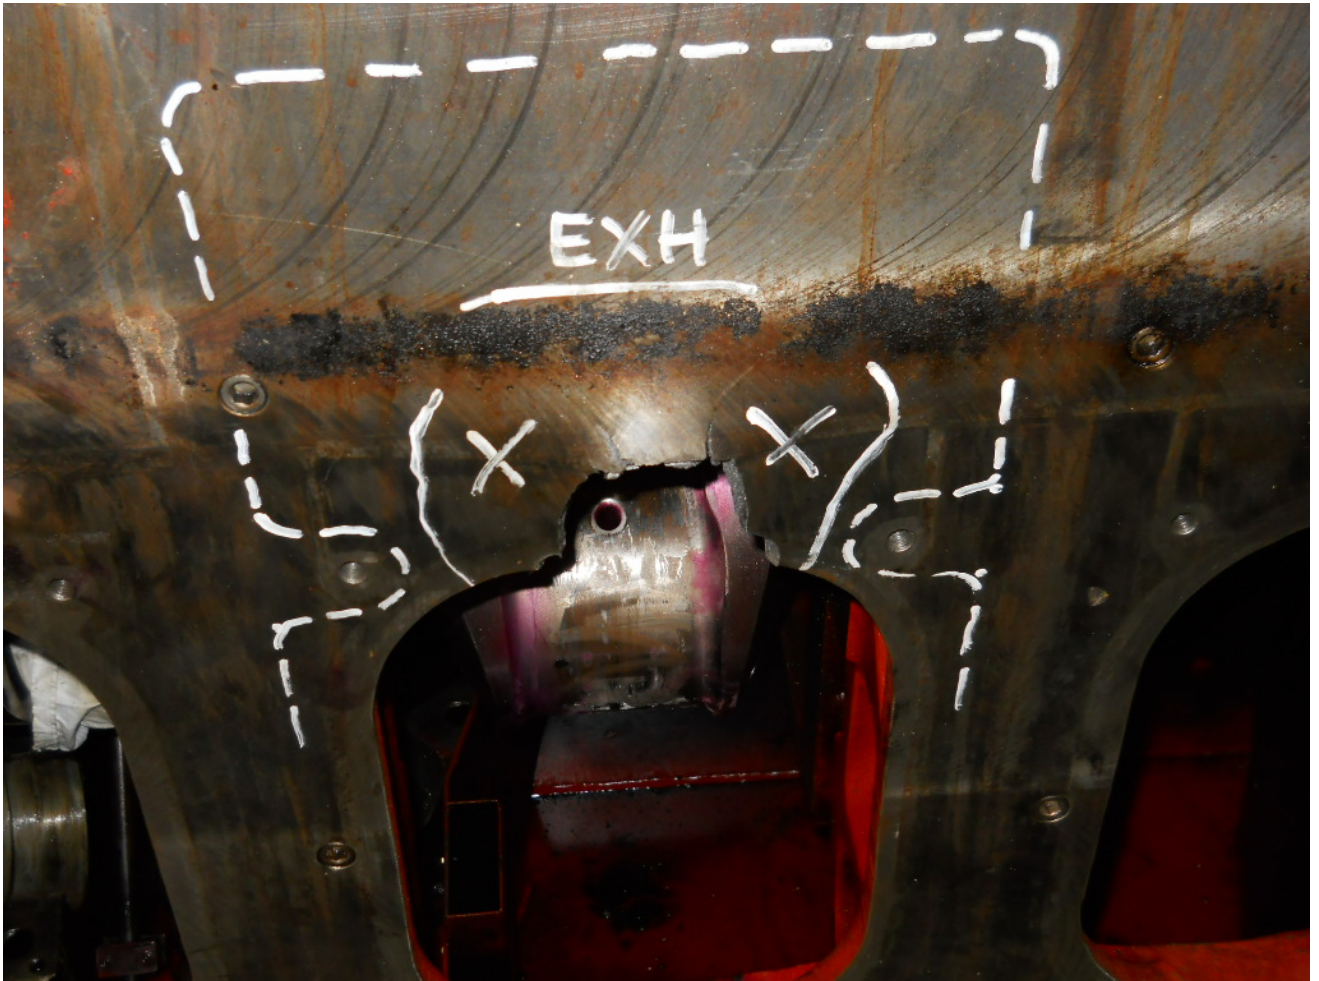
Exhaust side:

Inspection door exhaust side broken out, measuring 6 x 8 cm.

Required: Cutting out the damage area of cam side and exhaust side and installing new section of casting. Metal stitch with C3 Castmaster stitching pins and installing L20 locks around the joint line of new casting for additional strength.

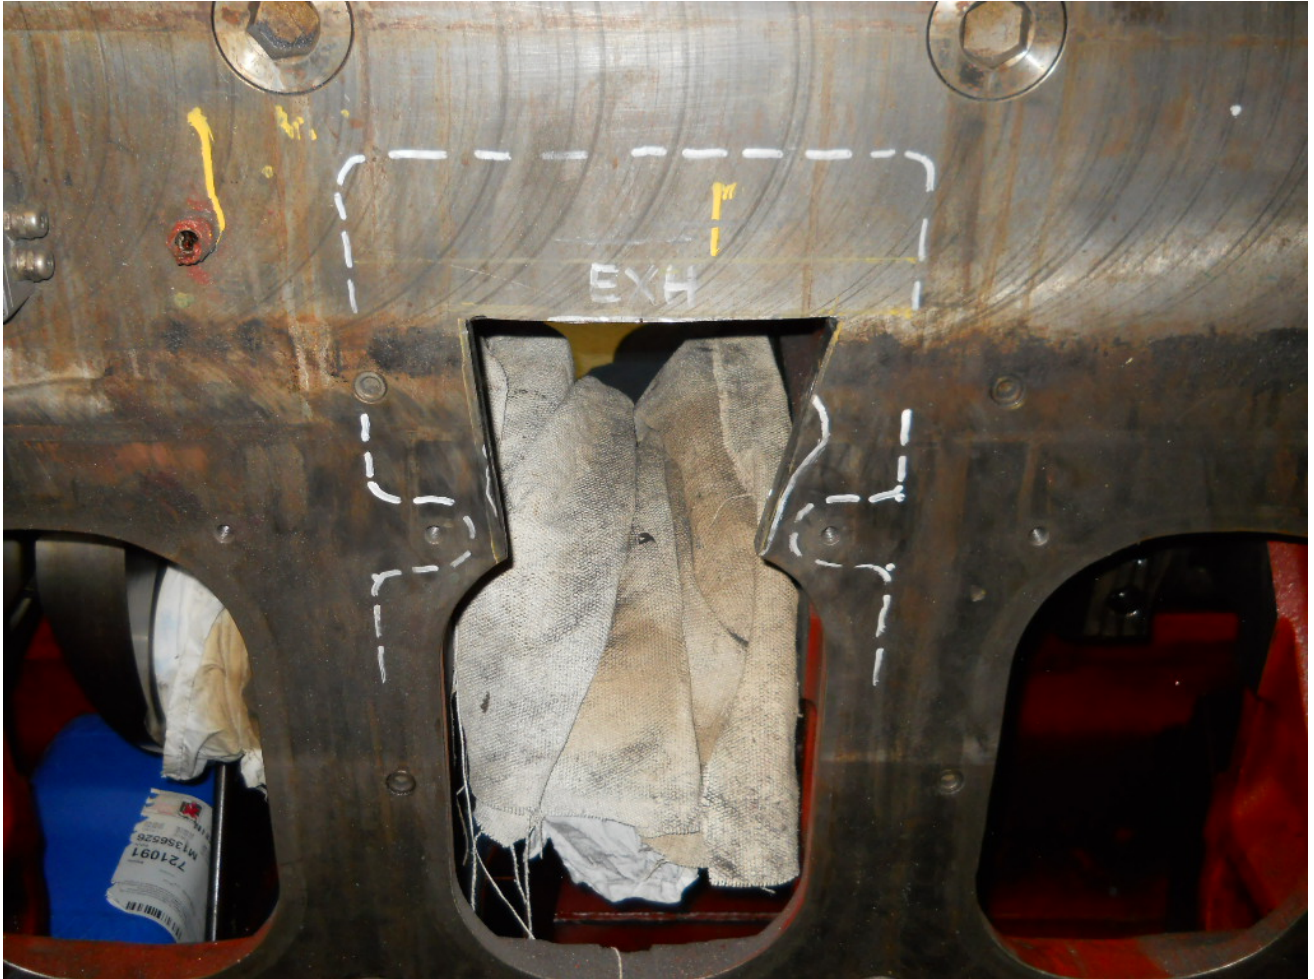
Exhaust side:

The damaged area has been cut out to accept new casting.

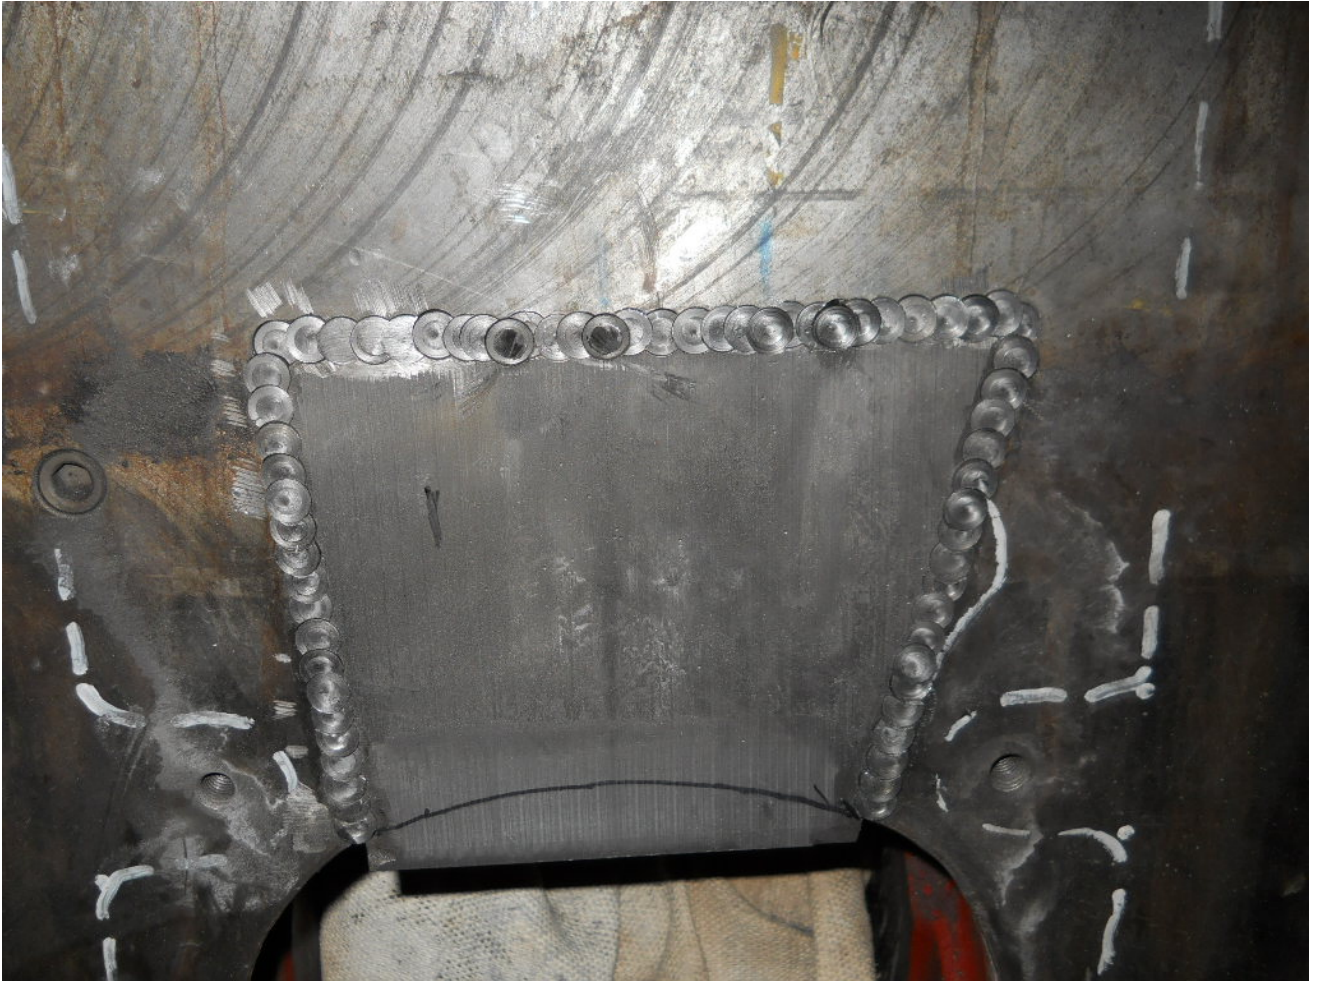
Exhaust side:

New casting fit in place and stitched with C3 Castmaster pins.

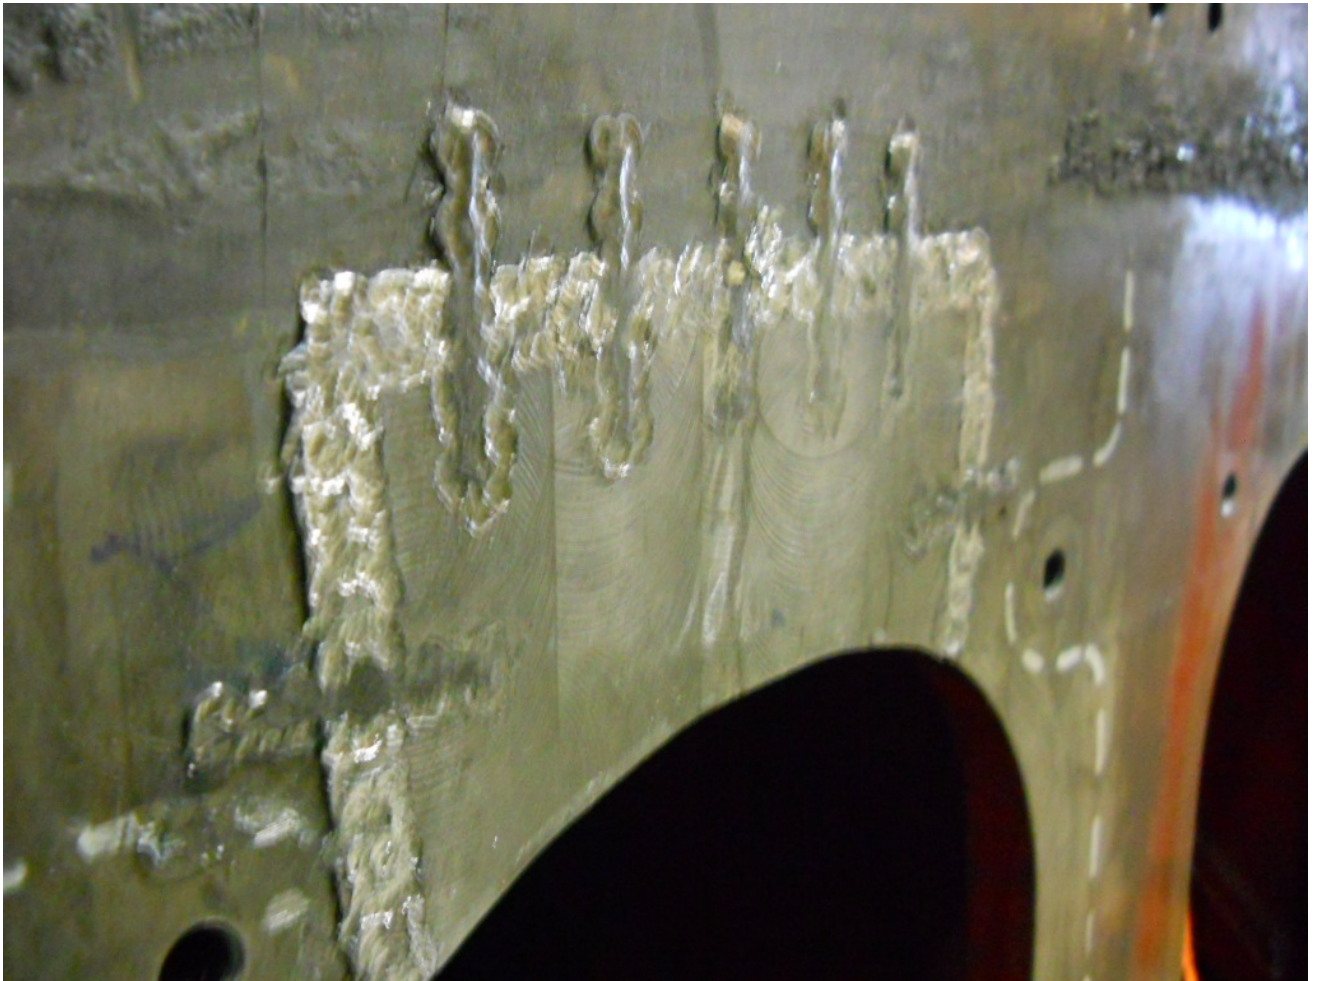
L20 locks installed around the repair for additional strength.

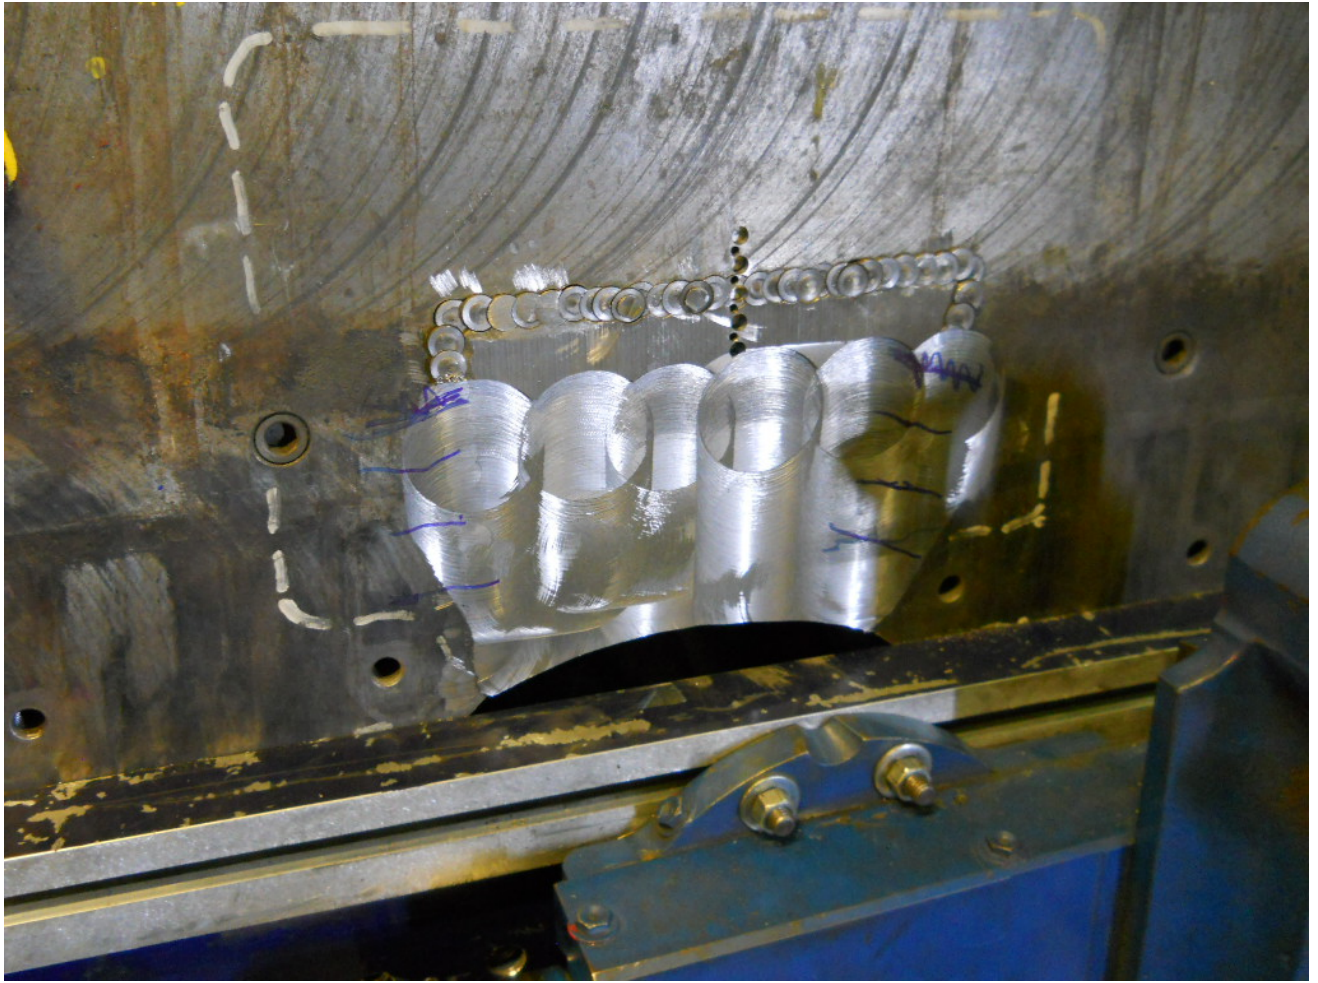
Exhaust side:

Set up and machine inspection window seal surface at exhaust side and cam box side.

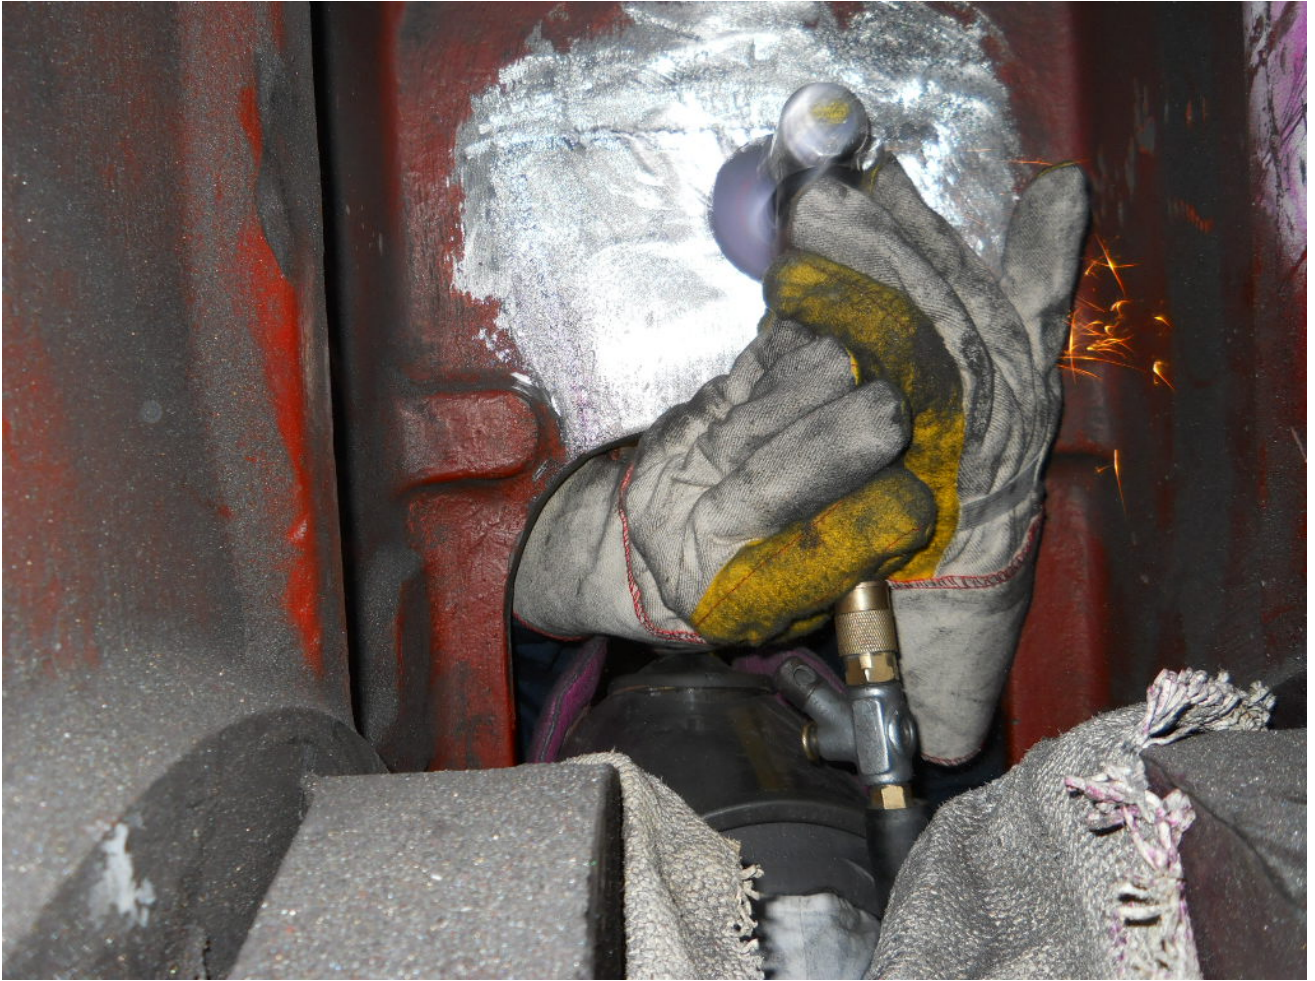
Cam side interior:

Hand finish and completed interior and exterior of the block.
