Wartsila Diesel Generator, El Salvador, 2004

Nejapa Power Co
Edificio Fusades

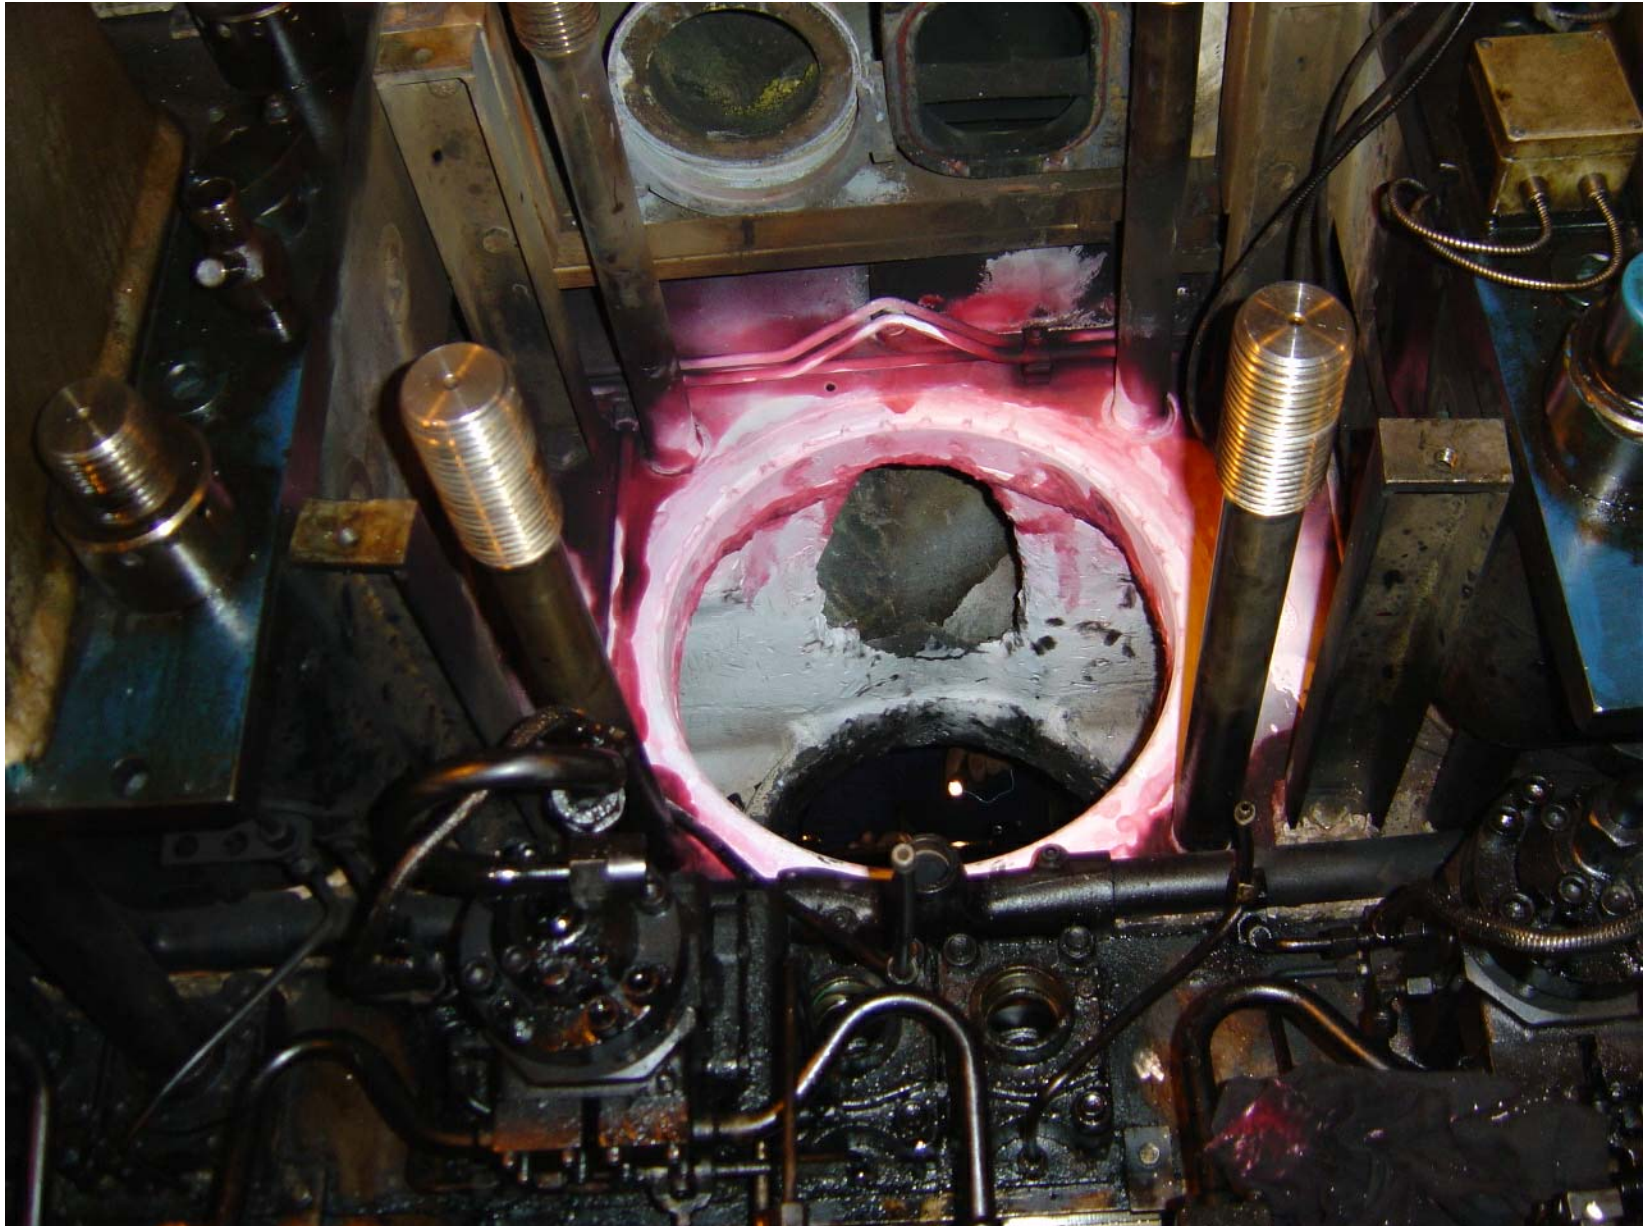
Lower liner bore damage

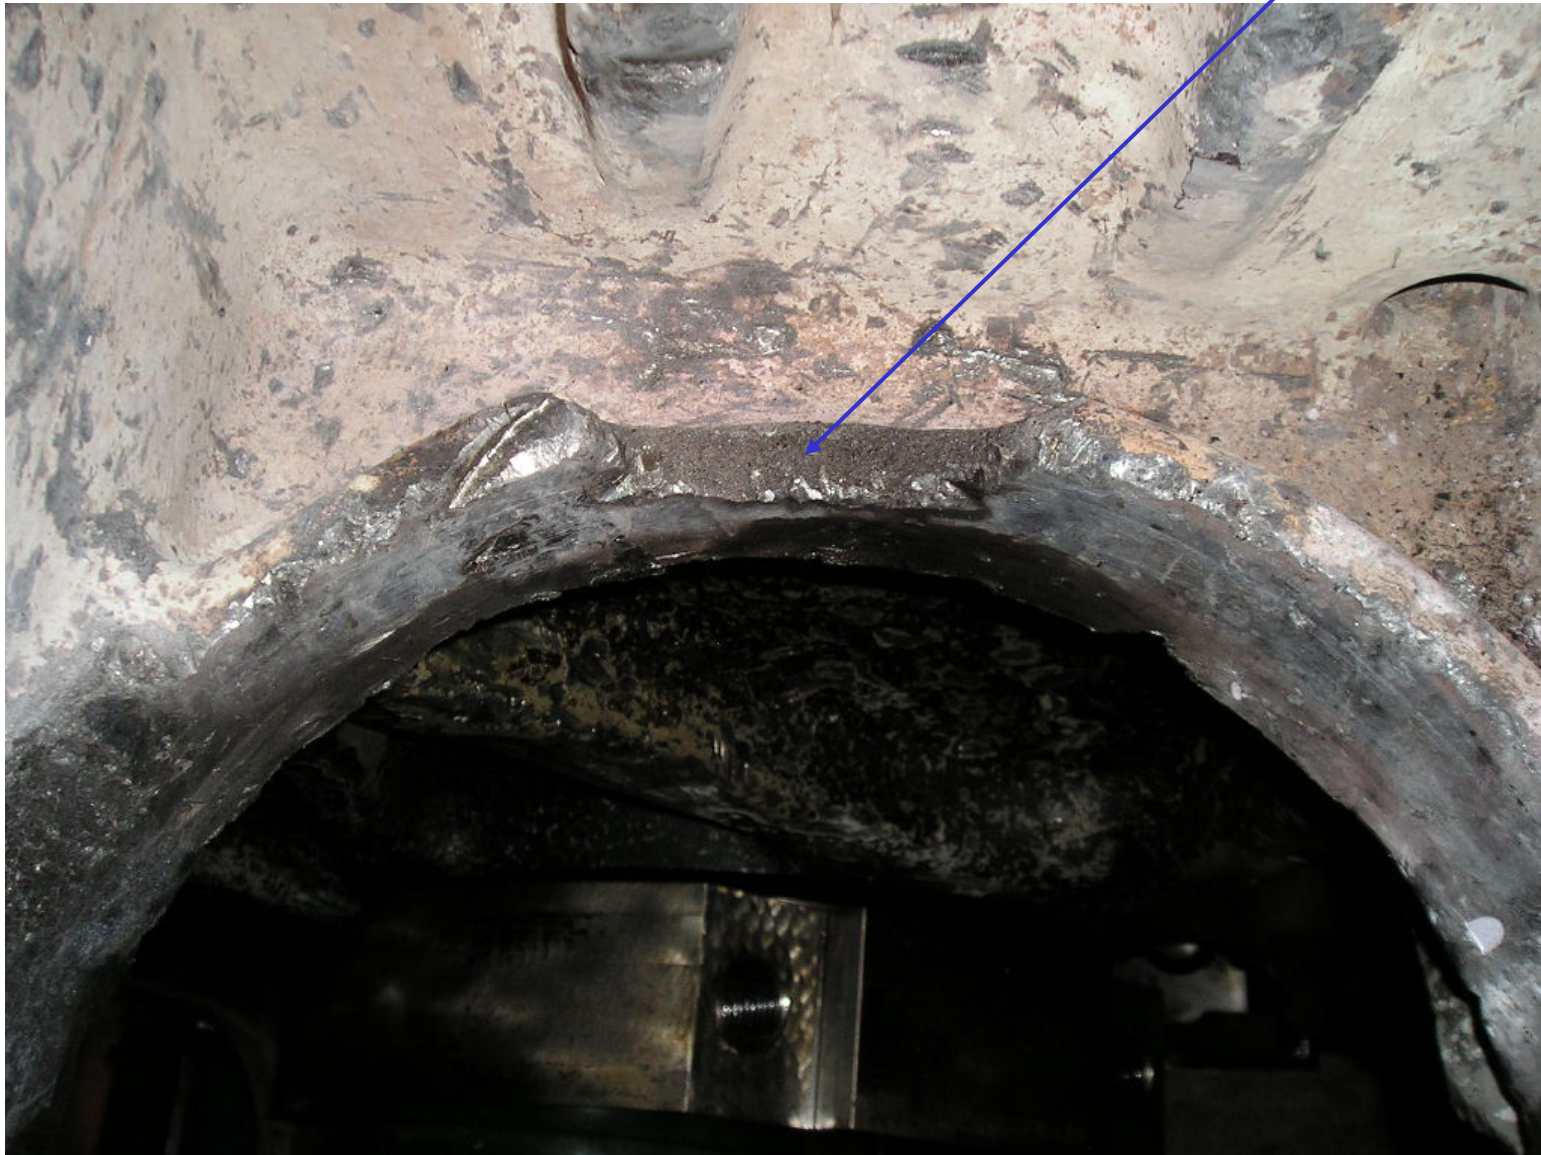
Air box side damage

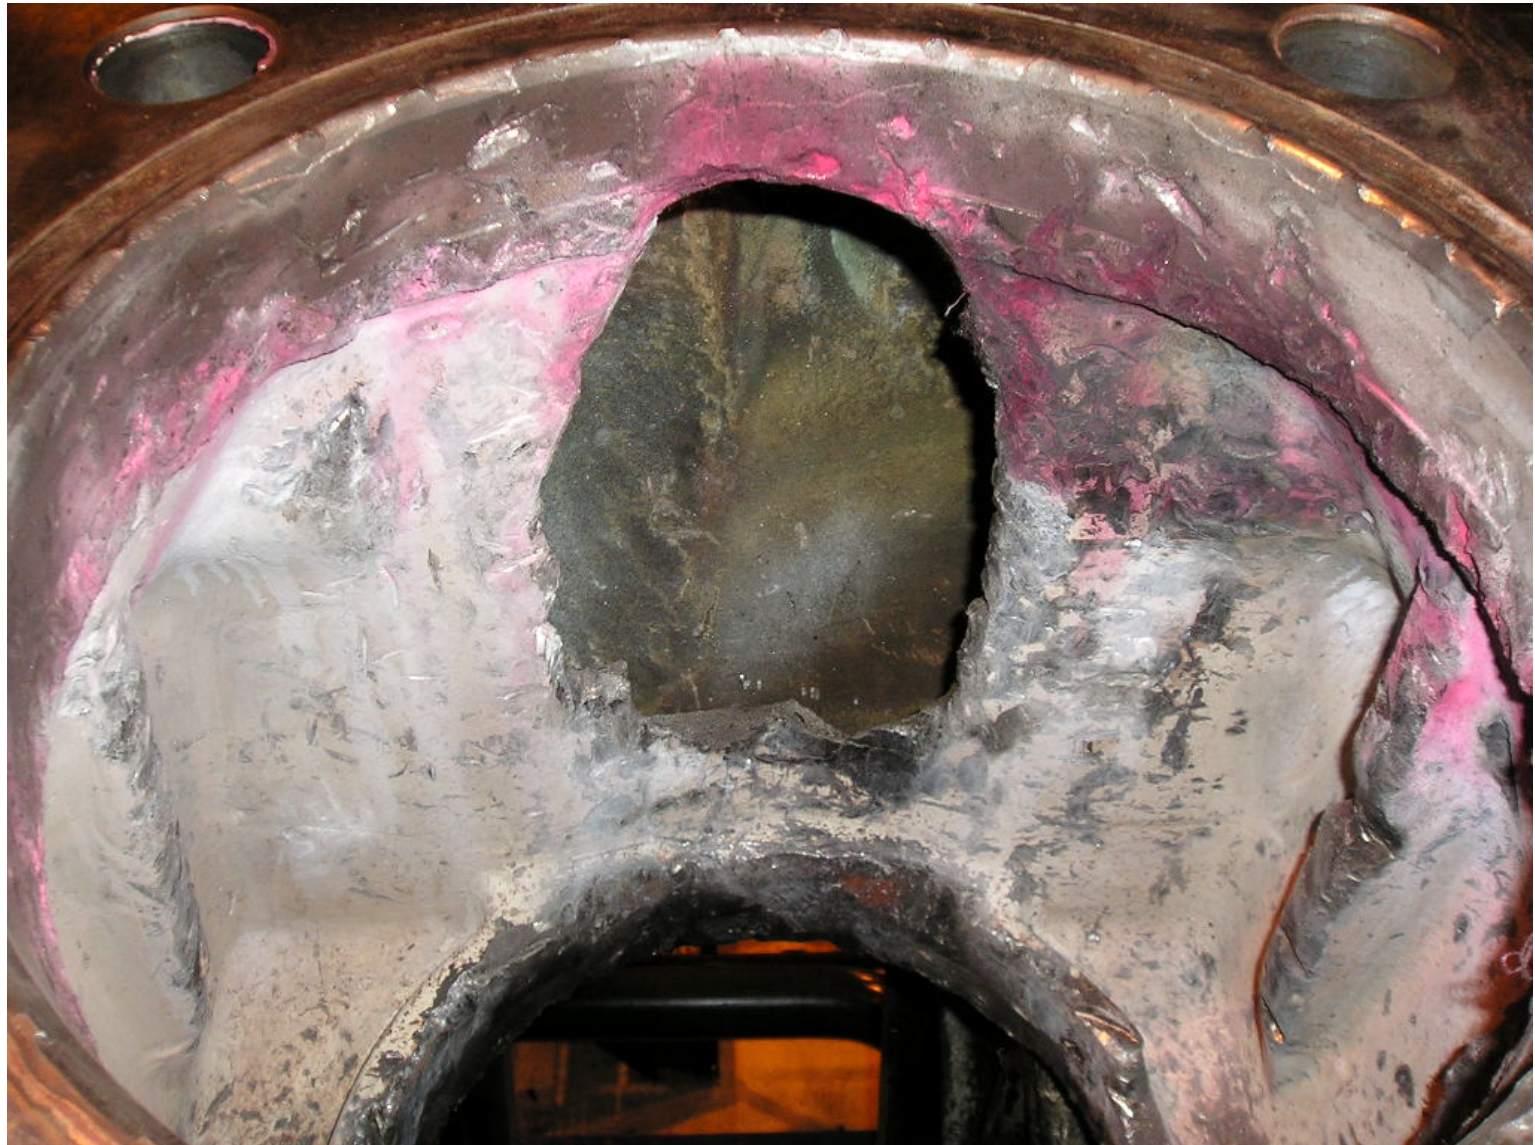
Cam side damage
