Turbine repairs by  
***LOCK-N-STITCH***

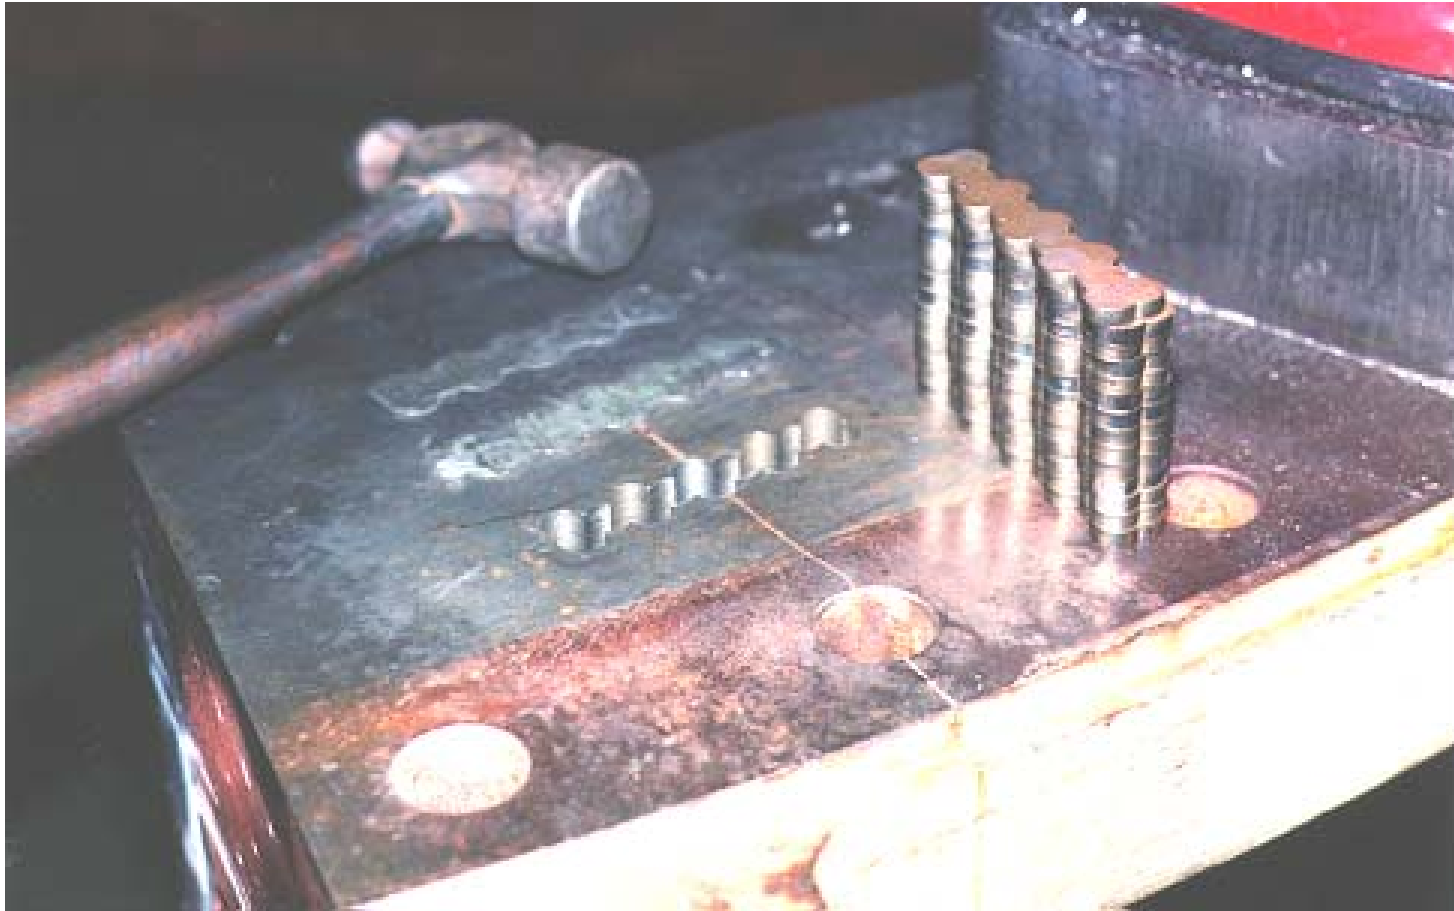
GE Gas turbine shell repaired in 1992 for Sicamore Co-Gen Near Bakersfield California. The unit is still in use. The crack was through the outer bolt flange and was approximately 800mm long and 75mm thick.

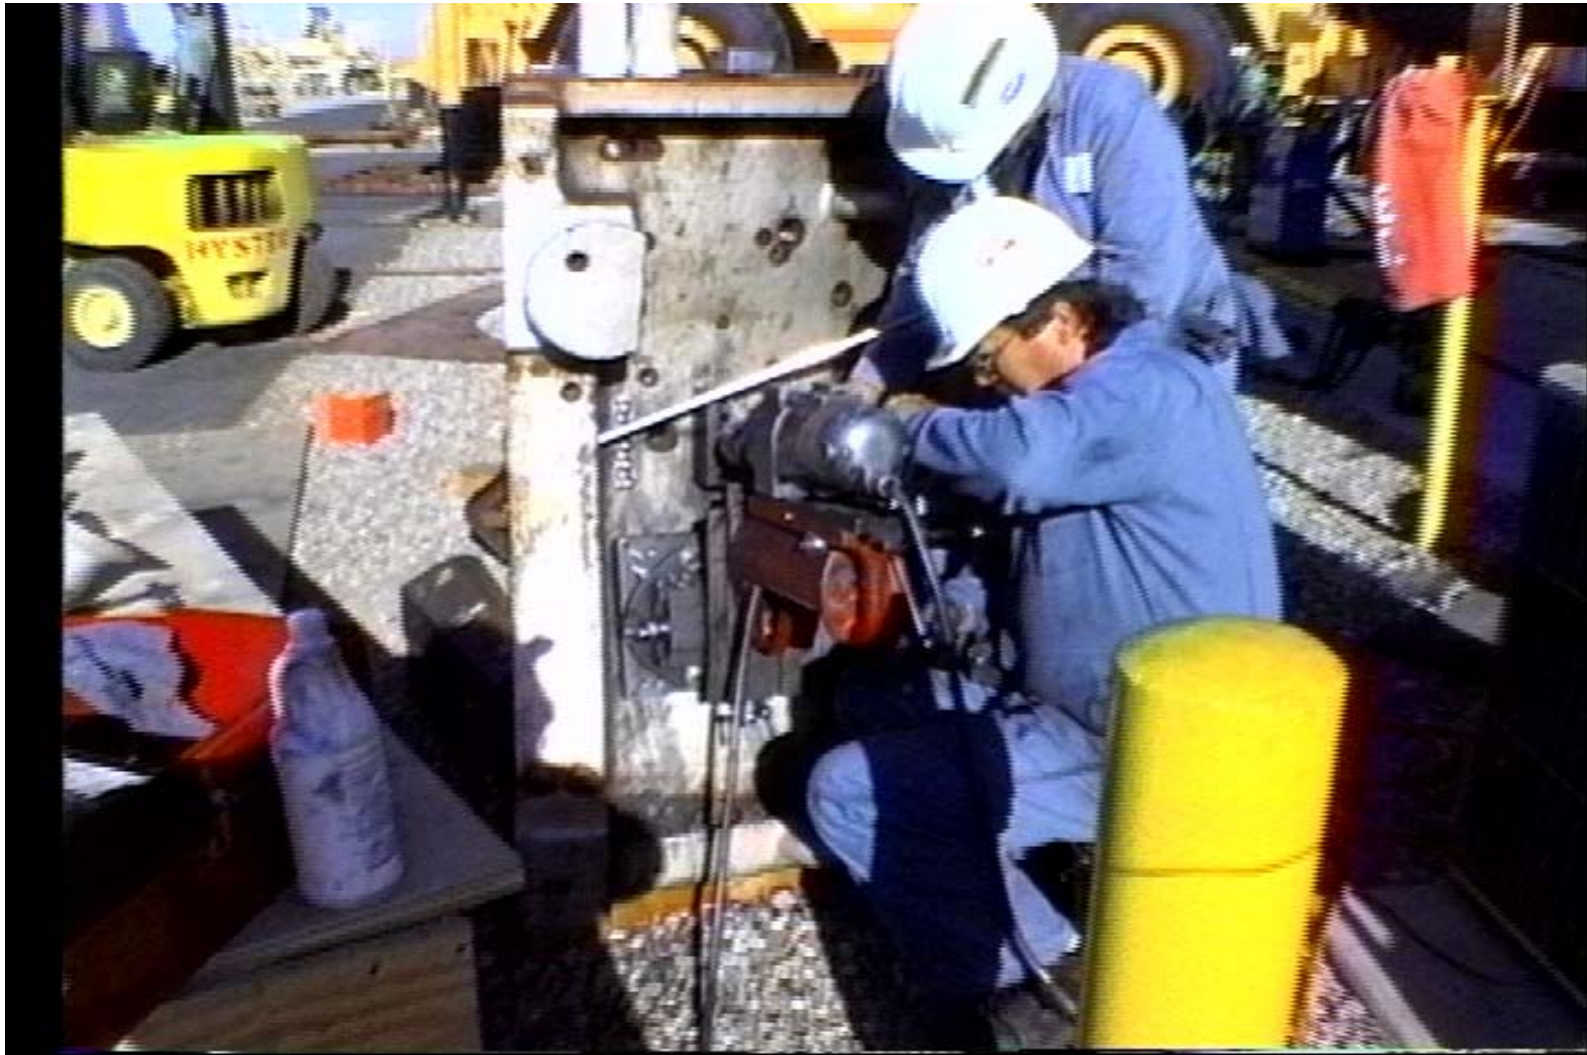
This gas turbine shell also belongs to Sicamore Co-Gen near Bakersfield California. The crack was about 100mm long and extended through a threaded hot-inspection hole. The repair was completed in 1998 and the unit is still in service.

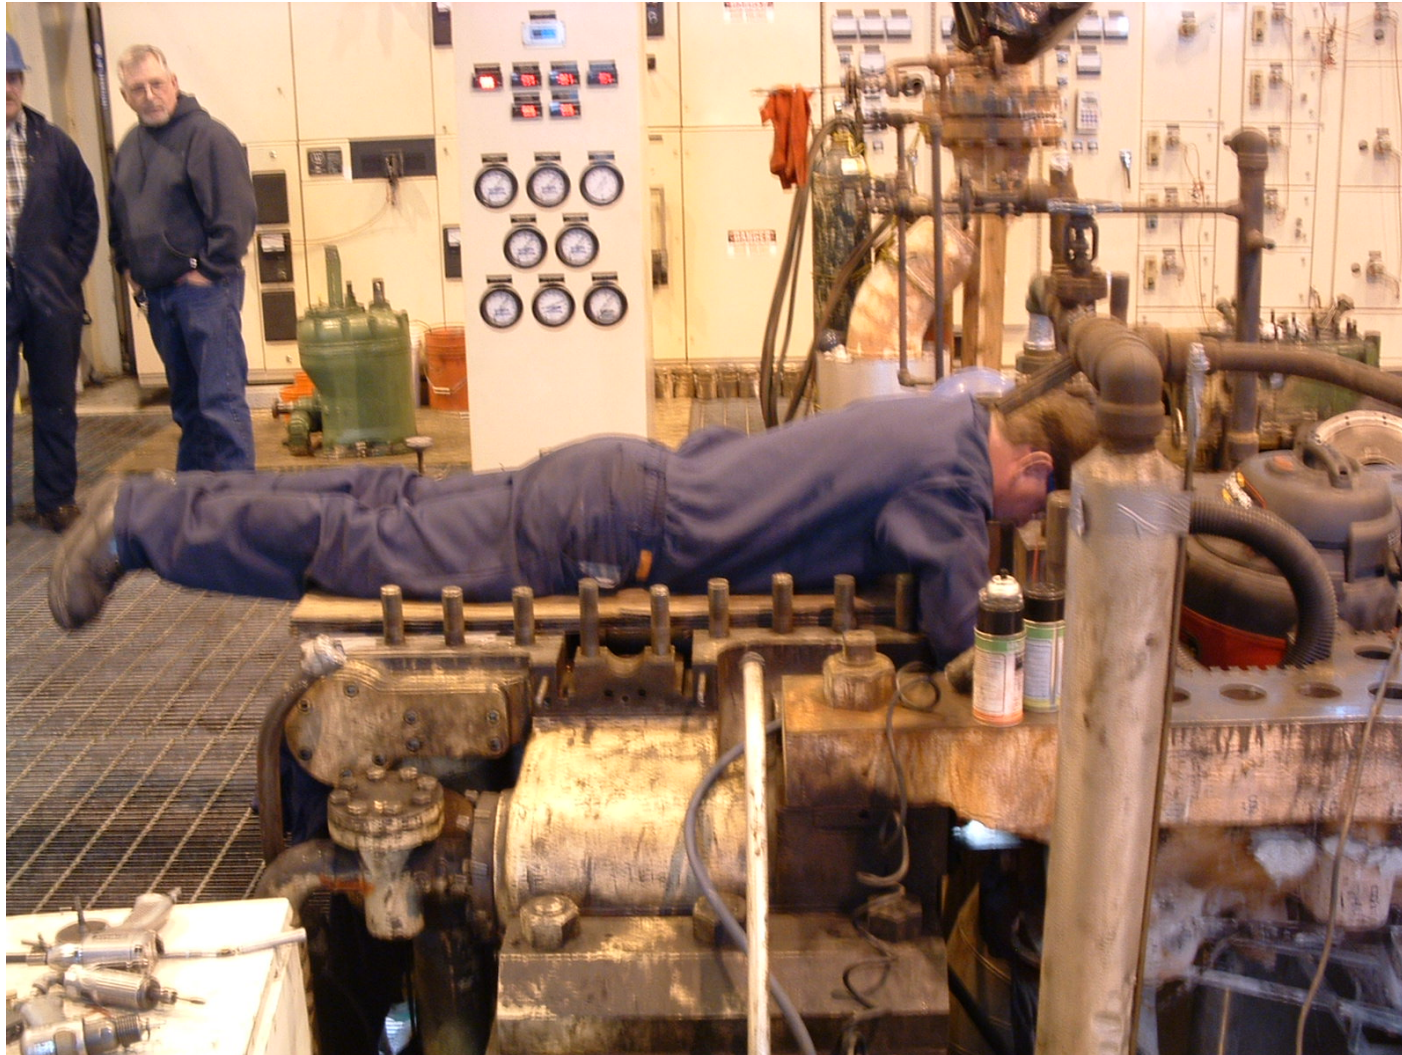
Small GE turbine shell with internal cracks. The repair was done In 2002 and is still in service.

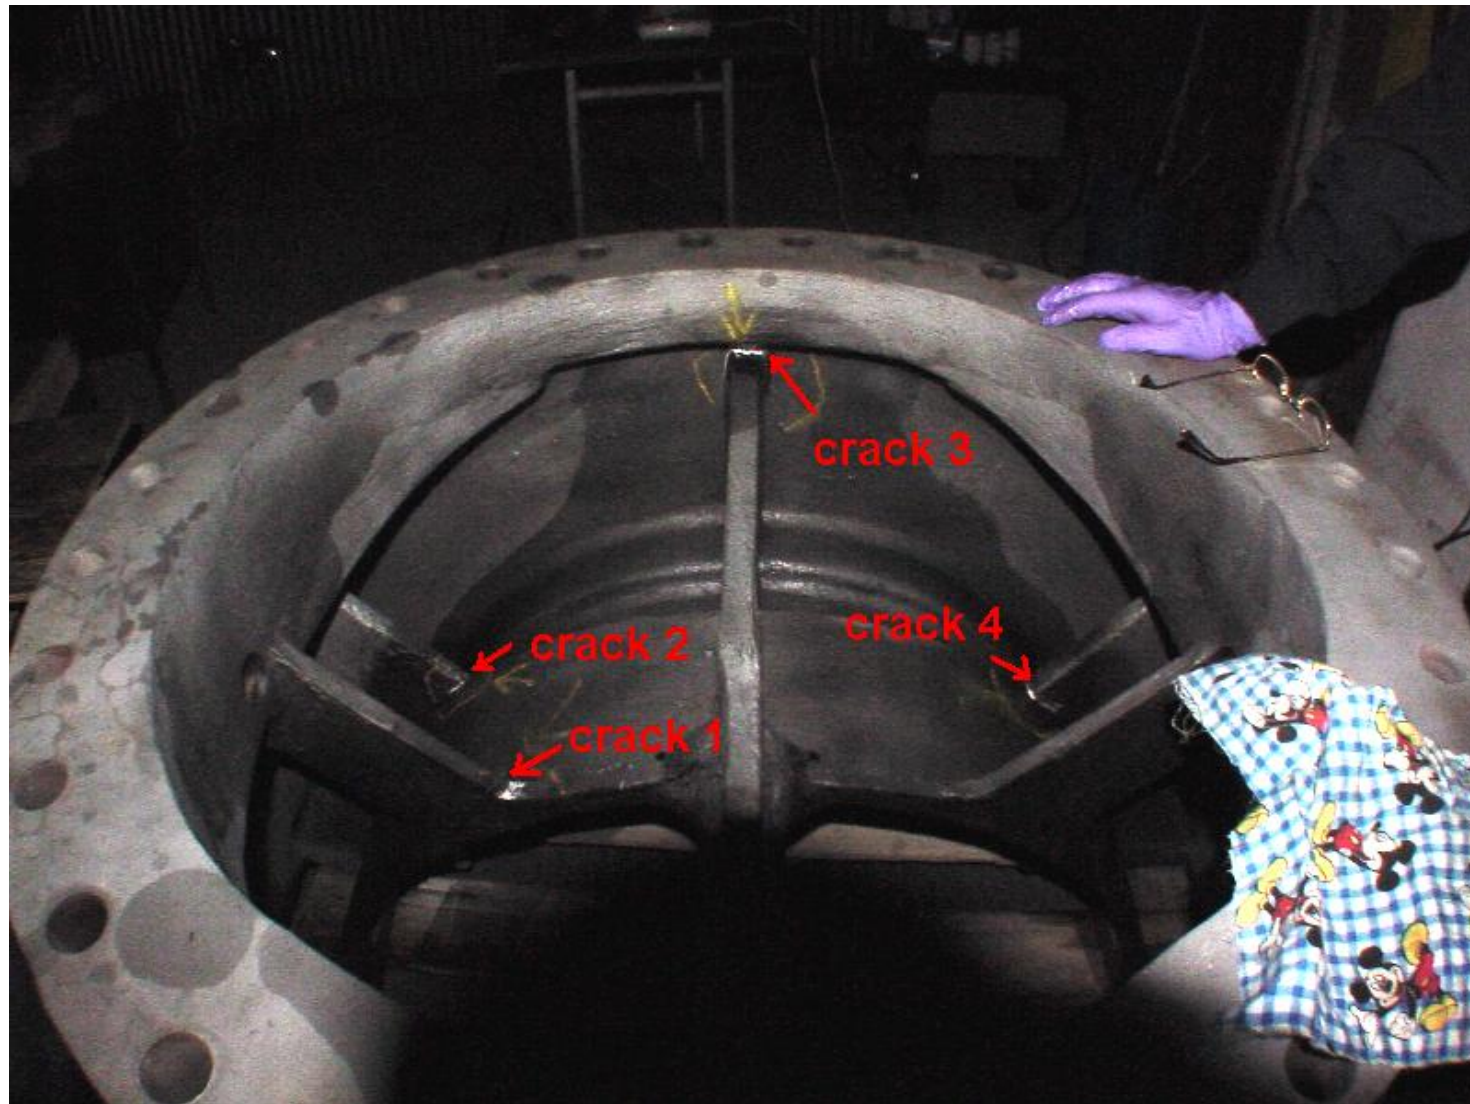
Dresser Rand steam turbine lower case, bottom side with several cracks.

The repair was done in 2001 and is still in service.

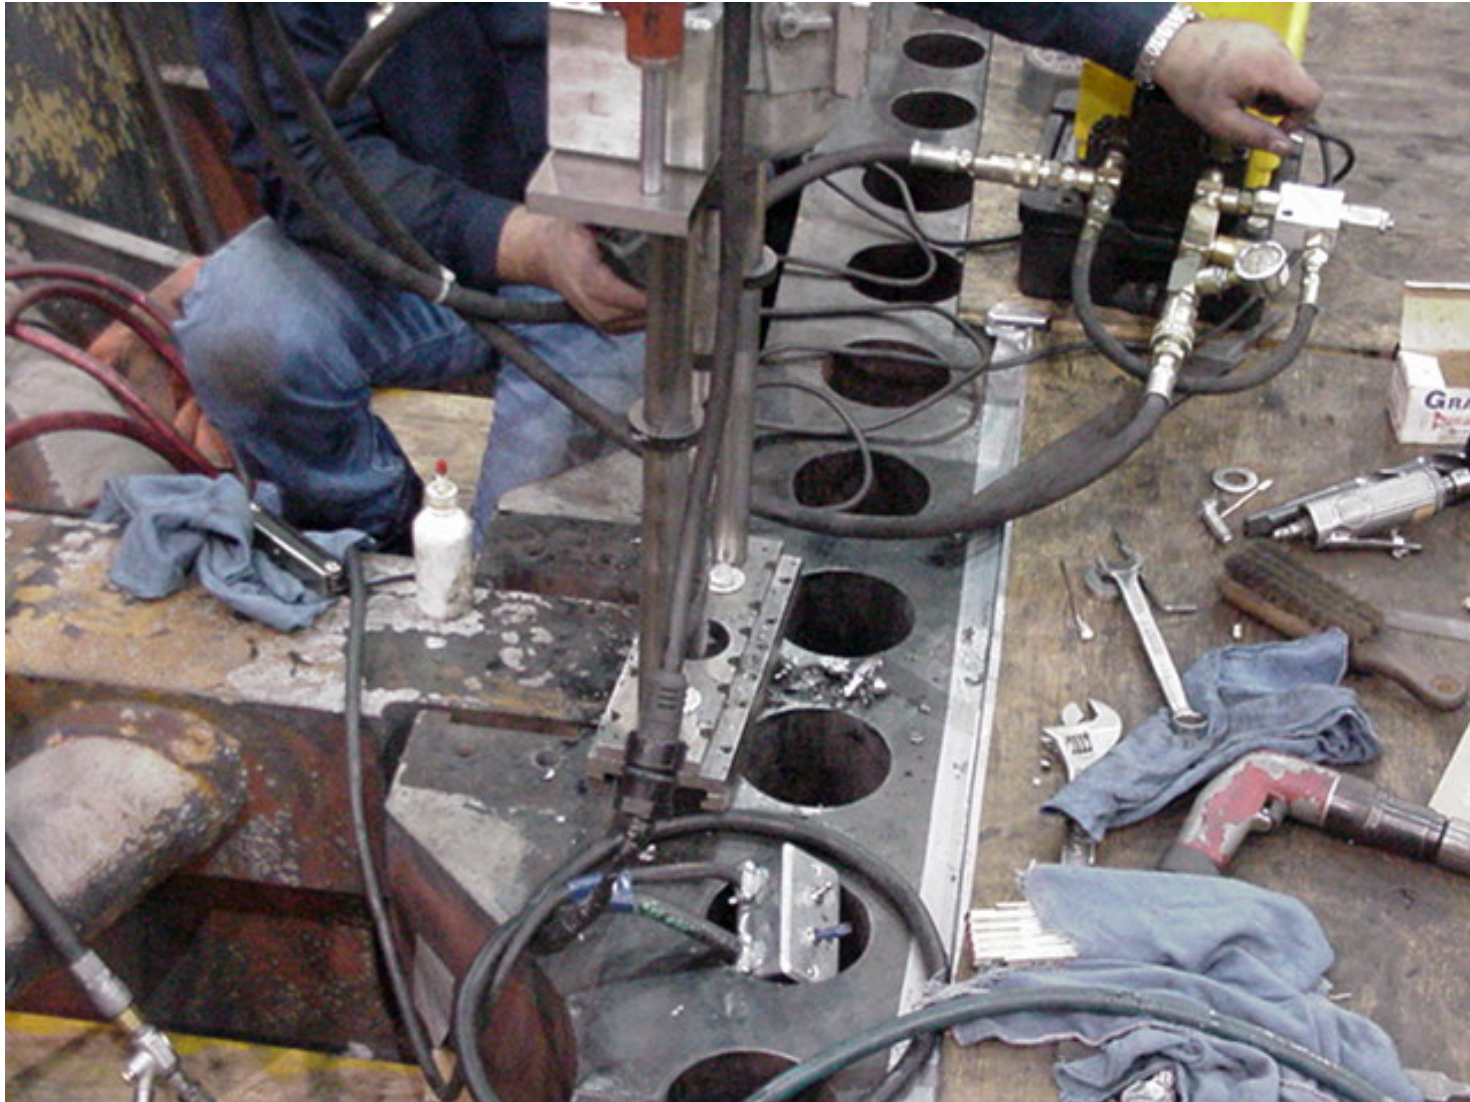
Frame 7, GE steam turbine shell with a crack extending from a bolt hole. The crack had a previous weld repair attempt that failed.

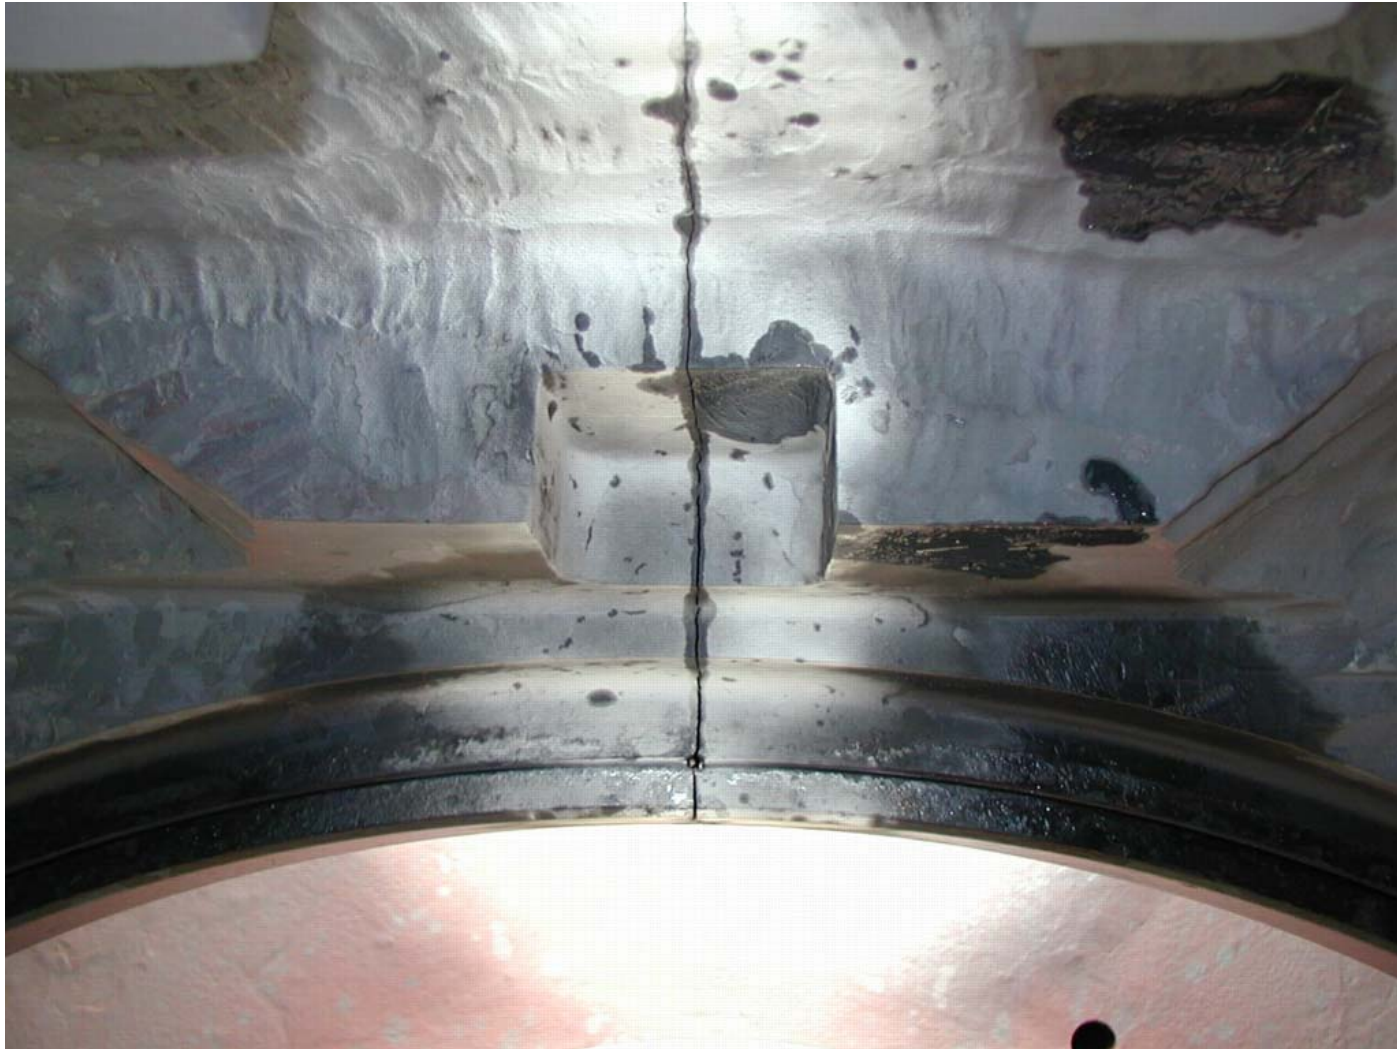
Crack looking up from underneath.
