LOCK-N-STITCH Inc.
Casting Repair Specialists
1015 S. Soderquist Rd.
Turlock CA 95380

Turbo air box repair final report

Date: 1/25/2013

Part: DG #1 Airbox,

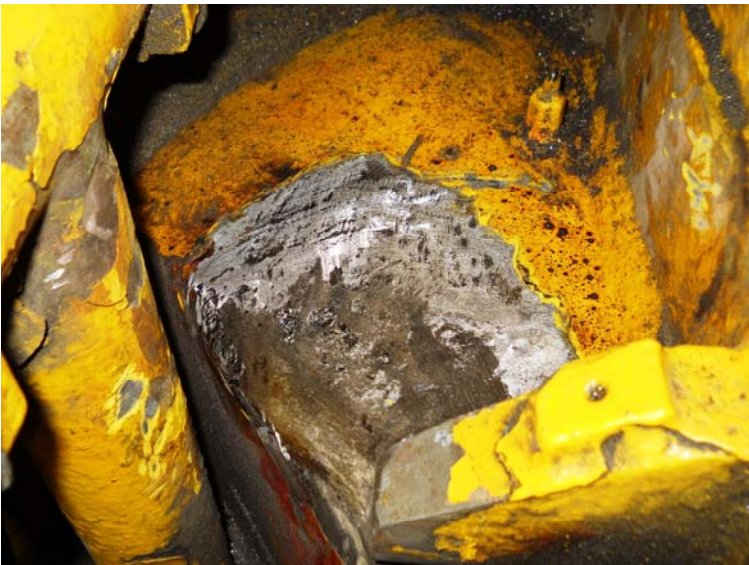
#2 Turbo support gusset is cracked.
Prep for welding.

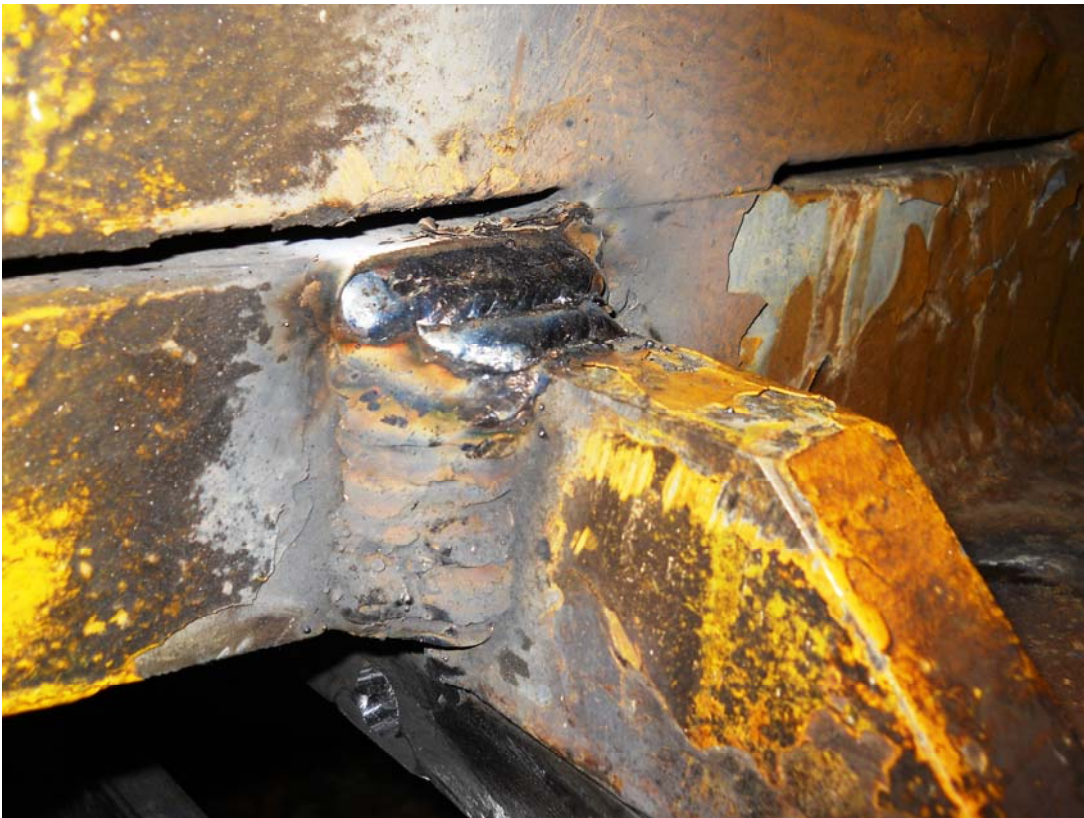
#3 Vertical support bar cracked.

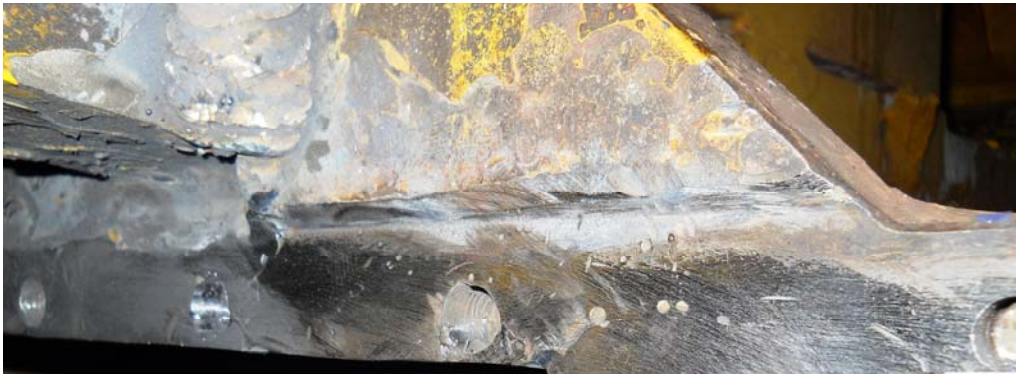
#4 Overhead crack in center of air box, was previously welded.
Removed old weld, and crack.

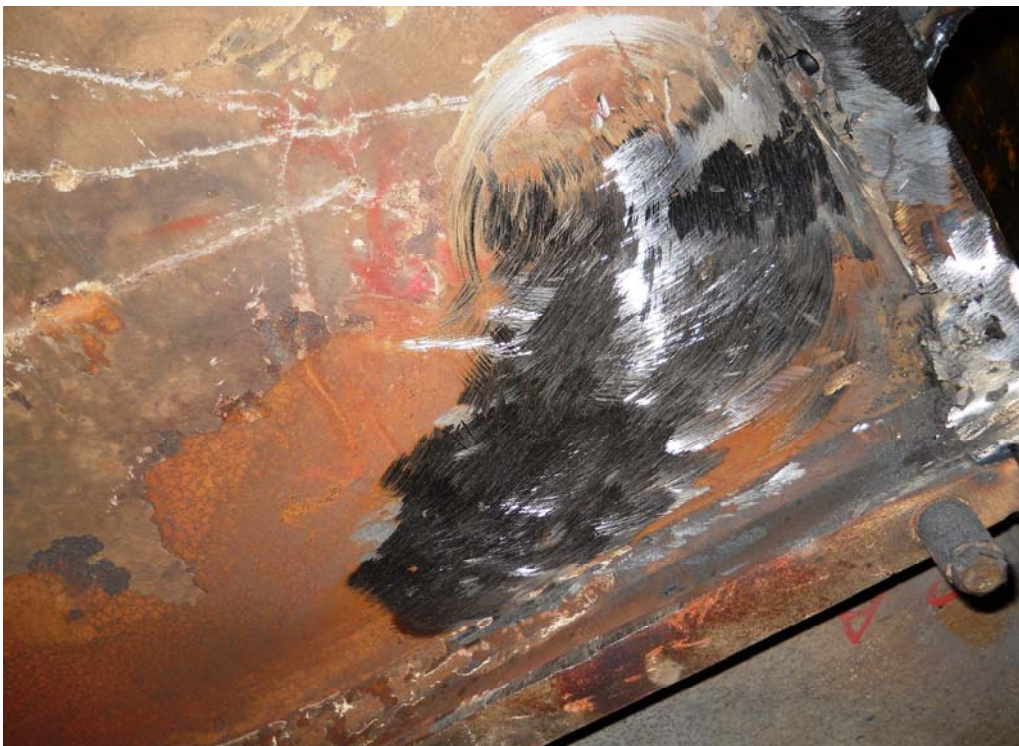
#5 Two broken stud holes.
