Wartsila engine block repair Final Report

Date June 18 2013

Part W18V32

Serial number Engine G-612

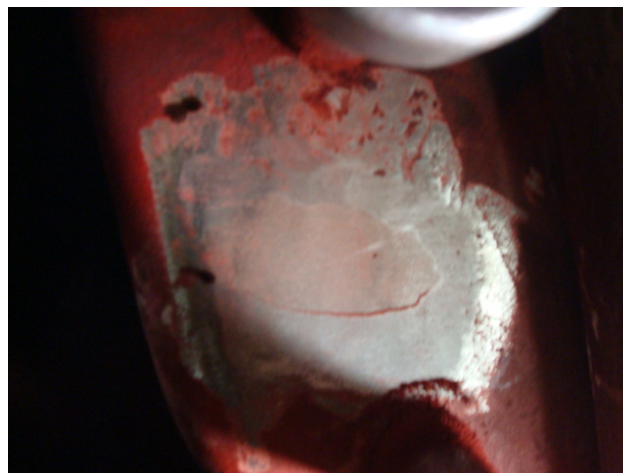
#1: Proceeded with removal of the paint and inspection using magnetic particle.

Found casting had been welded which caused the crack and leak in Water pumps cover.

The welding of the Water pump cover casting caused confined expansion and contraction which was the cause of the crack and water leak.

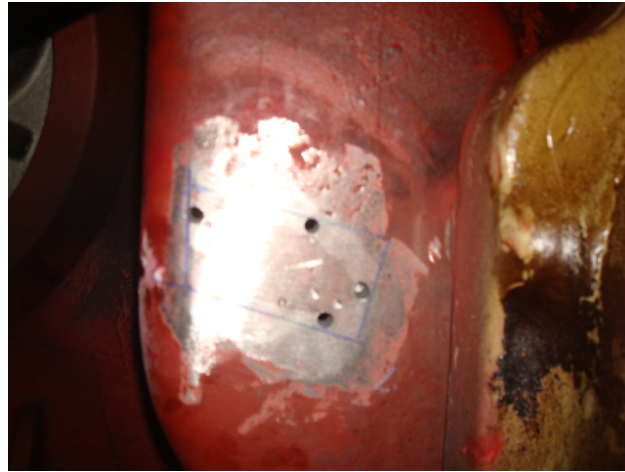
#2: Laid out lines and drilled test hole to determine how far the hardness was extending out from the welded area in the casting and where best to prepare for new casting.
