LOCK-N-STITCH Inc.
Casting Repair Specialists
1015 S. Soderquist Rd.
Turlock CA 95380

Inspection / Repair Report

Part: Worthington Compressor 27 1/2" bore

Serial number: A11675-22A2 Inspected by: Alaa Al'Robaie

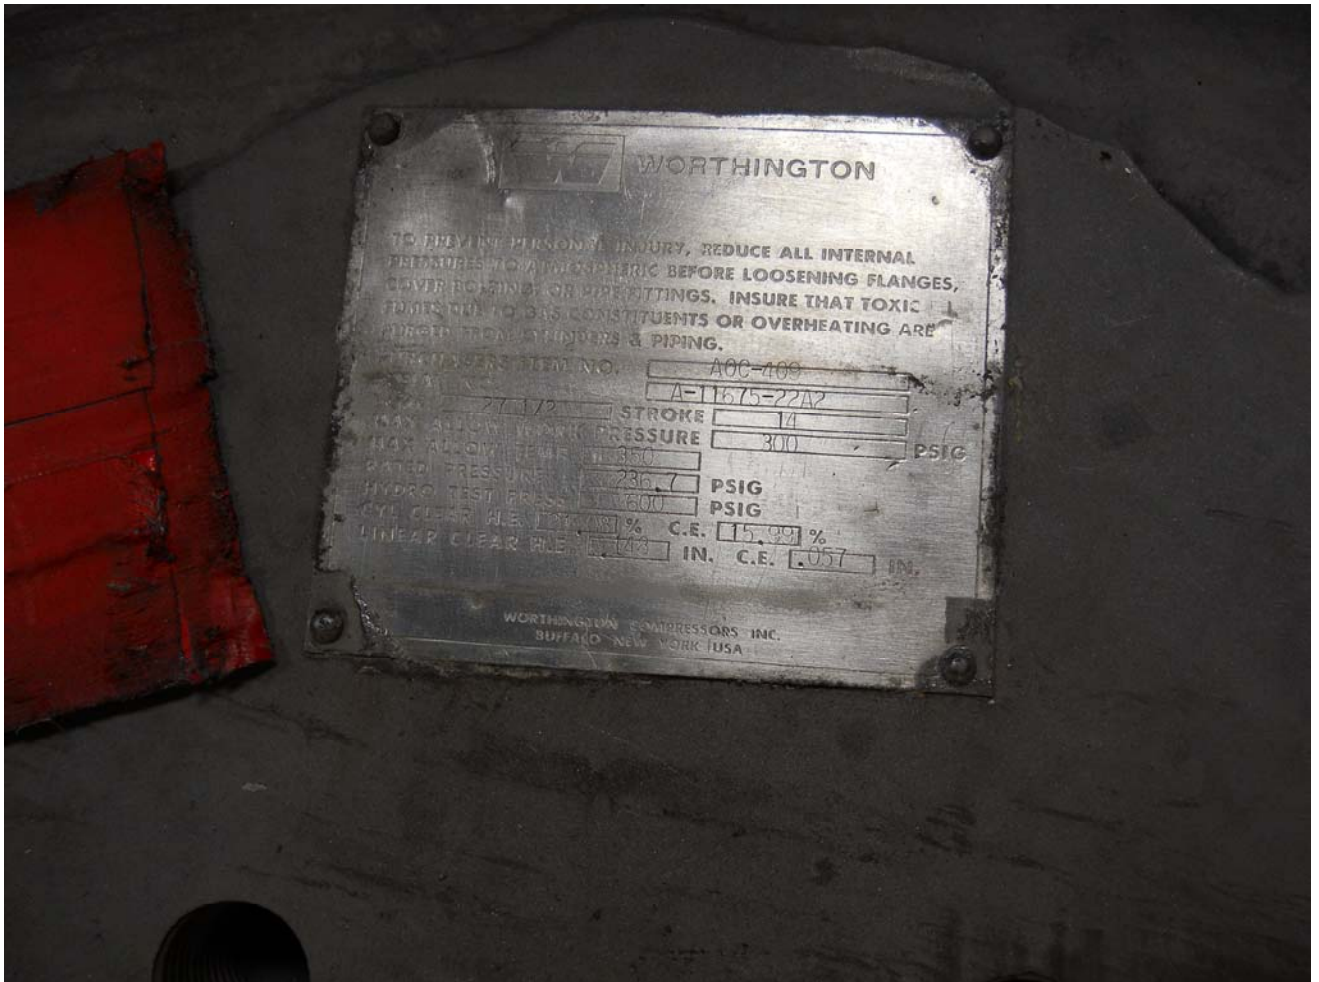
Worthington Compressor Name Plate

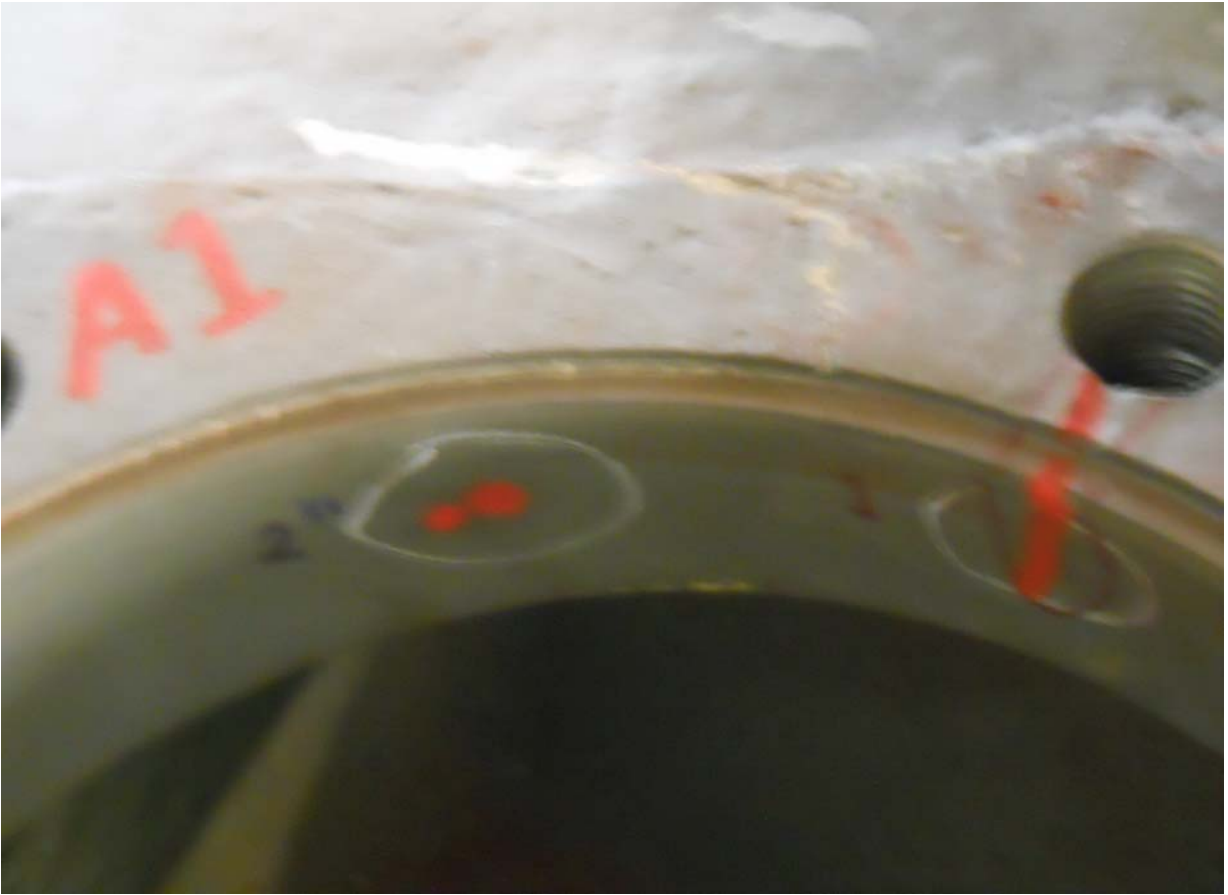
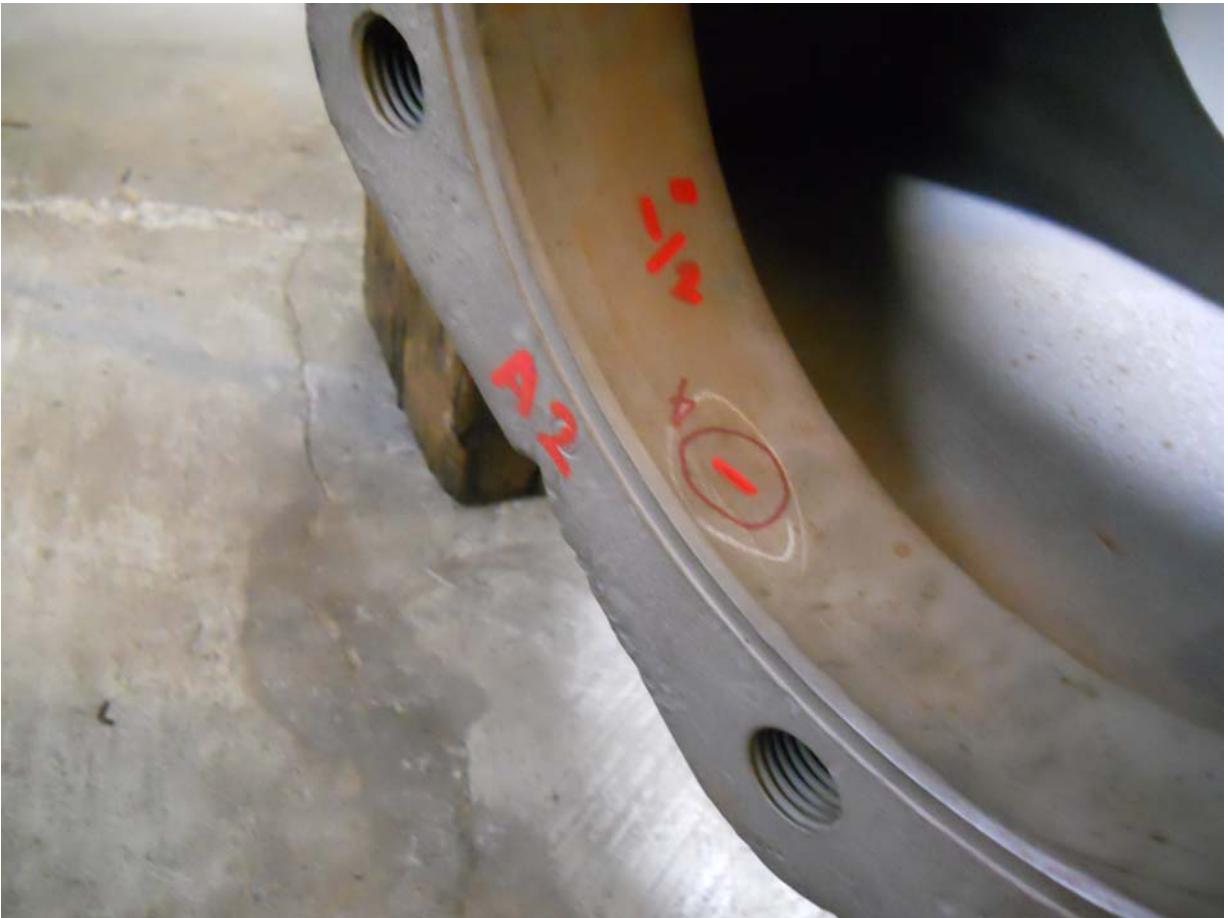
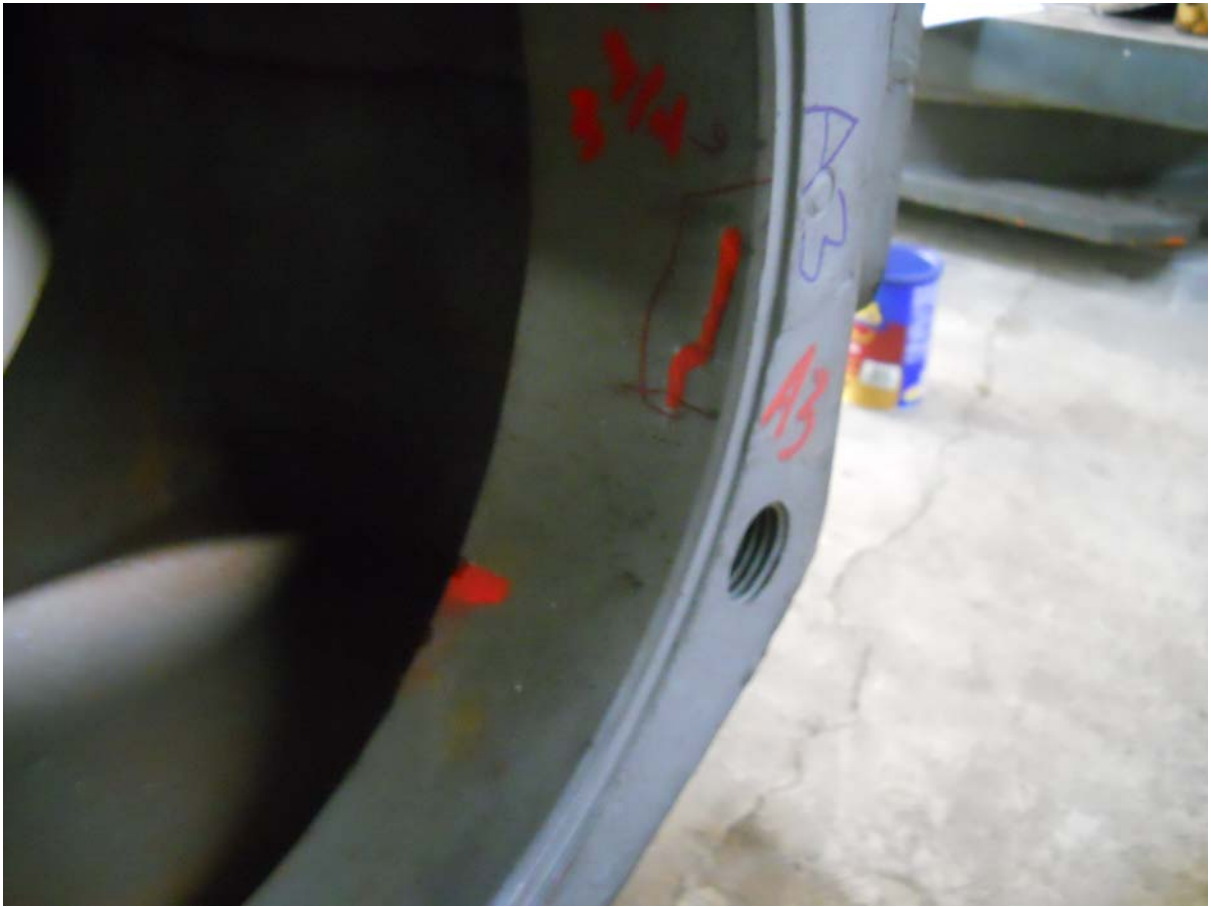
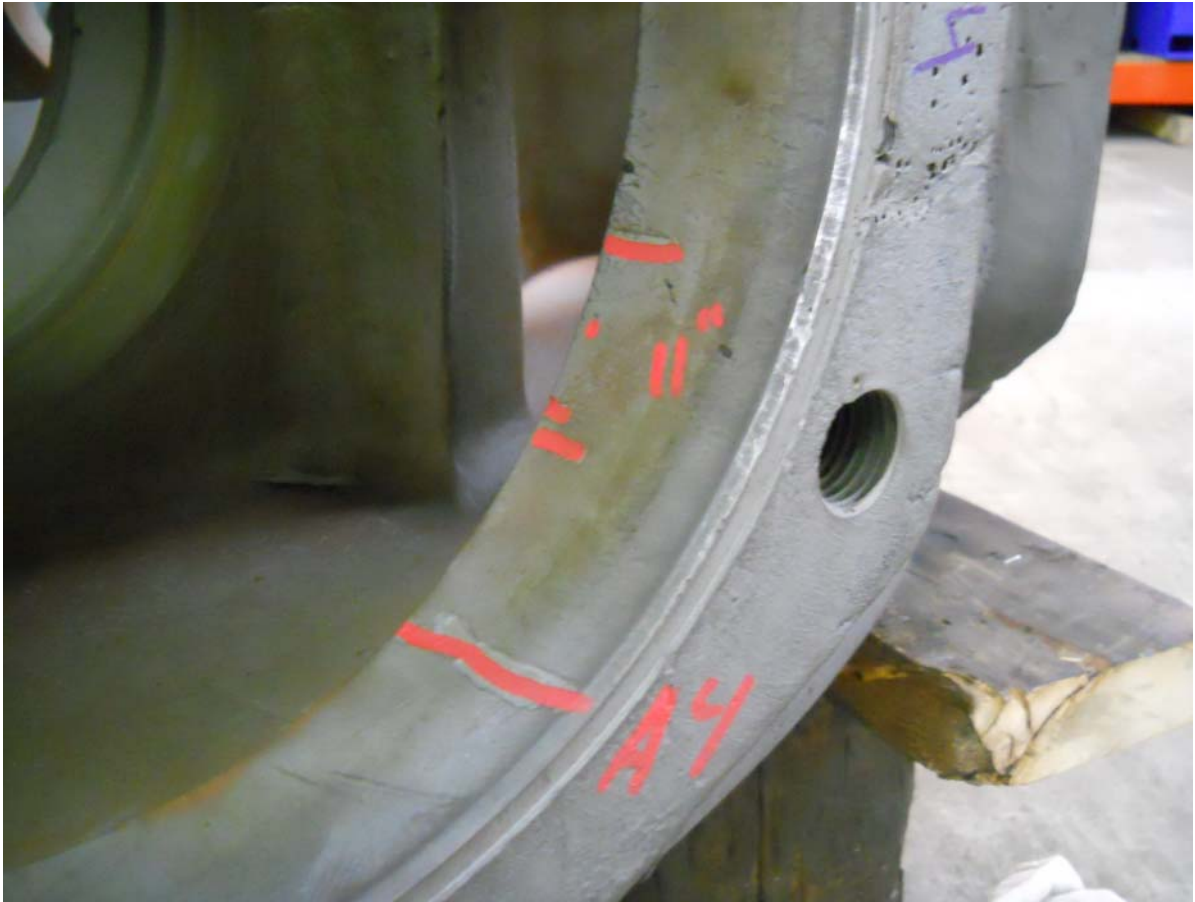
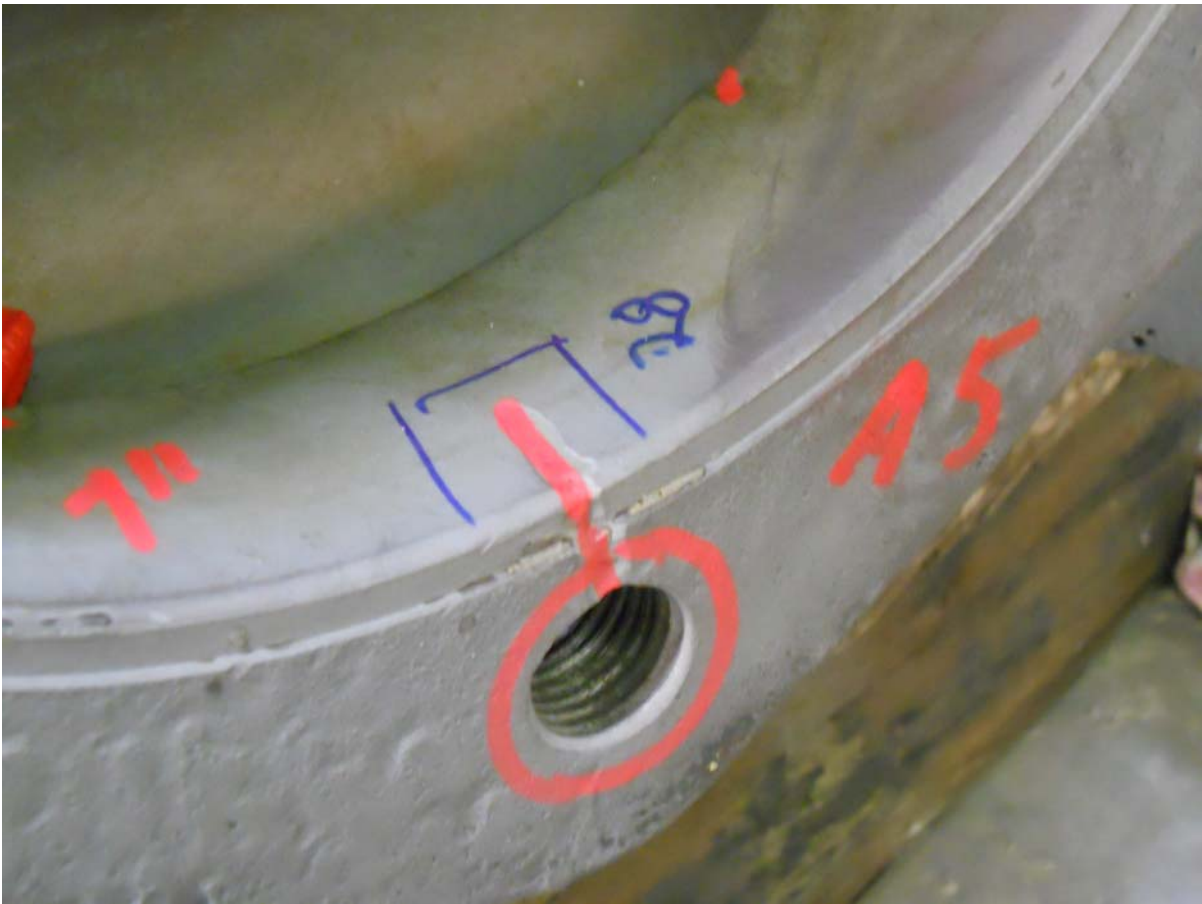
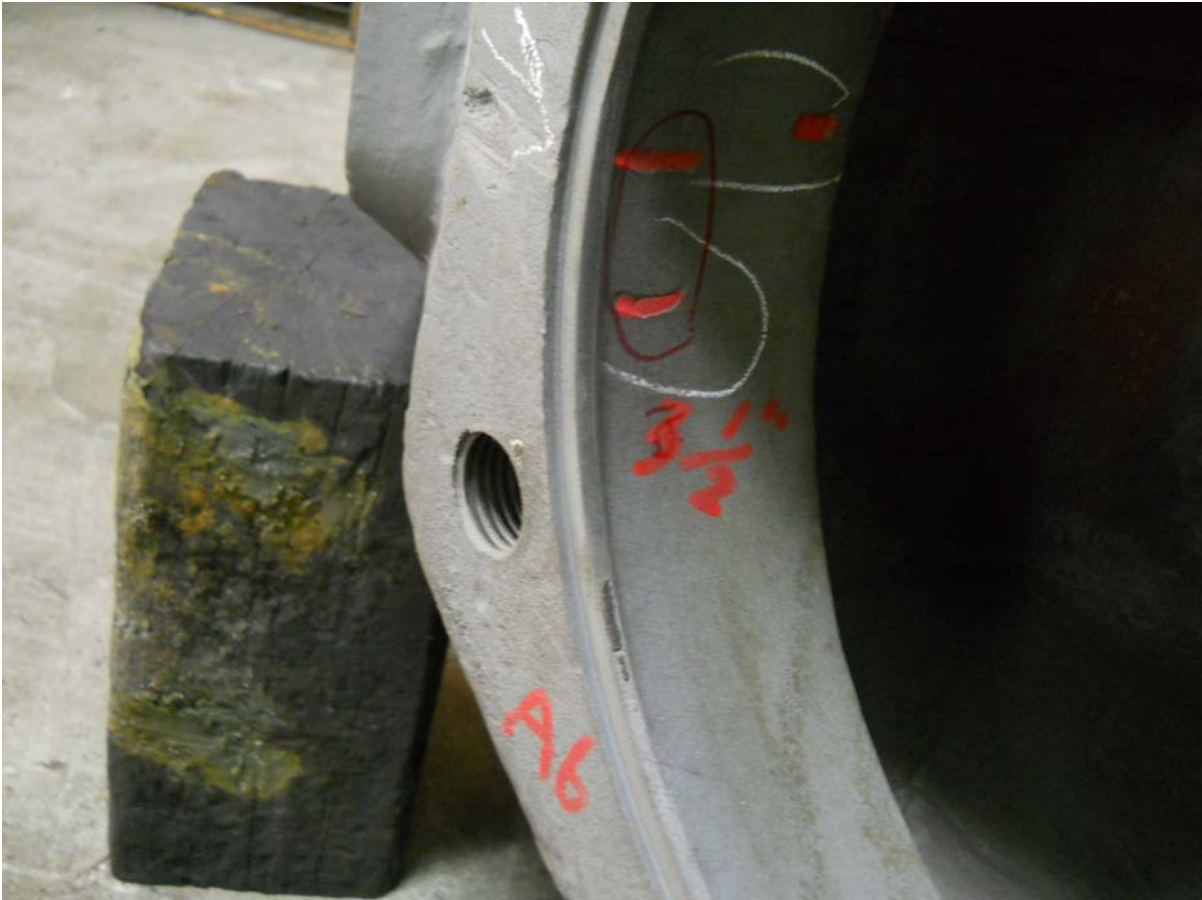
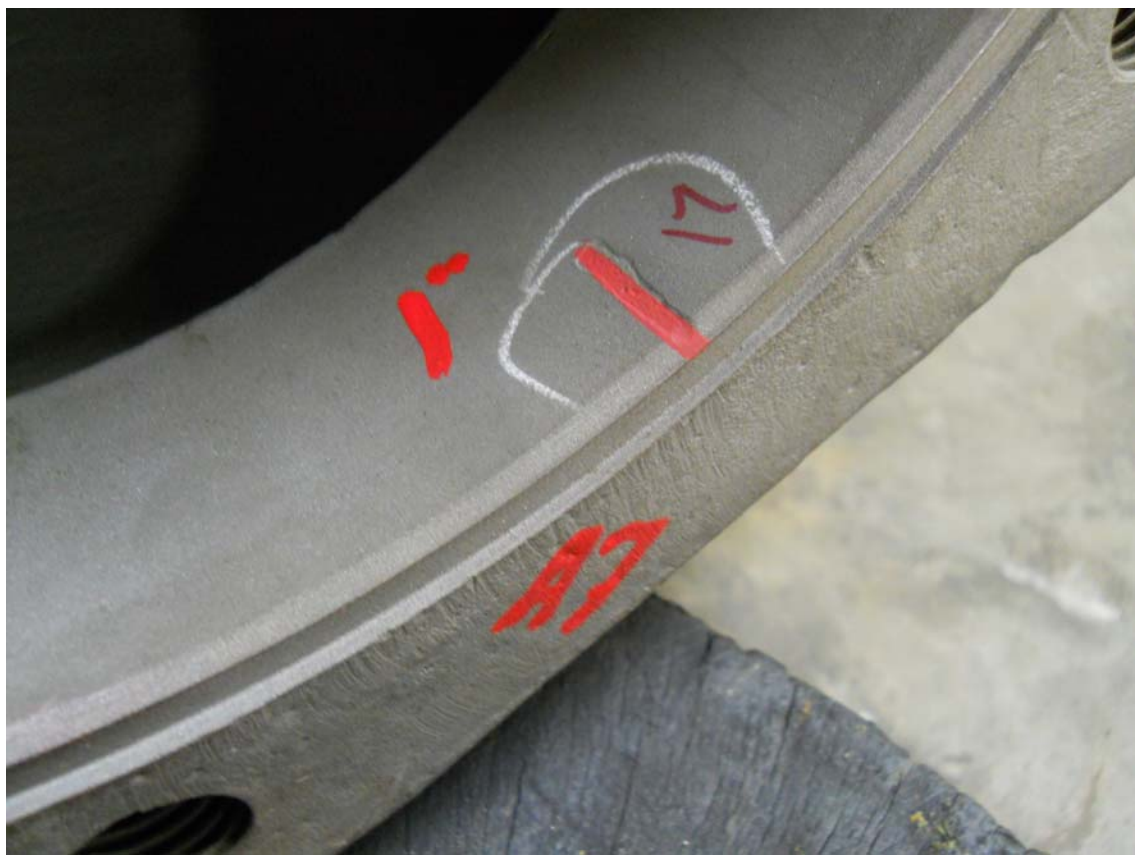
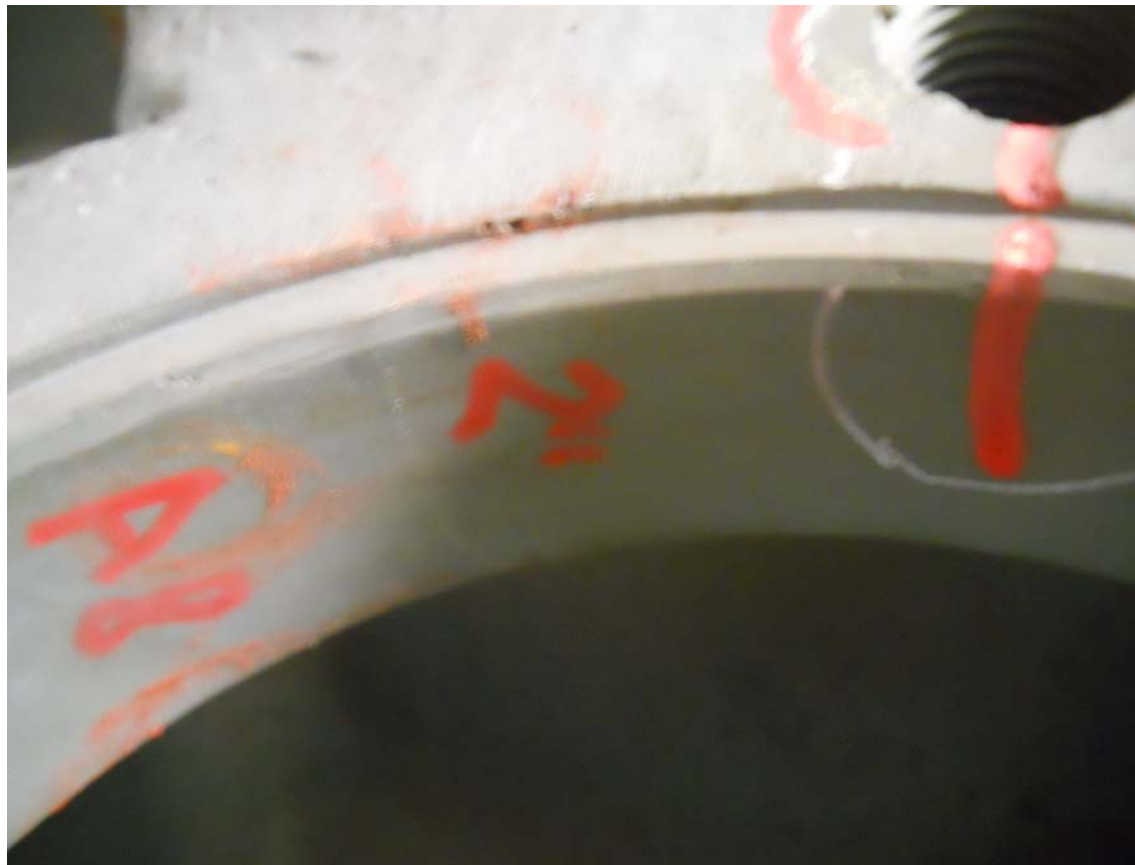
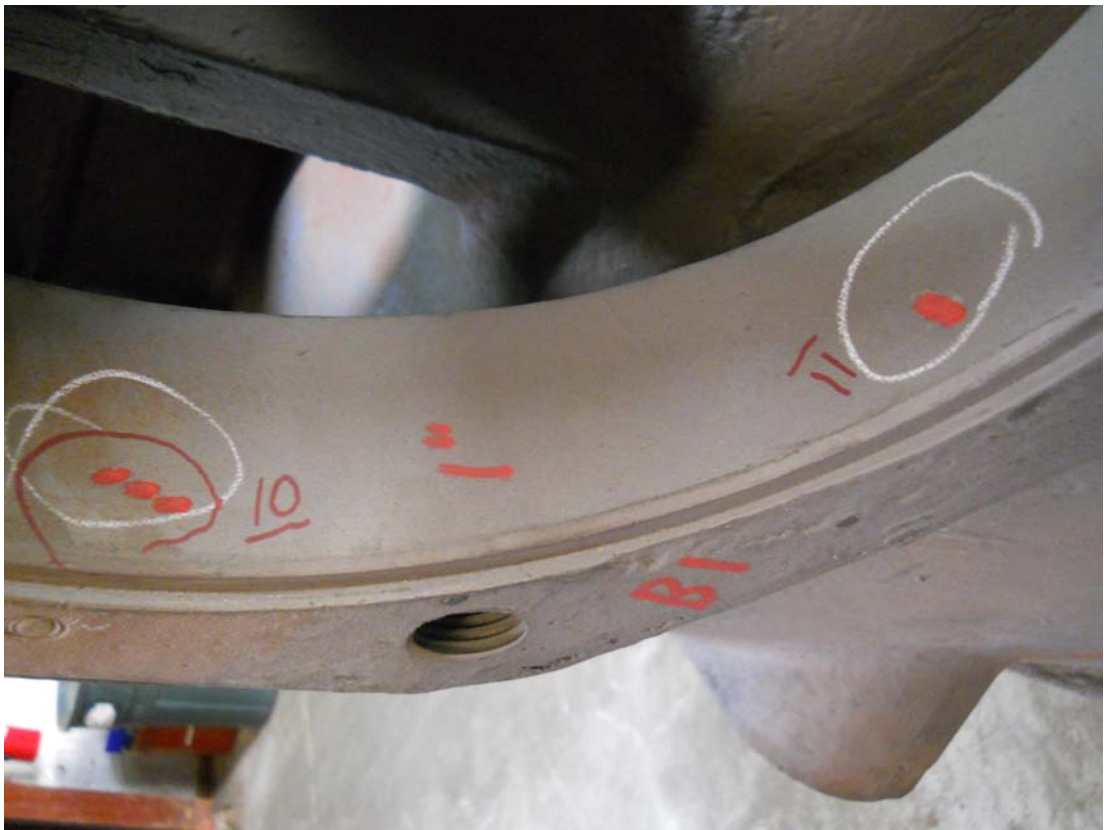
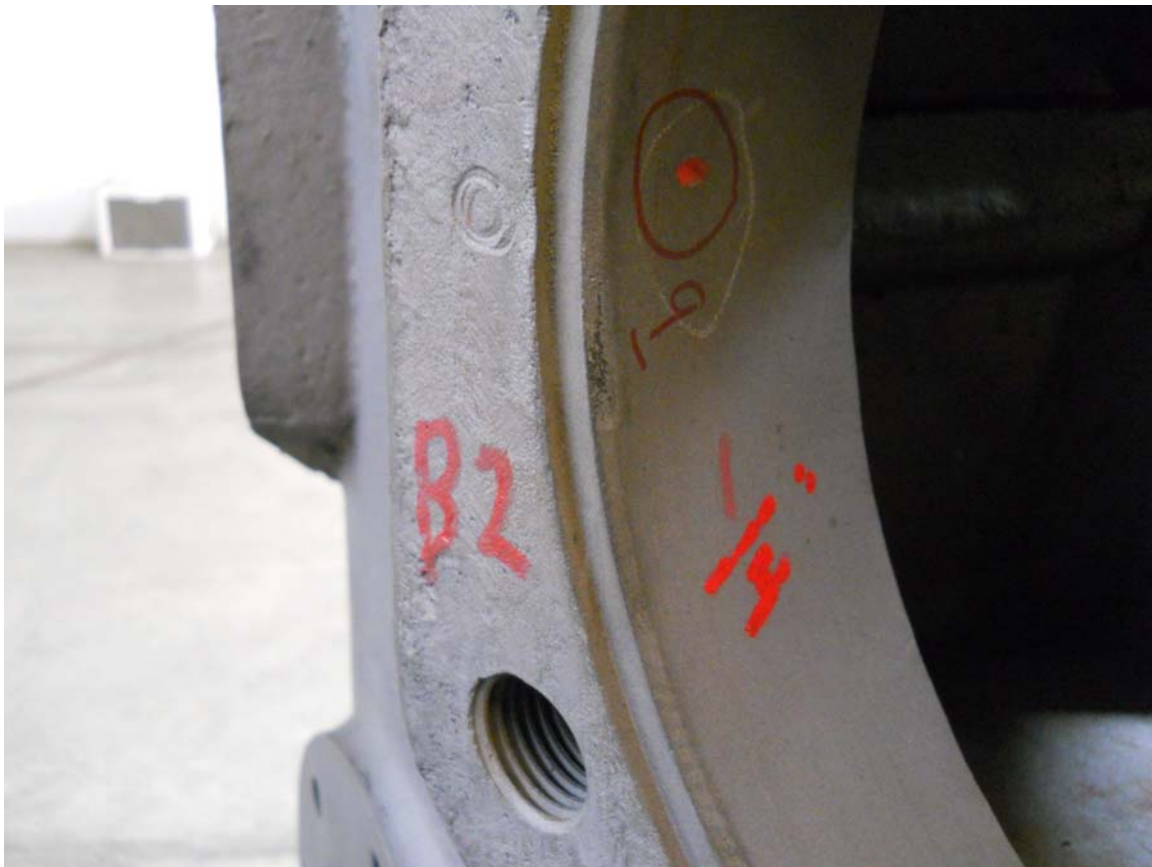
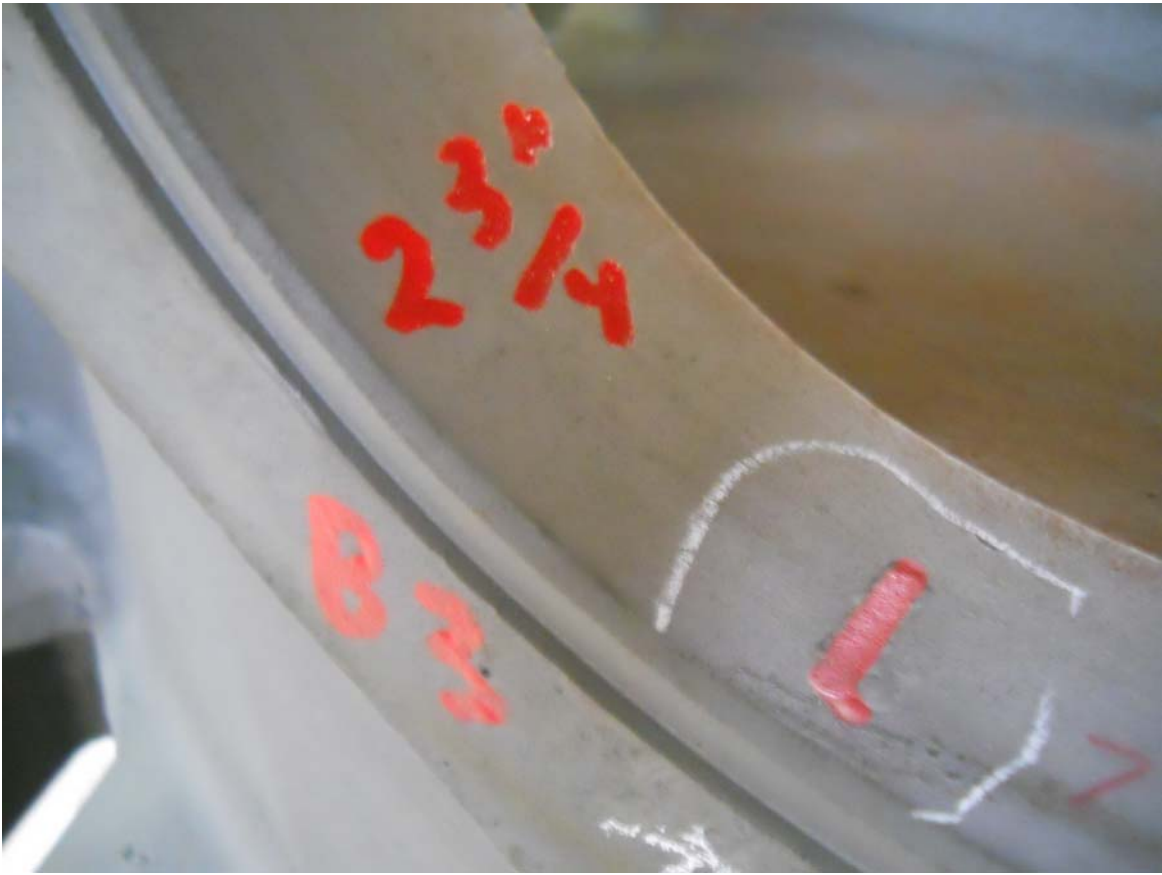
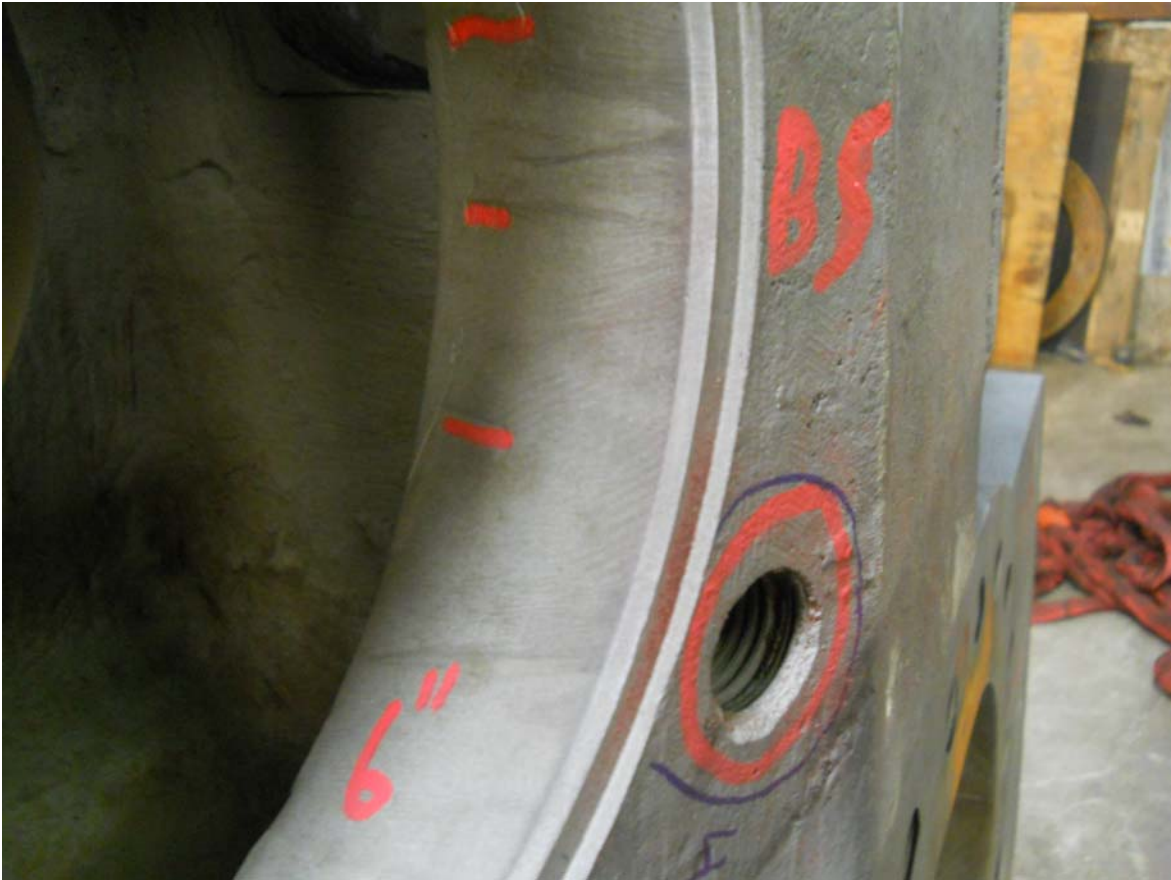
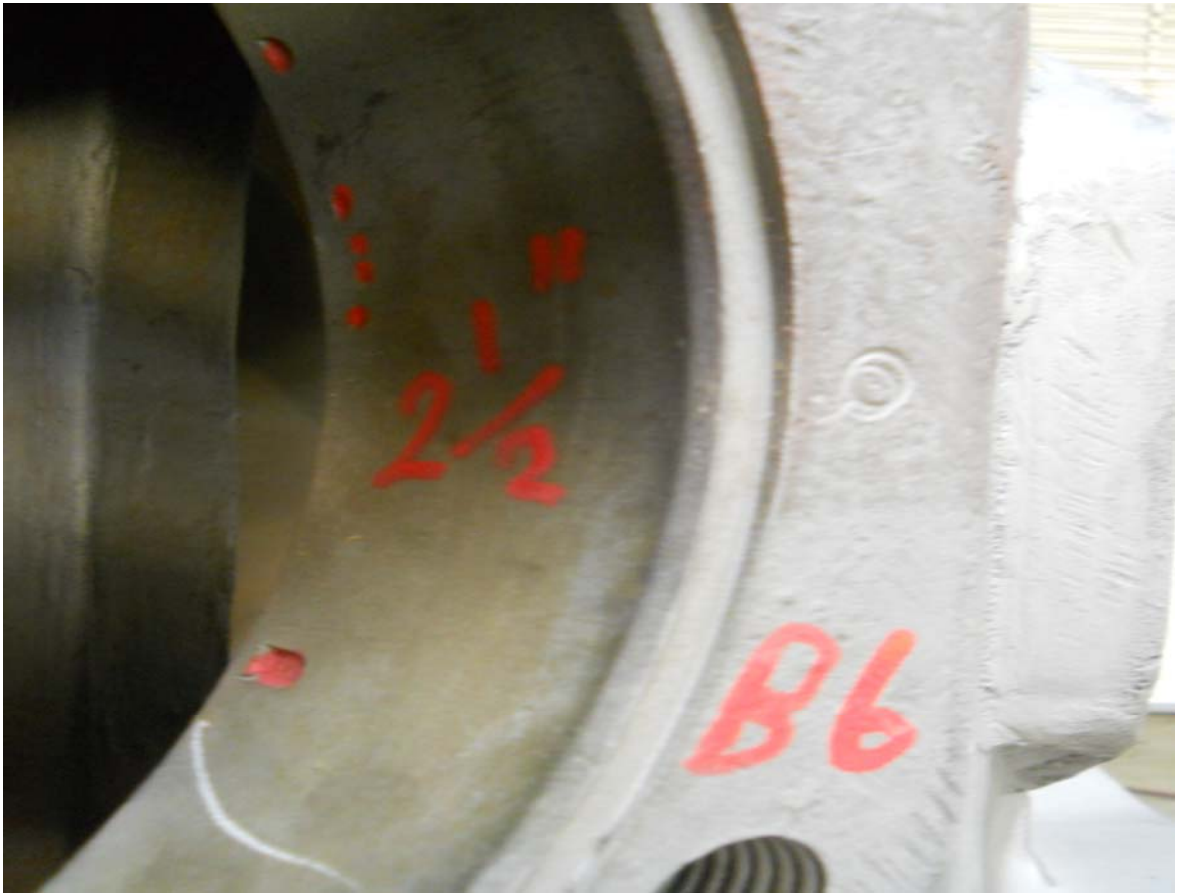
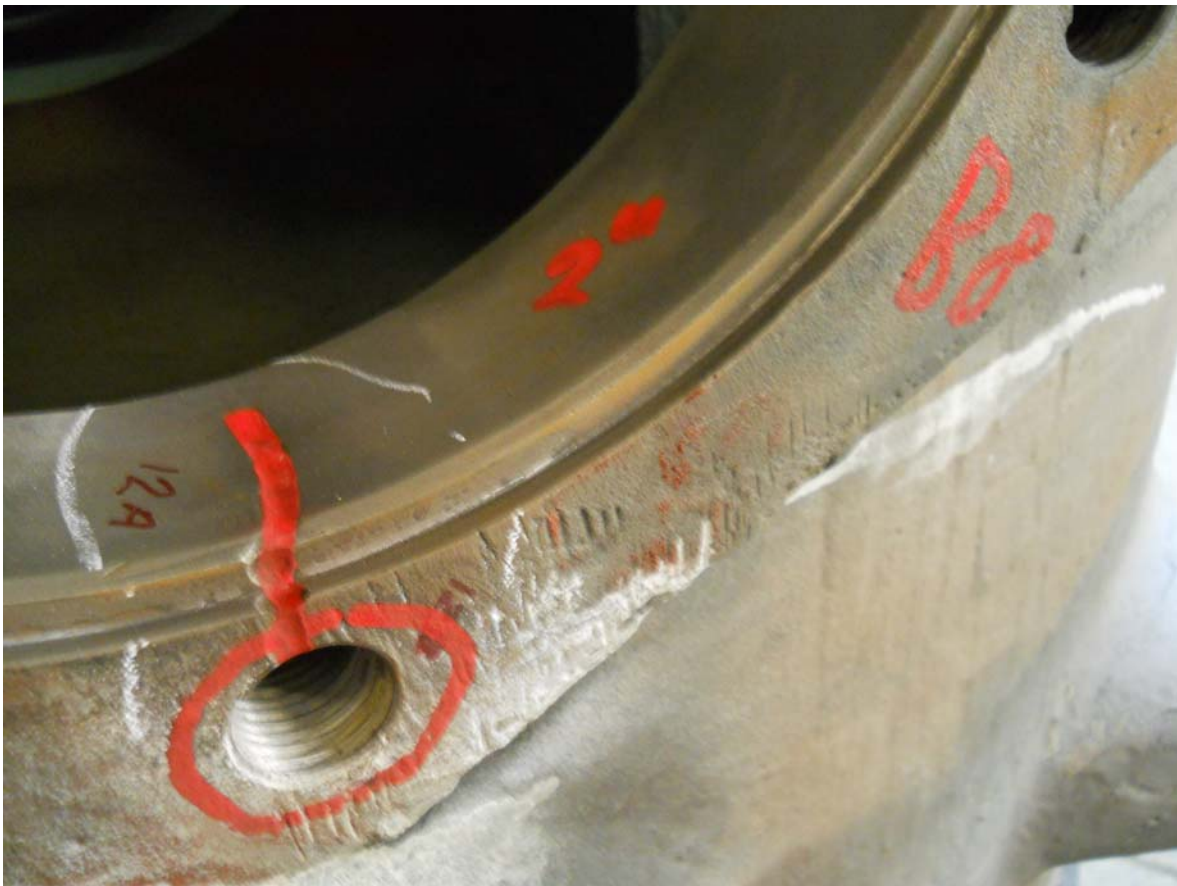
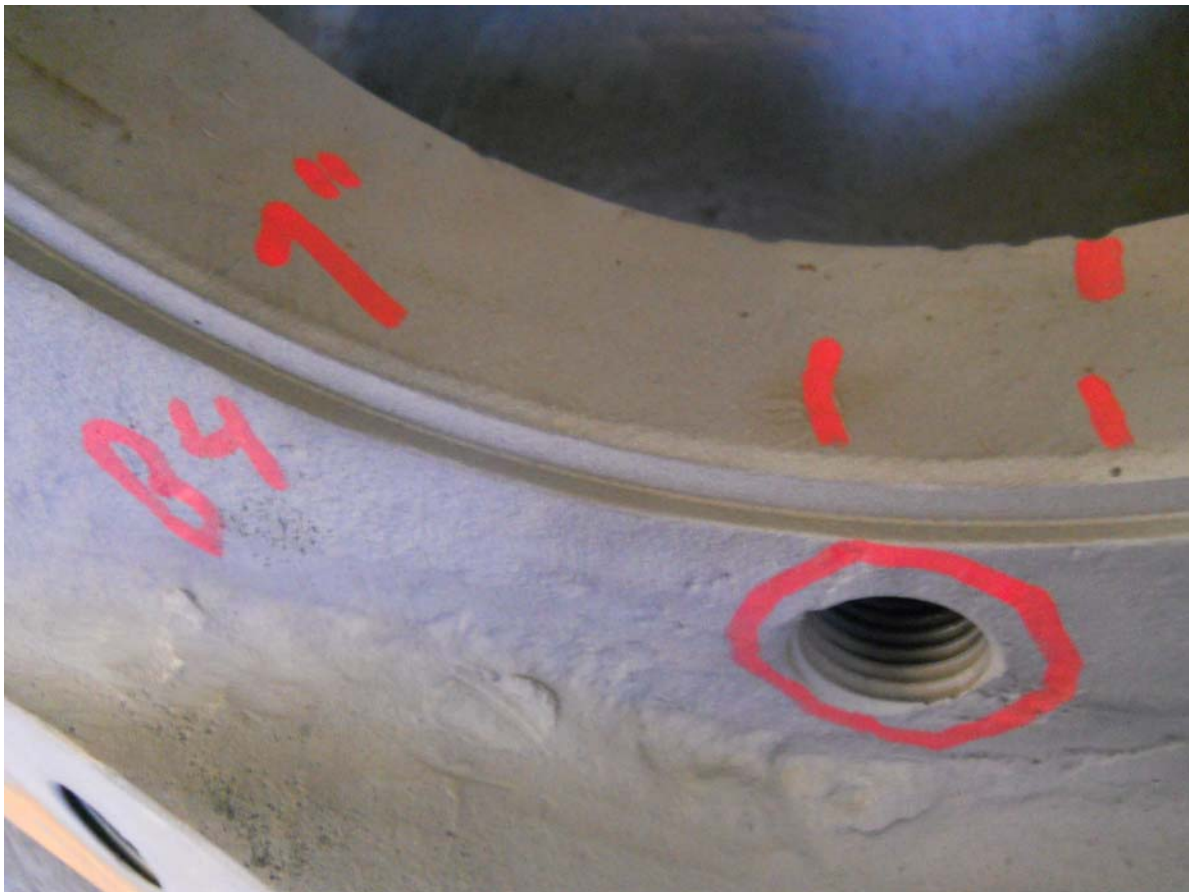
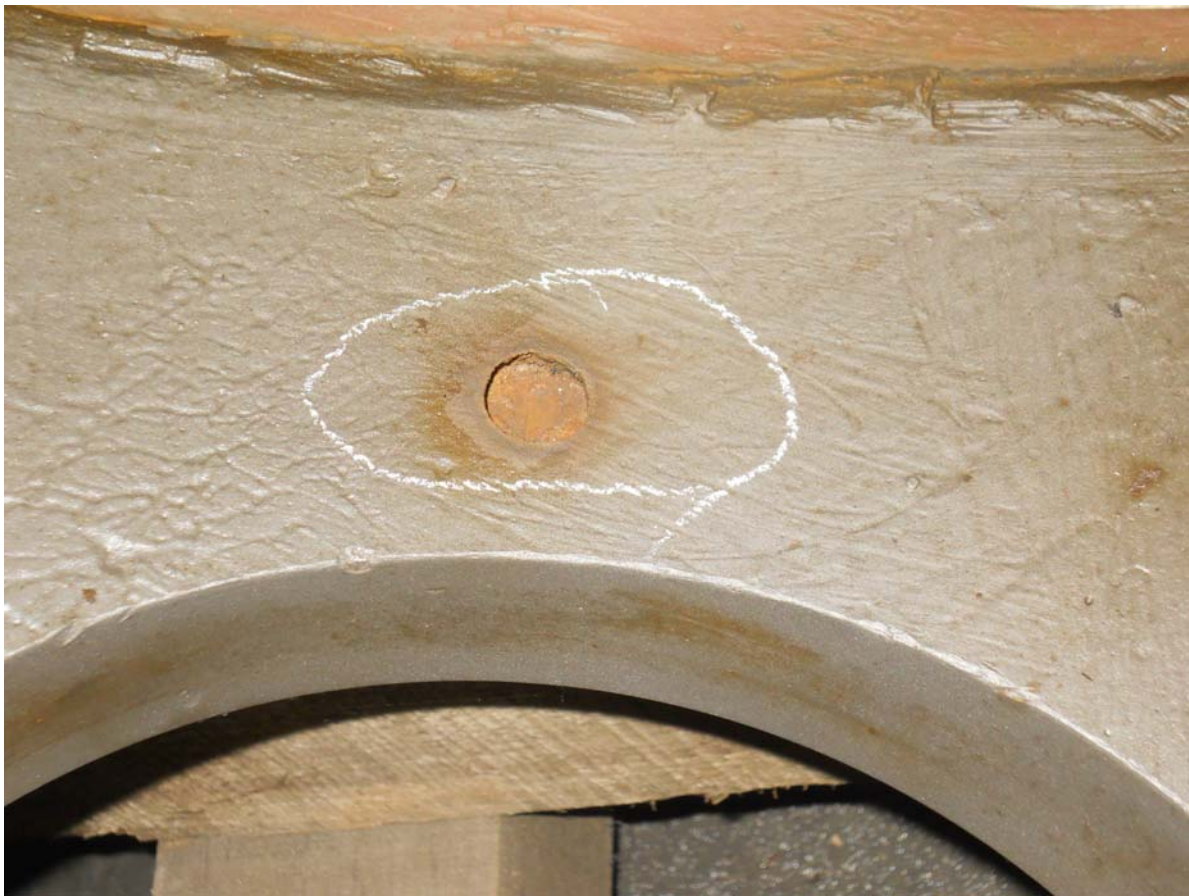
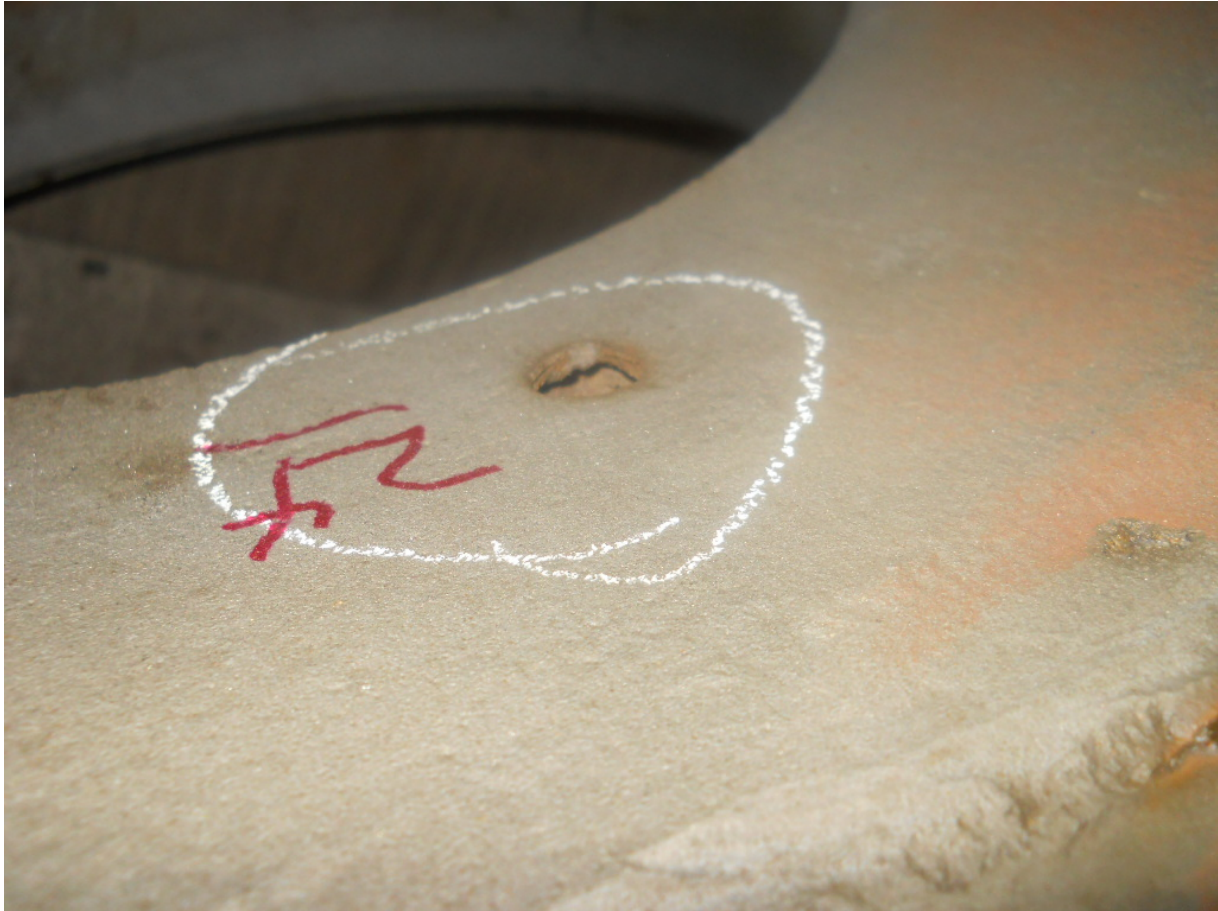
- #1 Found numerous low spots on the valve cover bores
- #2 Cracks in valve cap stud holes
- #3 Through holes in existing valve cap stud holes

- The first 18 pictures show the extent of the damaged valve cover bores. Some of the bores as you will see were quite deep and long. Some of the valve cover stud holes were cracked and had protruded thru the back of the valve cover stud holes.
- The next 8 pictures show the repair process of the valve cover bores and the valve cover stud holes.
- The next 6 pictures show the final repairs of the bores and stud holes. Pressure gage @ 400psi
