LOCK-N-STITCH Inc.
Casting Repair Specialists
1015 S. Soderquist Rd.
Turlock CA 95380

Inspection / Repair Report

Part: Worthington Compressor 27 1/2" bore

Serial number: A11675-22A2 Inspected by: Alaa Al'Robaie

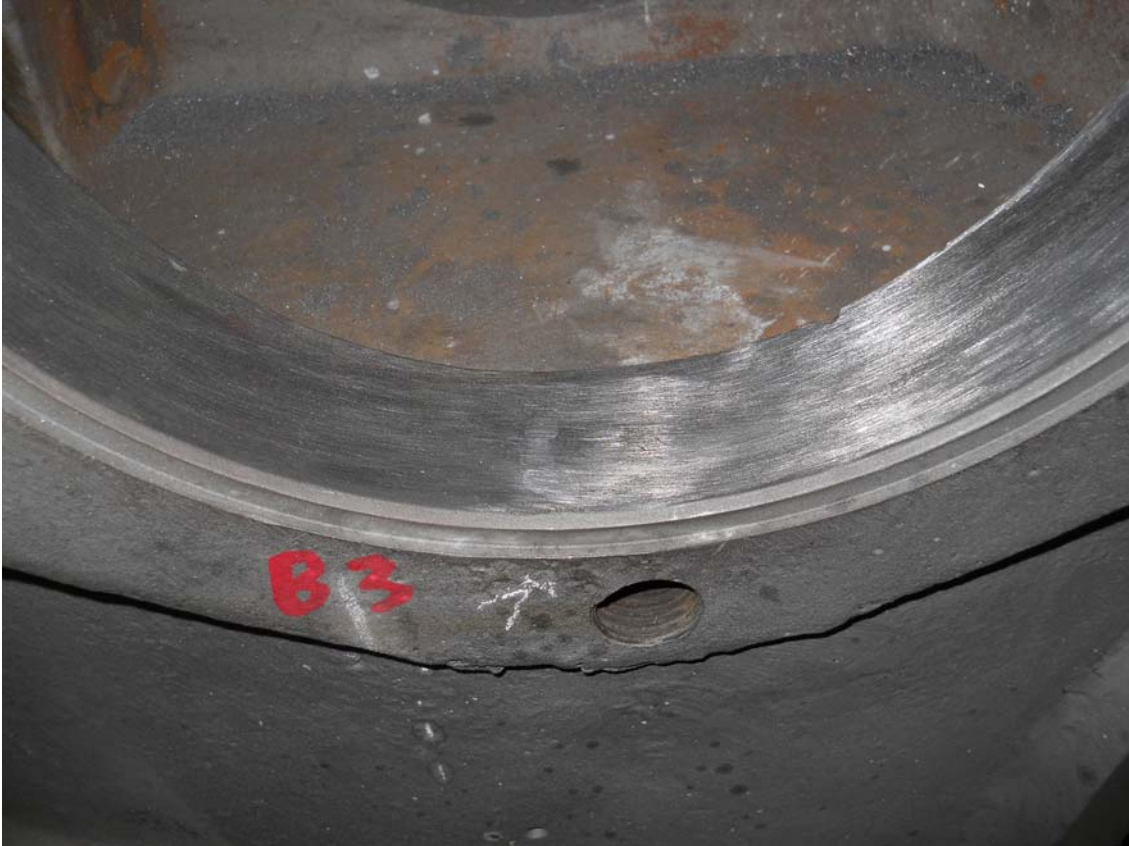
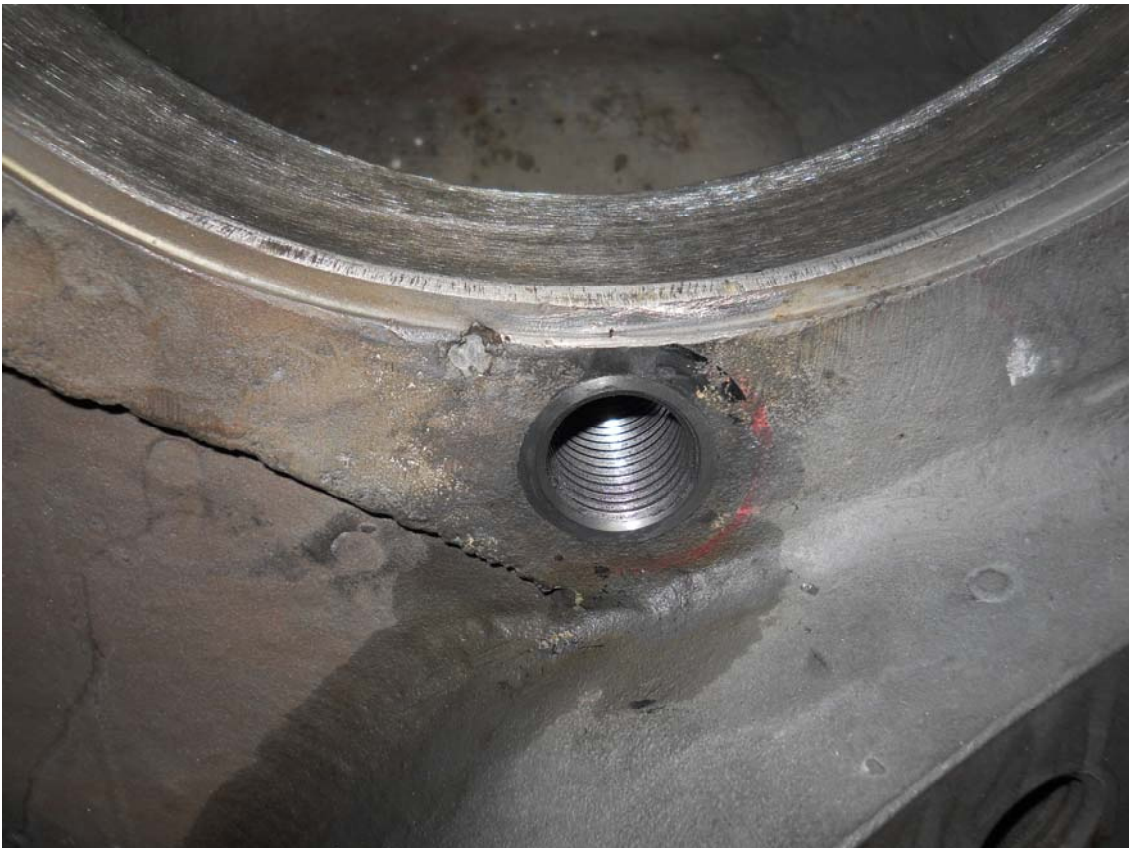
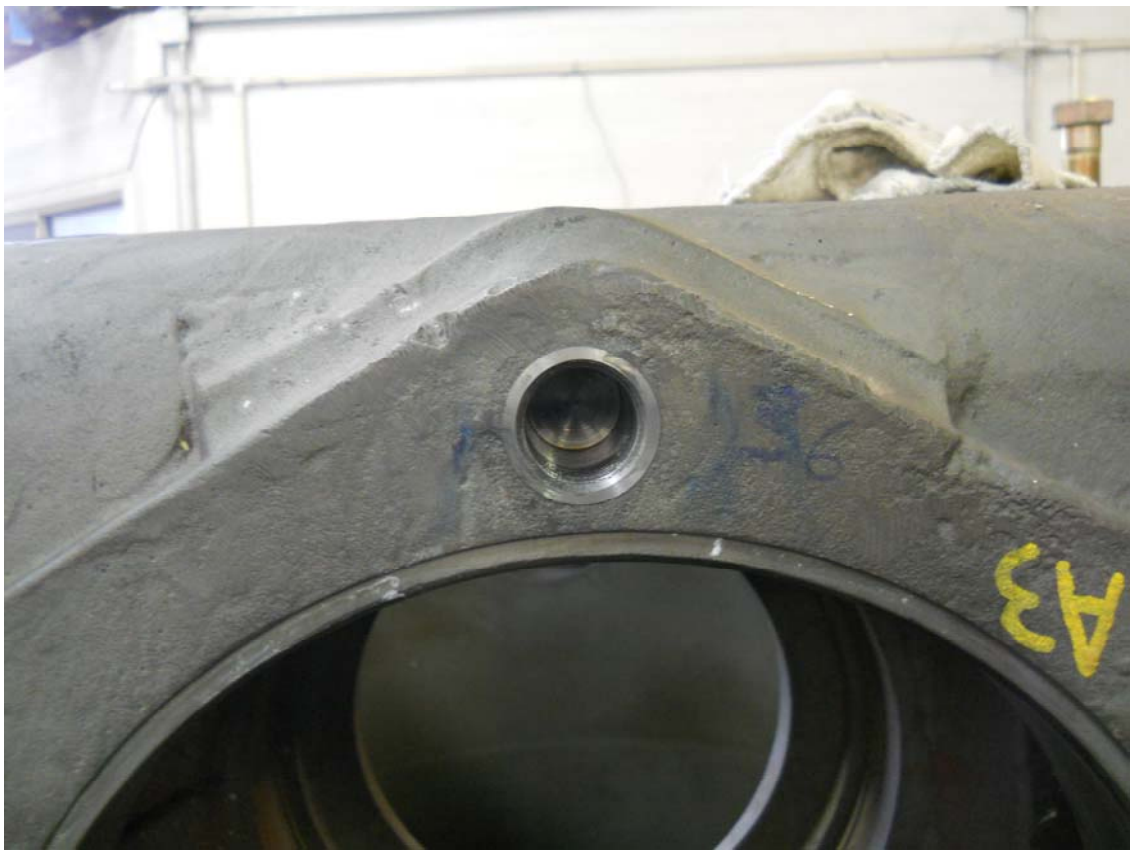
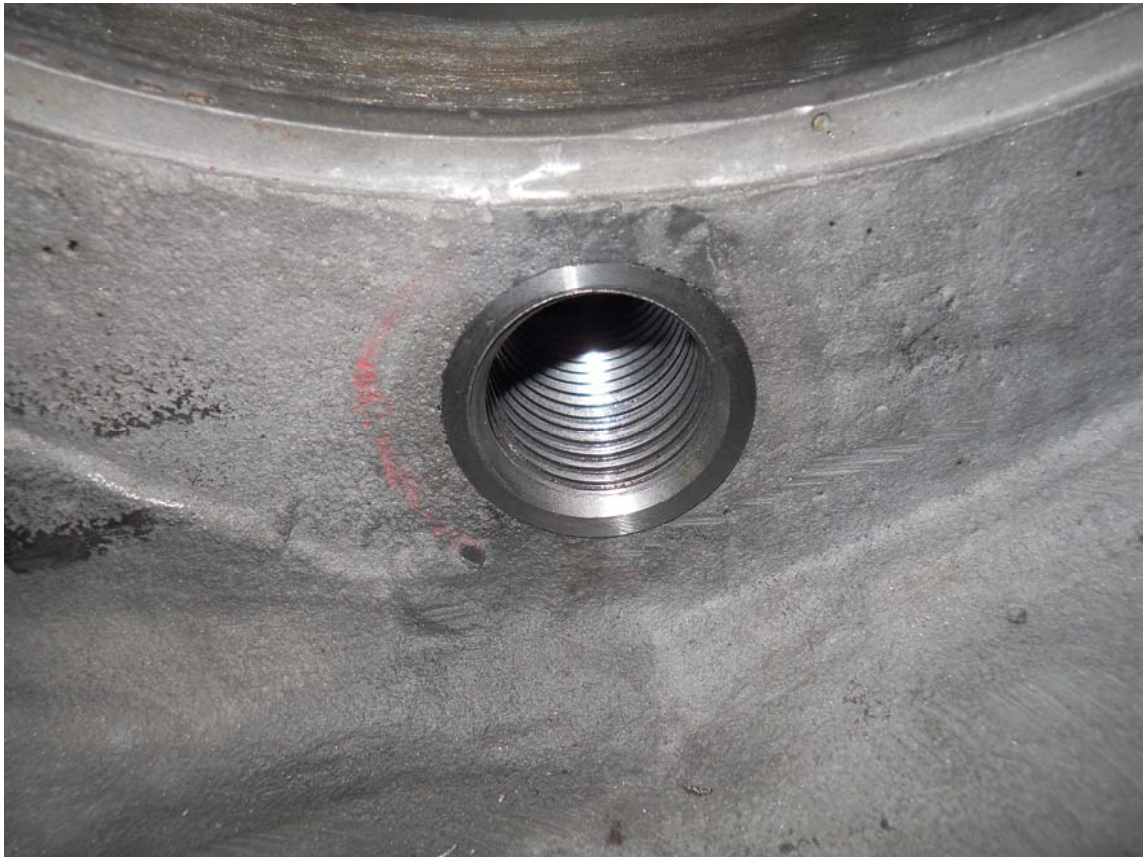
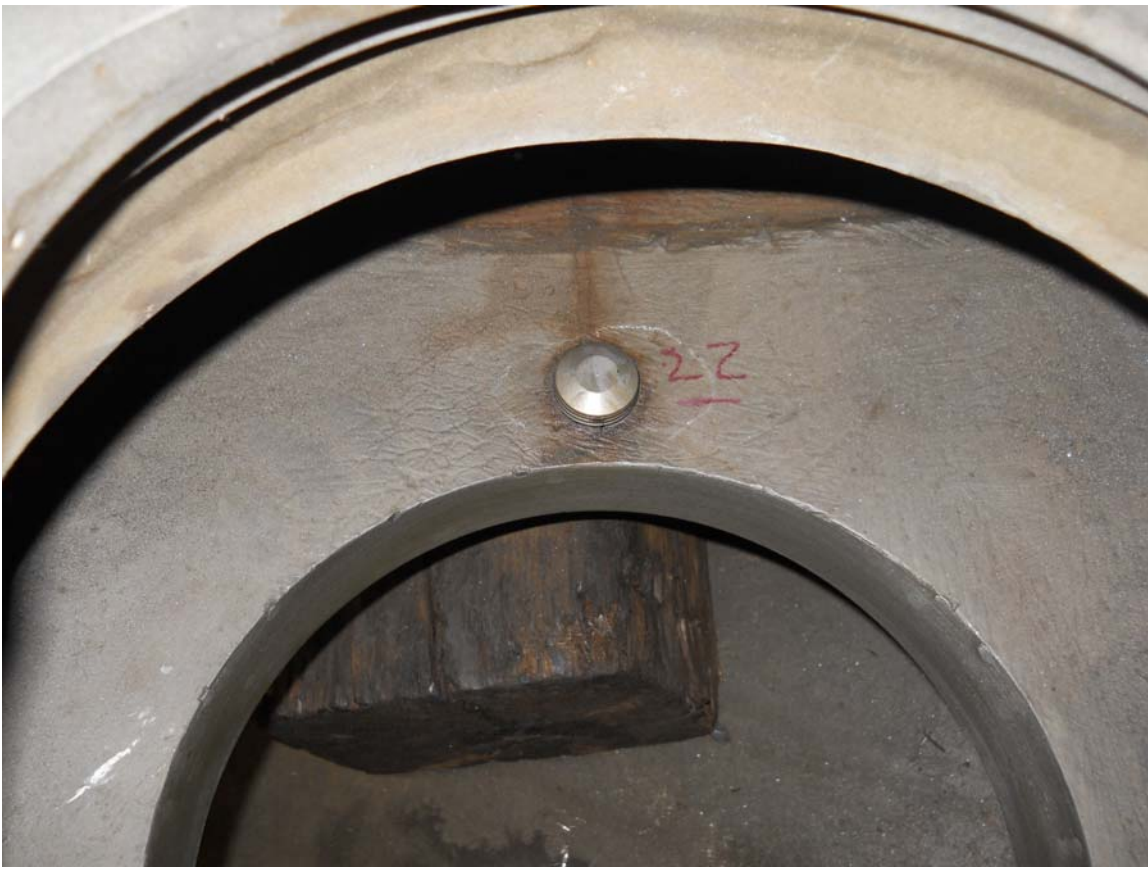
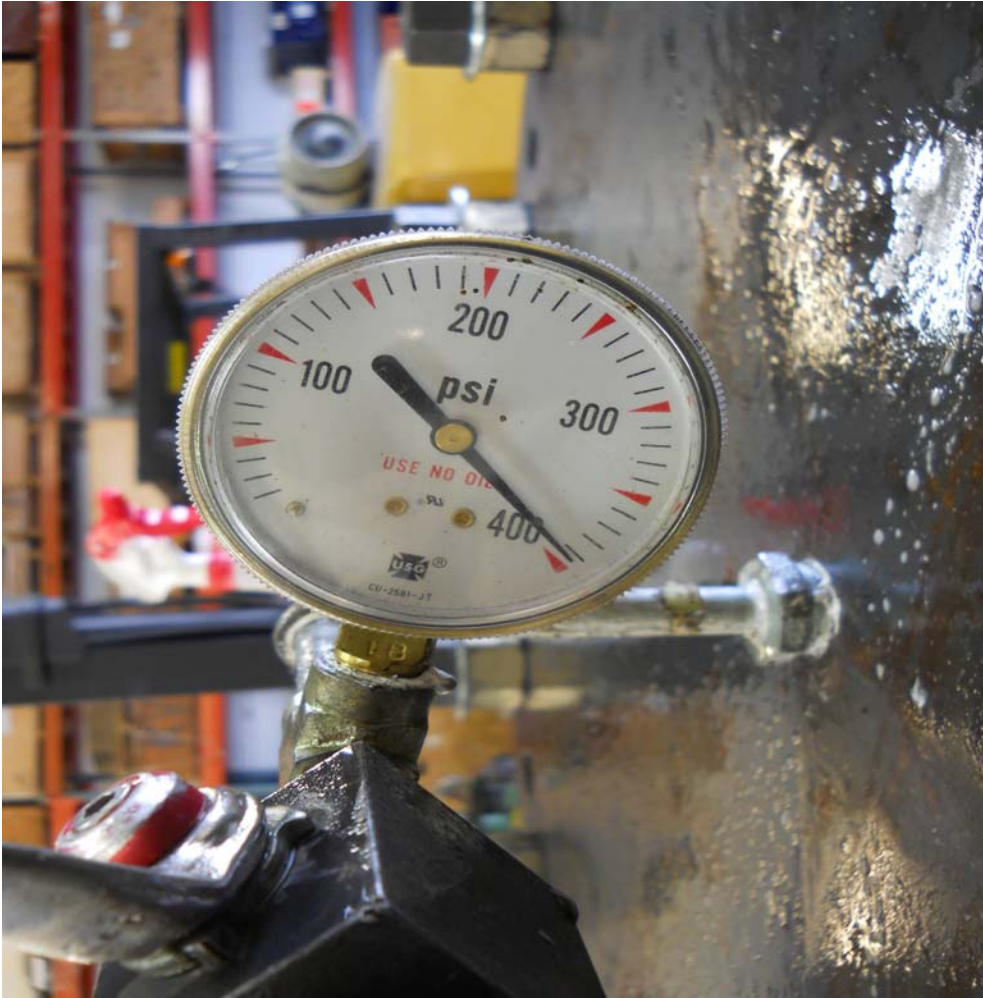
Completion of Stitching and Insert Repair

After completing the stitching and thread repair insert installation processes following our initial NDT inspection, we started the pressure testing process of the cylinder using compressed nitrogen gas. We found (4) four valve bores leaking @200psi. Testing was stopped at this point to determine the cause of the leaks. Roundness of the four outer valve bores were checked and found to be .008” out of round. We then honed the (4) four Bores and changed O-rings from 50 durometer to 70 durometer on all bores. We found 16 of the valve cap stud holes had short steel plugs installed at the bottom of the stud holes with lead used to seal them. These 16 stud holes had only 1” of thread depth when it should have had 2” of depth. We removed the lead by melting it out and chasing the holes with a tap.

We then reassembled the valve caps and pressure tested the cylinder again, and found 3 of the 4 stud hole that we cleaned out were leaking. We manufactured and installed additional blind thread repair inserts into the leaking stud holes and tested them again. The next pressure test showed three O-rings leaking slightly so we bled of the pressure again and inspected the O-rings and found minor miss alignment where the ends were glued together. The caps were reassembled and the testing proceeded again. At 400 psi some of the inserts developed very tiny leaks around their outside threads.

Our conclusion was that because of the way these stud holes had been sealed off in the bottom half, they must have had some small porosity that was causing these leaks. We decided to metal stitch around the inserts to seal them off permanently. It required a total of 14” of metal stitching around the thread repair inserts to get them to pass the 400 psi nitrogen pressure test. The final test at 400 psi was monitored for one hour with no leaks. The coolant jacked was sealed off and monitored for pressure build up during the one hour test with no pressure increase.

Here are the results of the repair work and pressure testing of the compressor cylinder
