# Custom truck with cracked 5.9 block

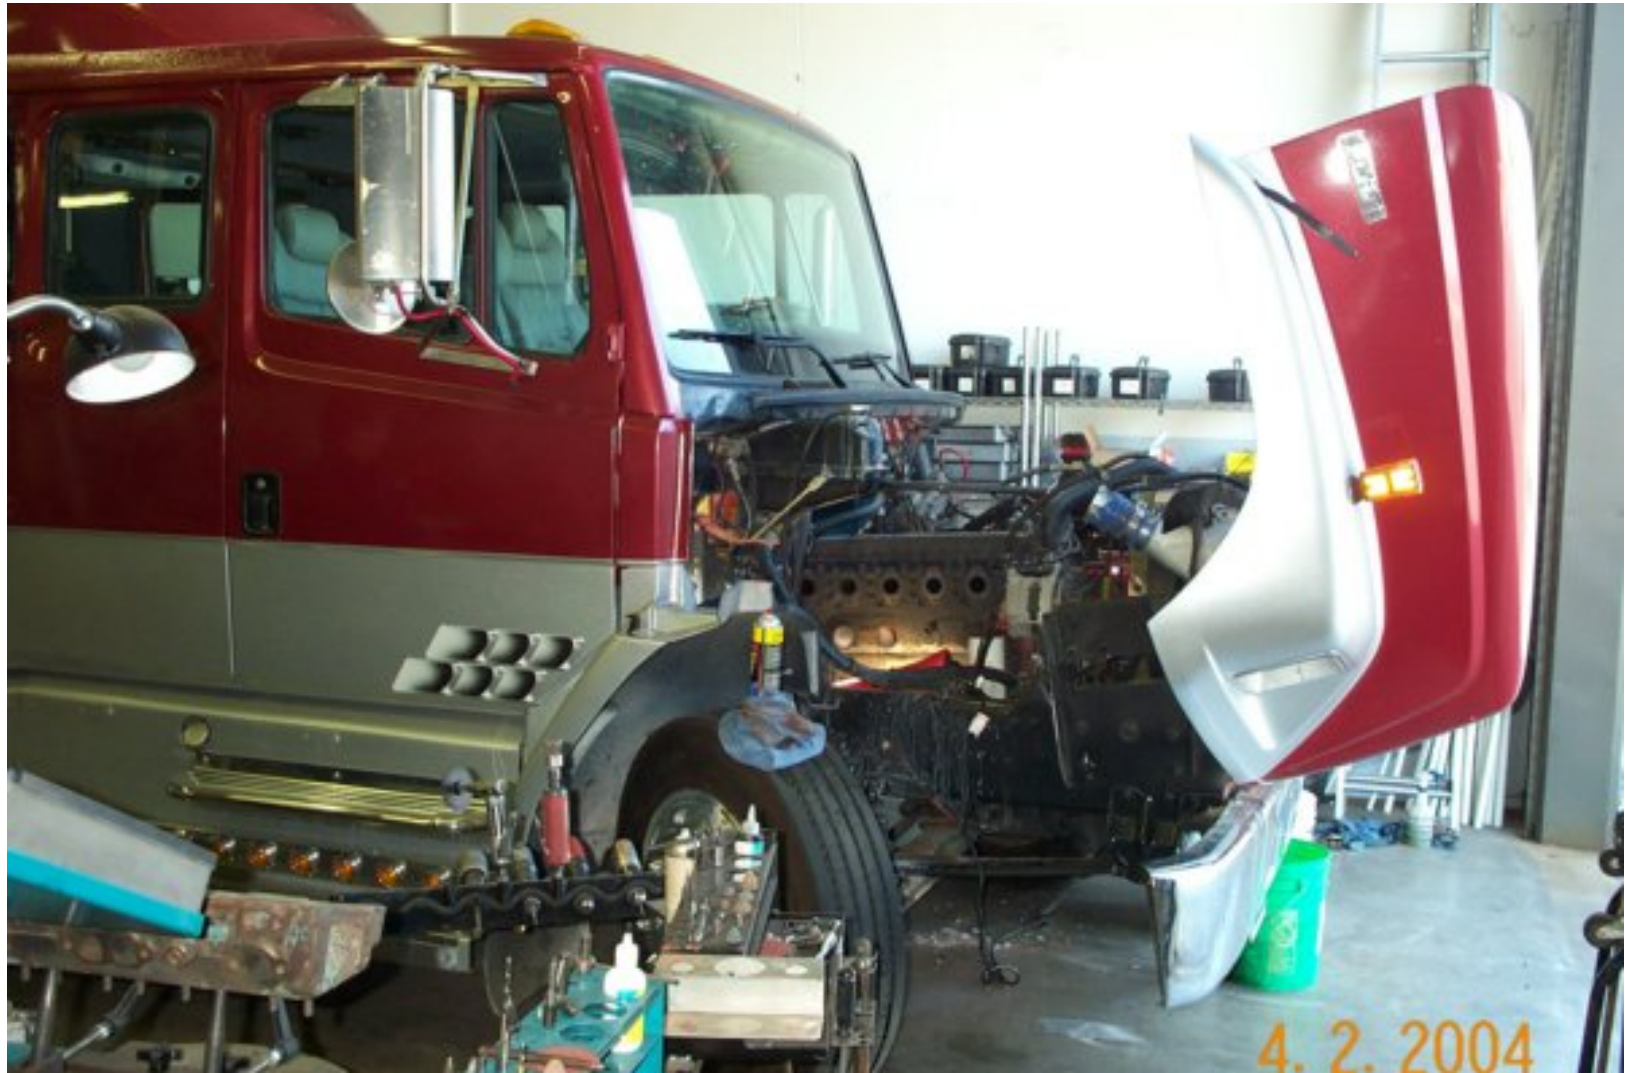
# Block had been arc welded with nickel rod causing many more cracks

Arc welding causes serious damage to the cast iron. Hardening, brittleness, pin holes and additional cracks.

Arc welding is the worst choice to repair a crack in an engine block.

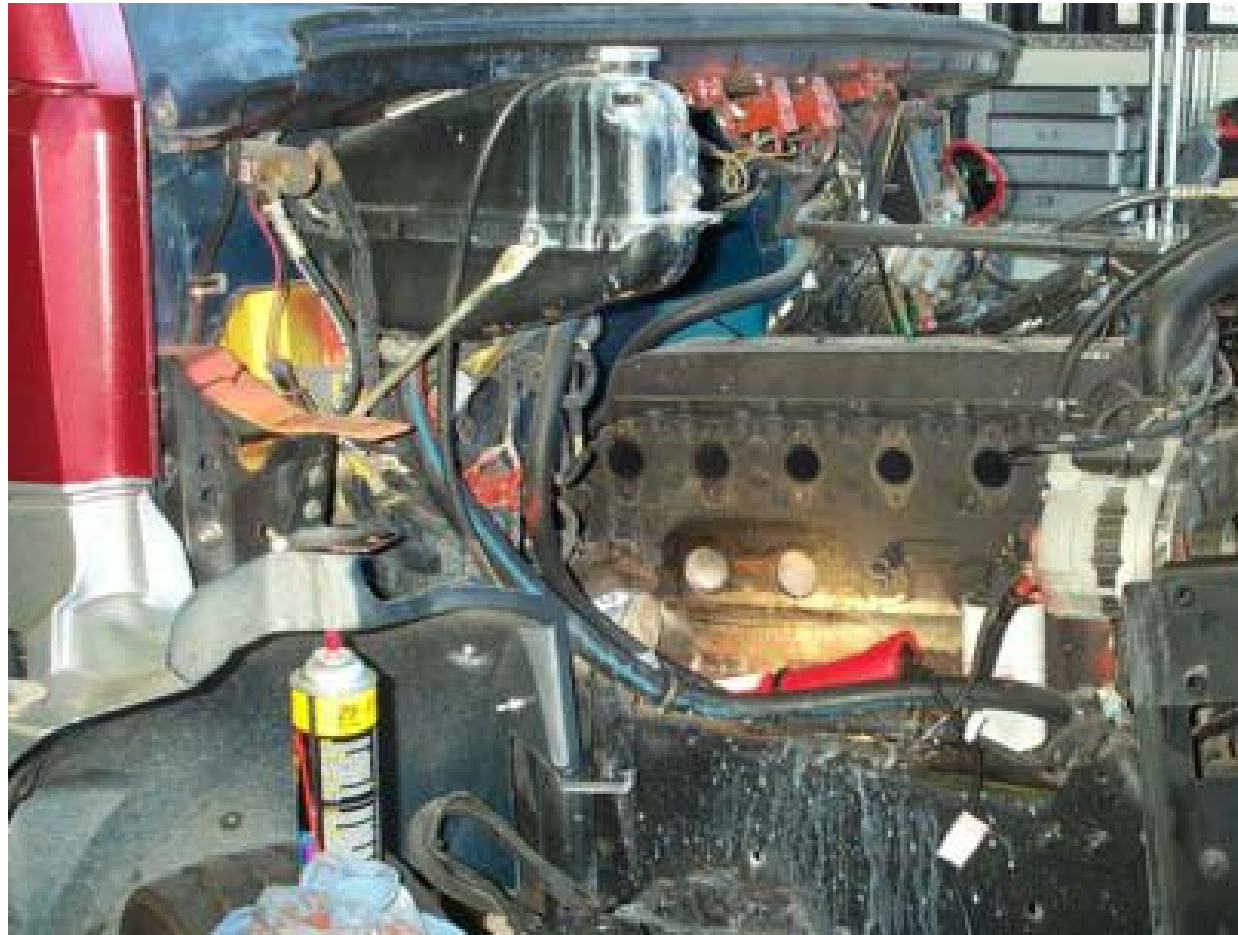
This part of the crack was not welded and was easy to fix

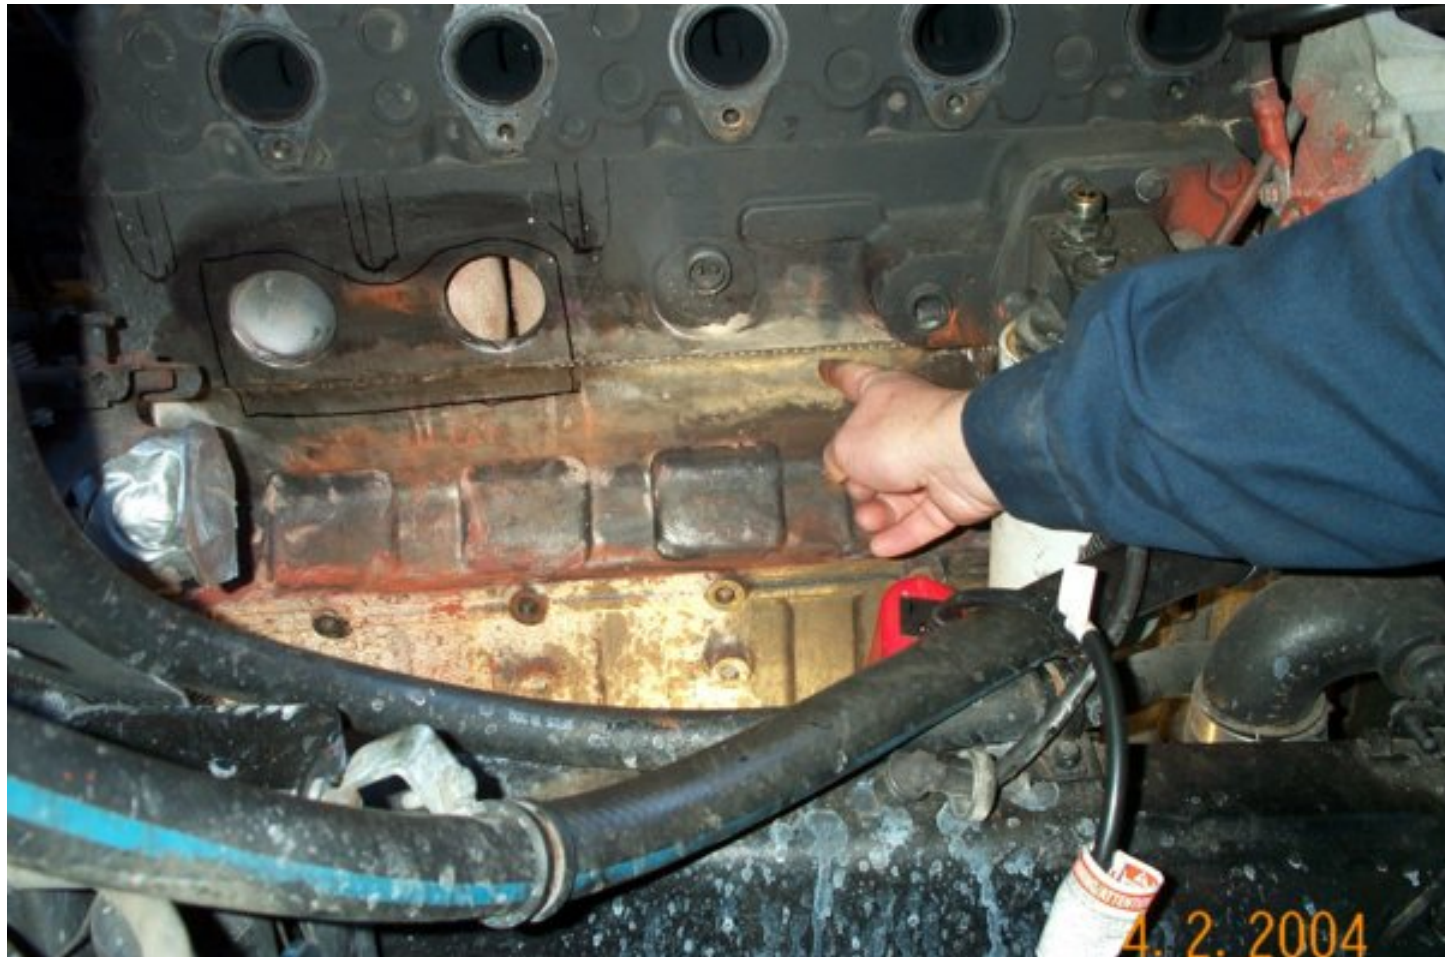
This section was welded and is now too hard to drill and tap

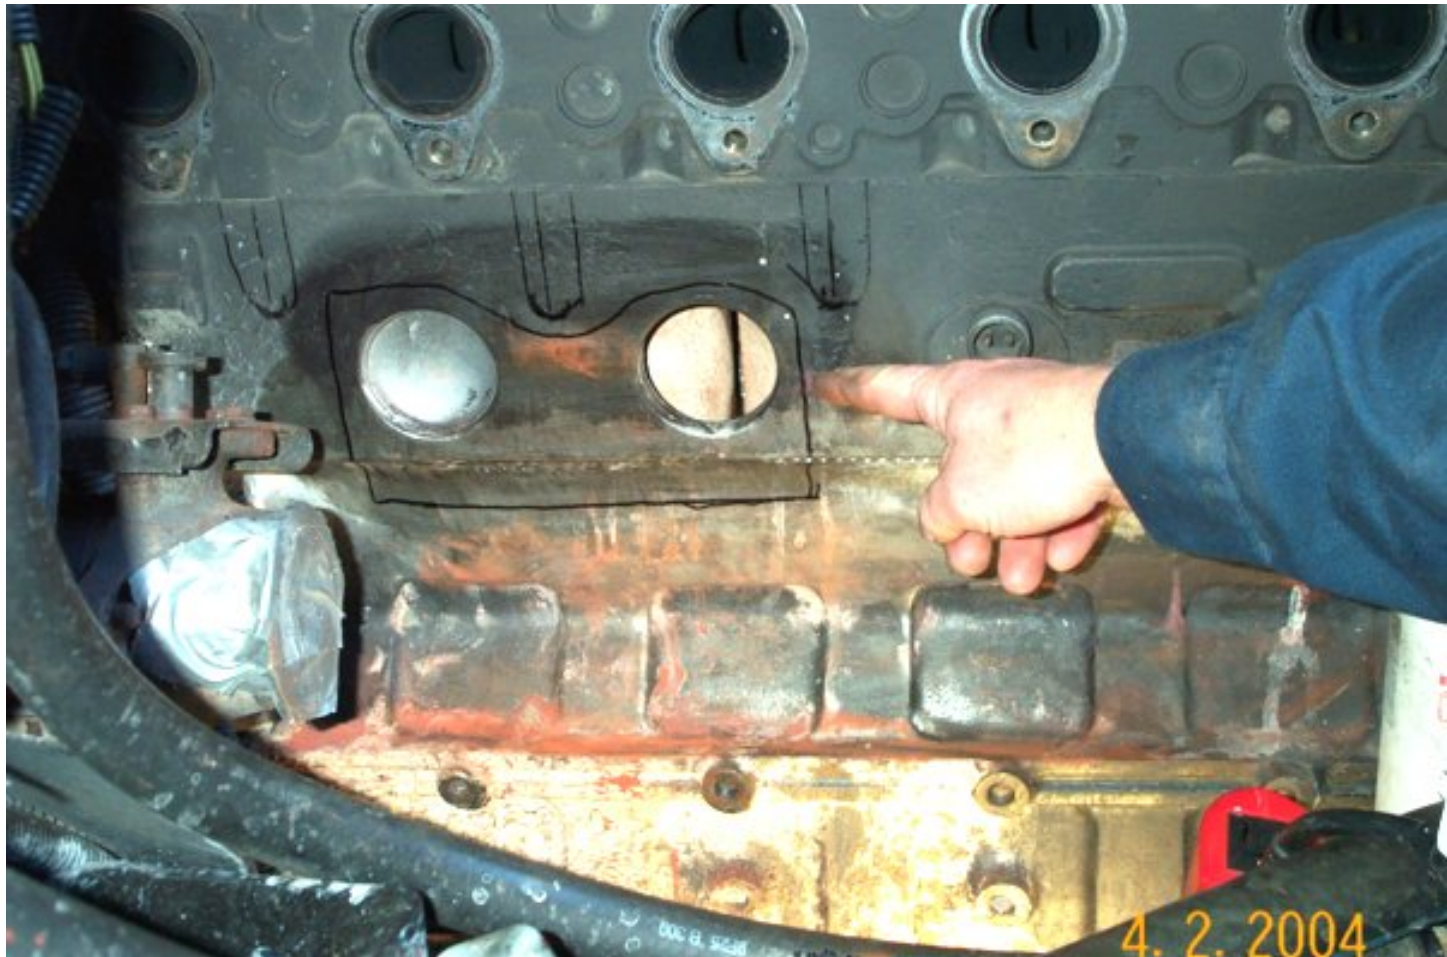
The outlined area will be cut from the block to remove the damaged iron

The weld extended into the core plug holes and could not be repaired by stitching.
