Repairing a crack across the exhaust valve seat on a 2.5L GM cylinder head

This procedure has been approved by General Motors.

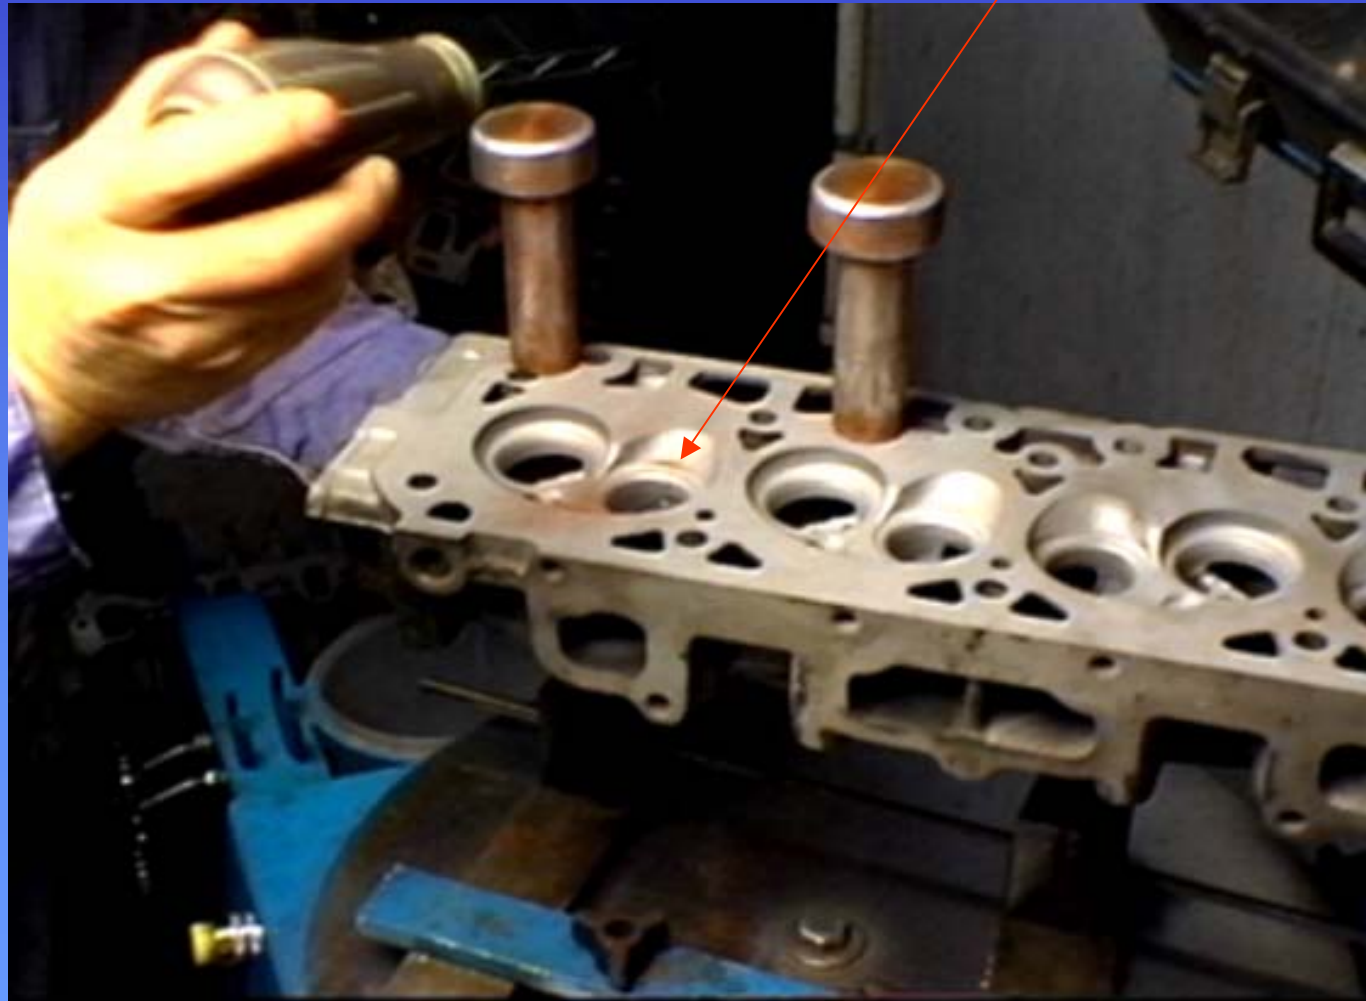
This is a common crack that extends across the induction hardened seat
