Repairing an OMC marine engine damaged by freezing

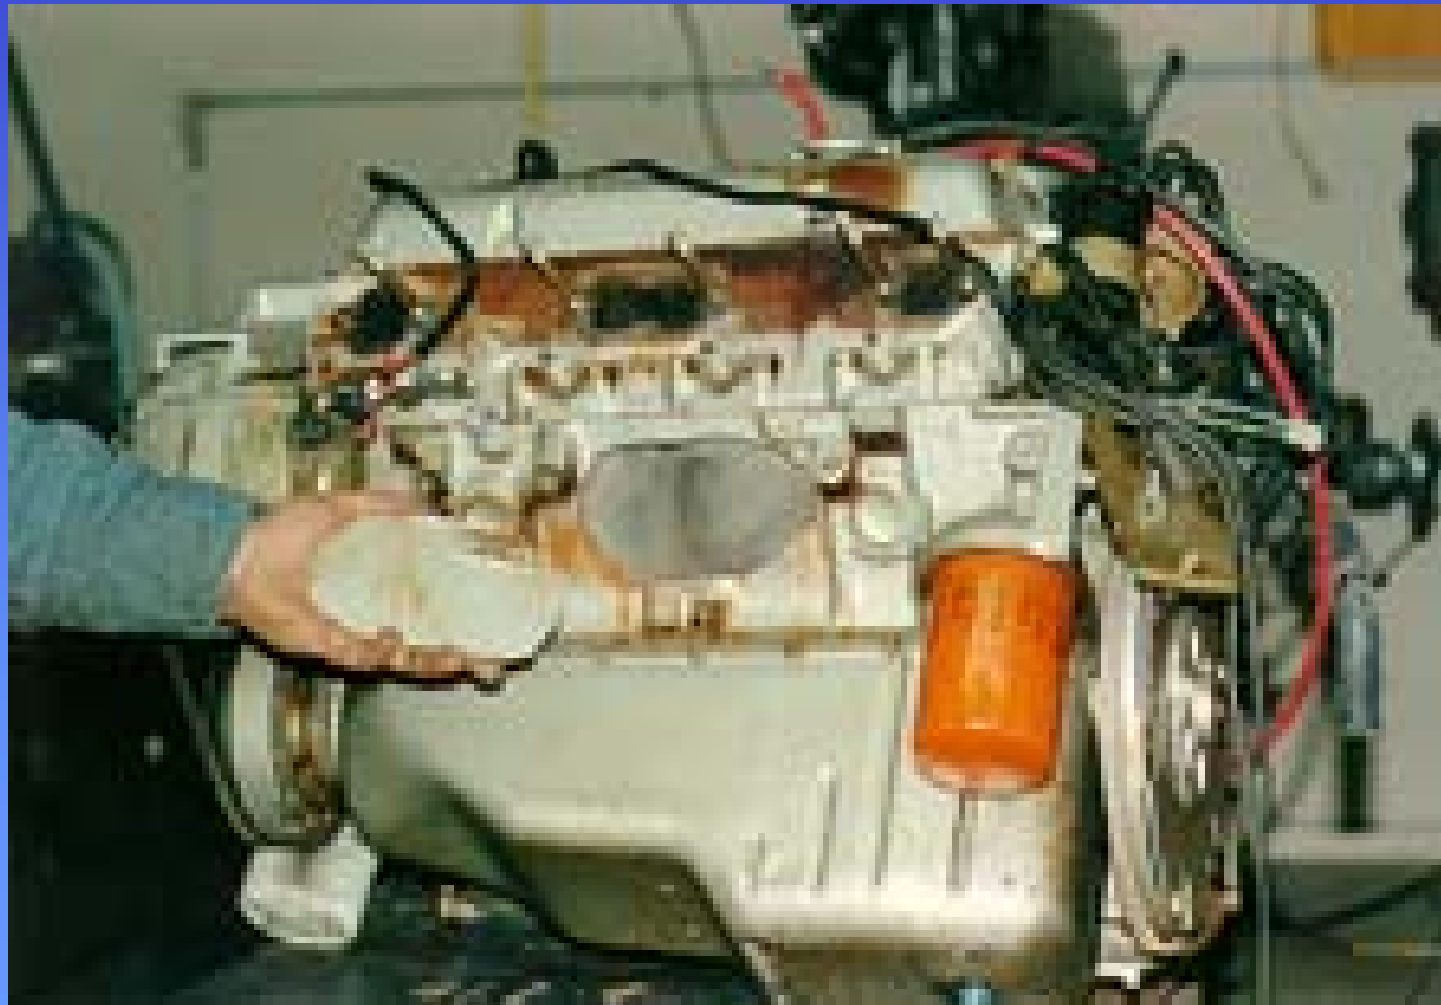
The edge of the hole is lightly ground to smooth the rough edge

The edges of the patch also need to be smoothed. Grind off only the tips of the course grain surface to allow the patch to fit snug back into the hole.

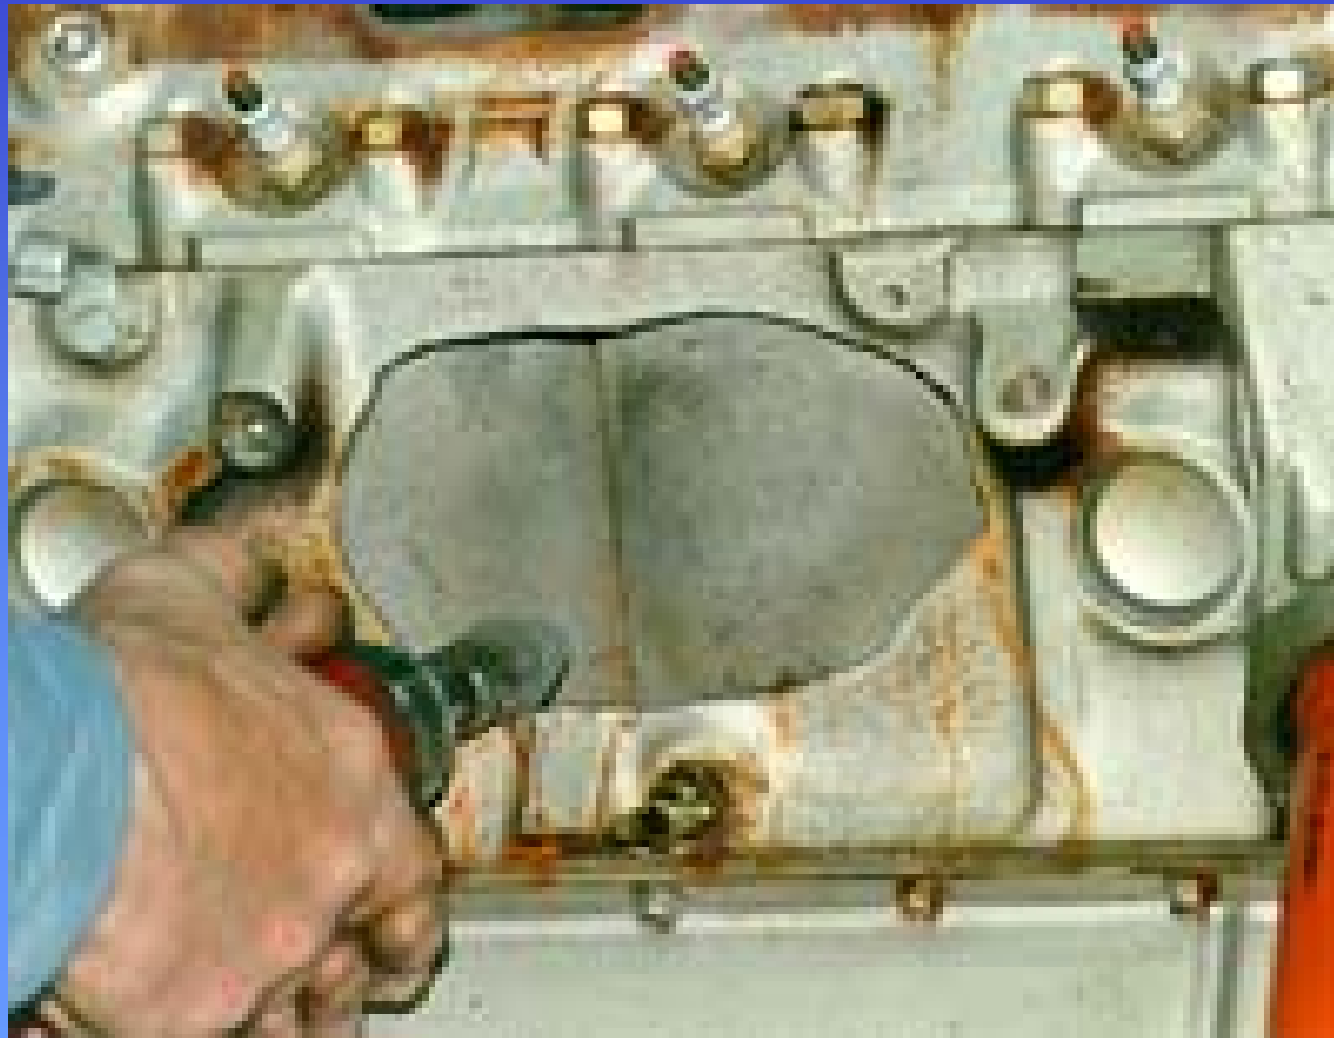
The patch is carefully fit back in

A small amount of epoxy can be used to hold the patch firmly in place until the first few stitching pins are installed.

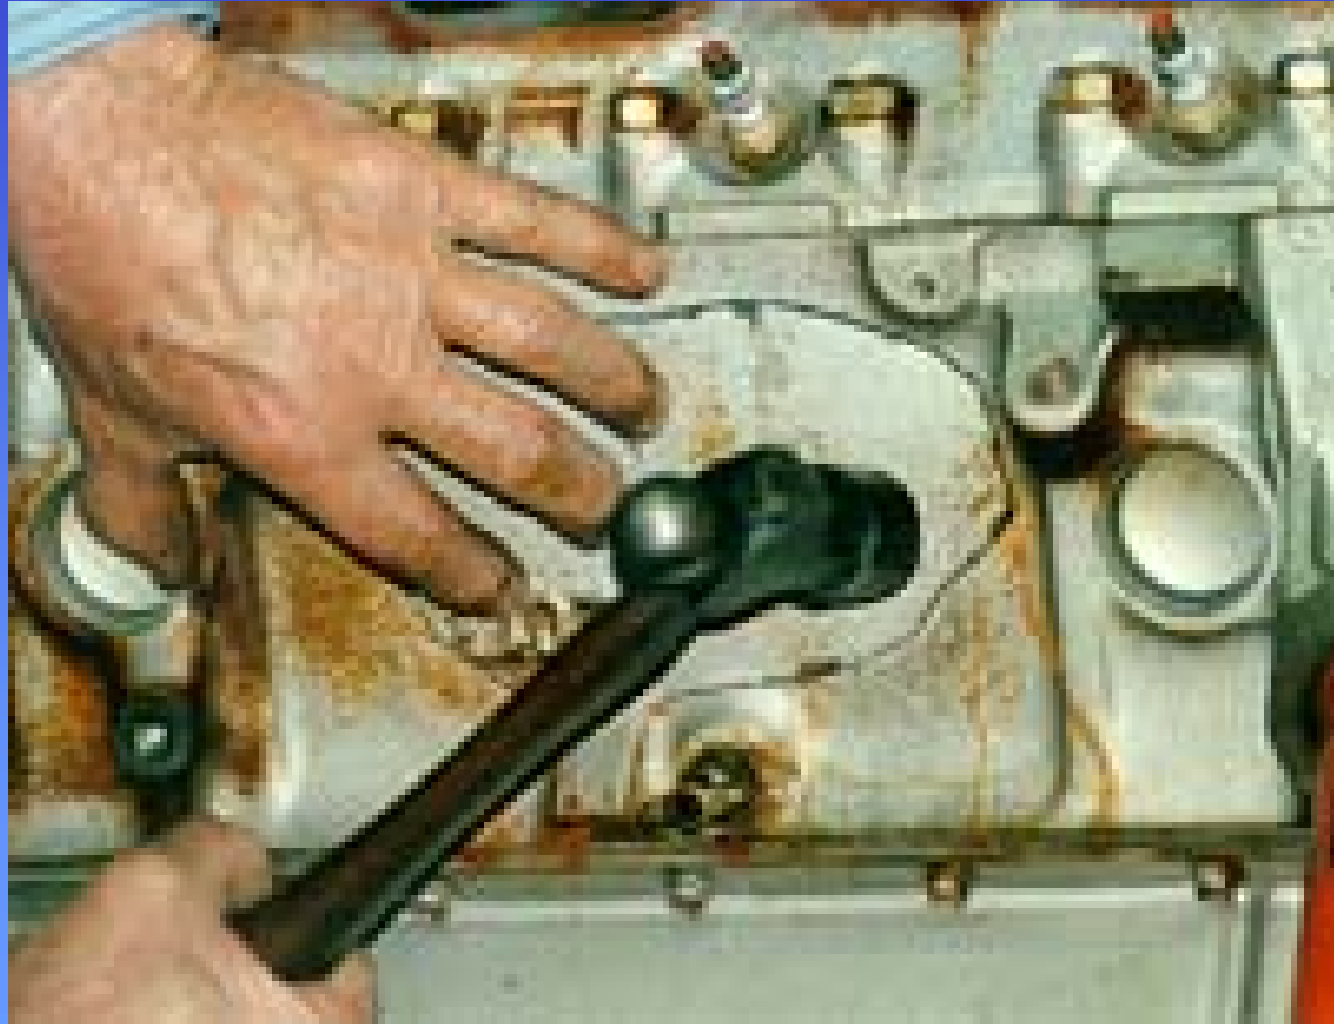
Four L6AS pins are used to secure the patch

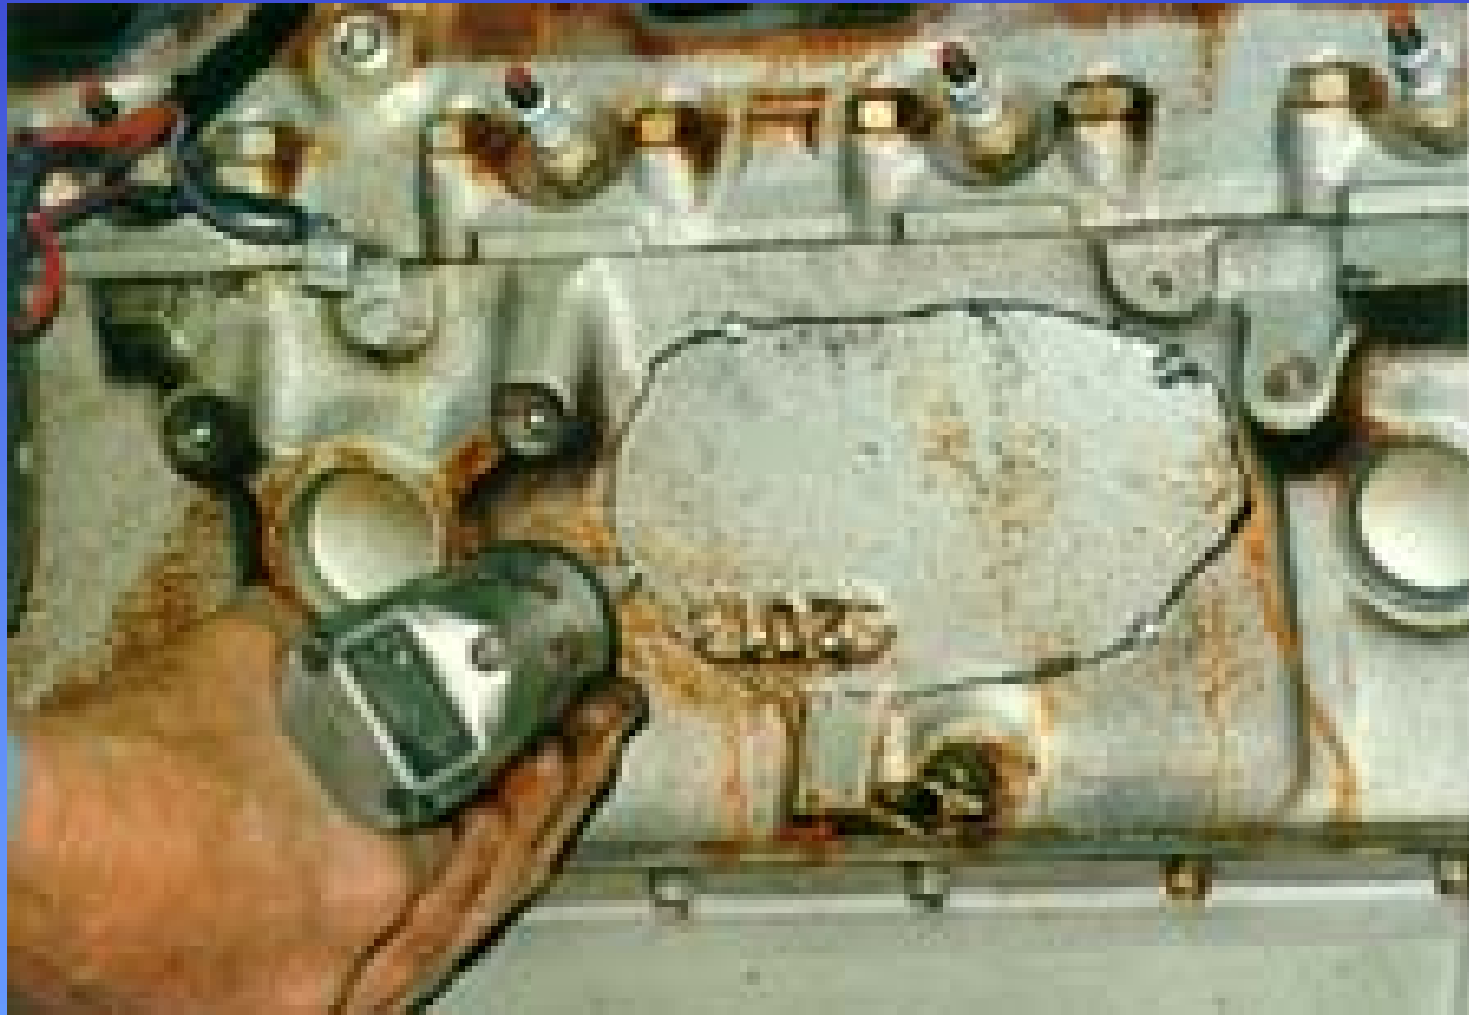
The first series of holes are drilled and power tapped around the joint

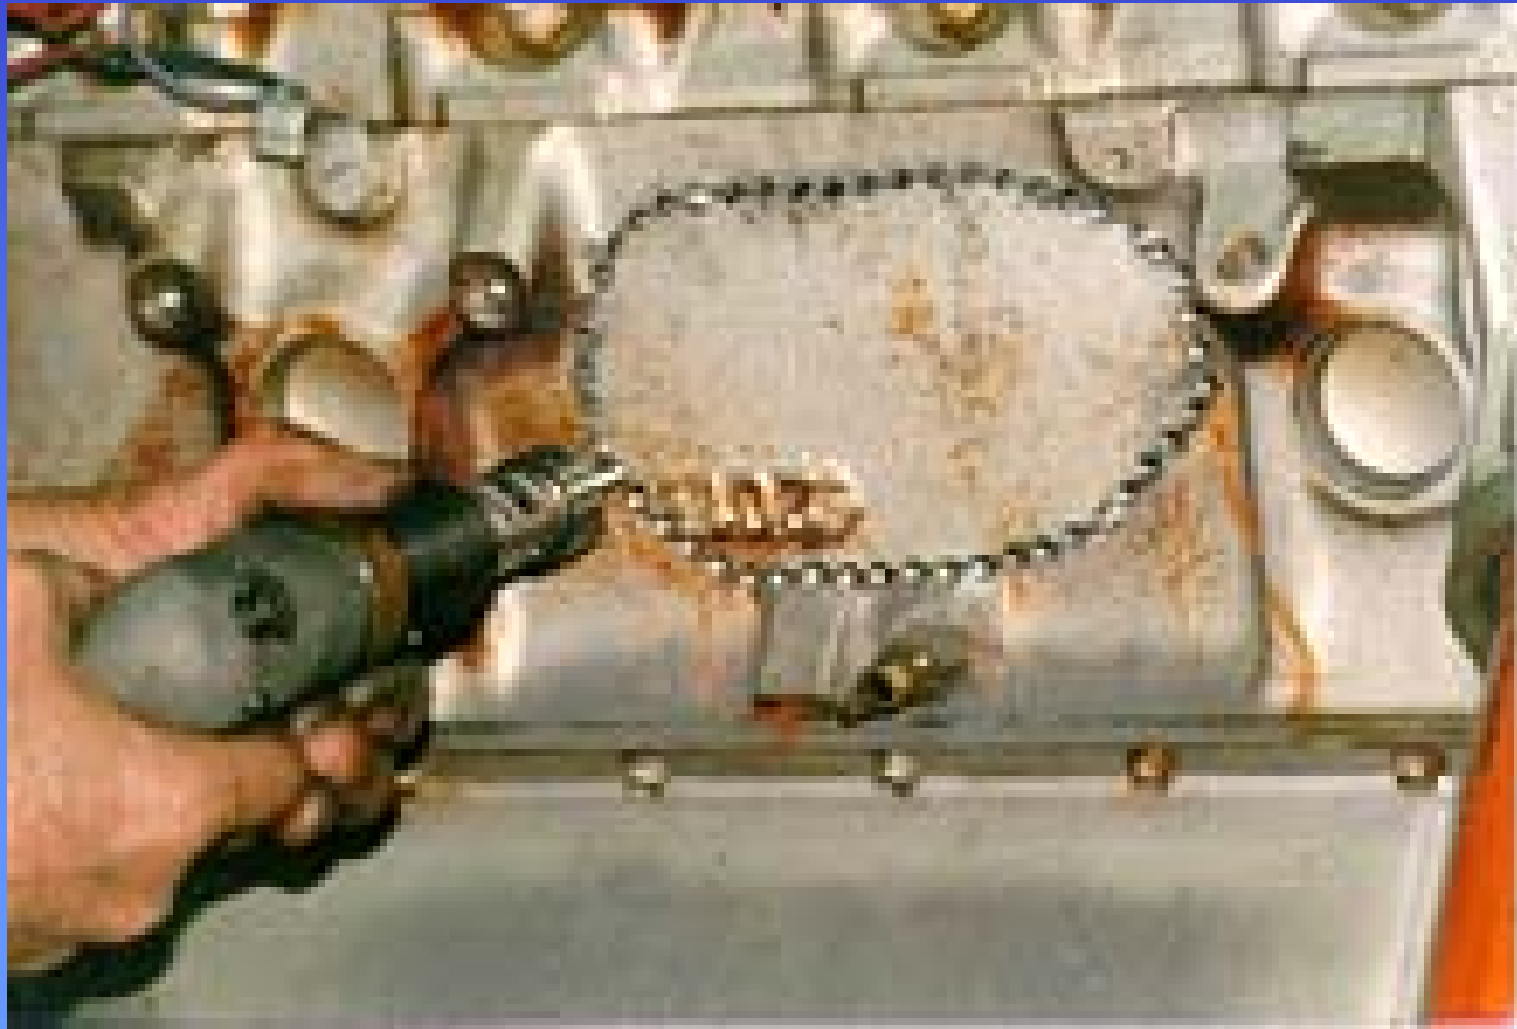
Installation of the pins continues until there are no spaces left

The pins must overlap each other. After all pins are installed and ground flush, the repair is pressure tested to check for leaks. If a leak is found, simply install another pin.
