LOCK-N-STITCH Inc.
Casting Repair Specialists
1015 S. Soderquist Rd.
Turlock CA 95380

Gas turbine shell crack repair final report

Customer: Exelon Power Generation
Contact: Carlos Lopez
Address: 10202 Strang Rd
City, State, Zip: La Porte, TX 77571

Part: GT-1

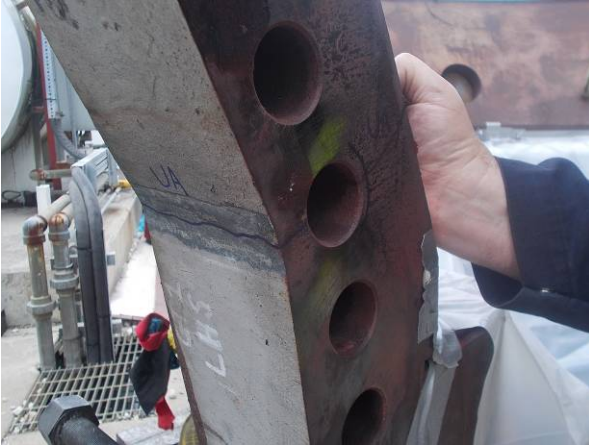
#1 Bolt hole on A side of upper shell

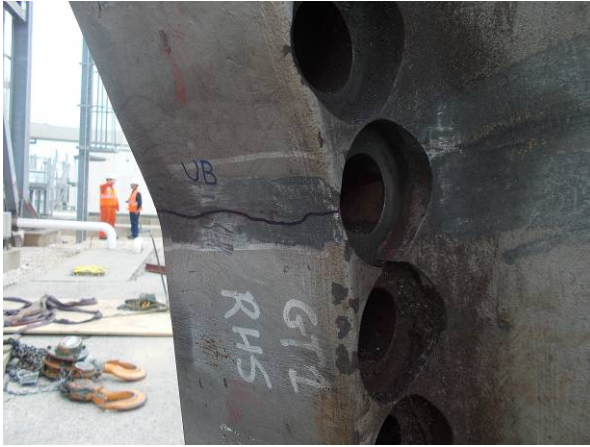
#2 Bolt hole on B side of upper shell

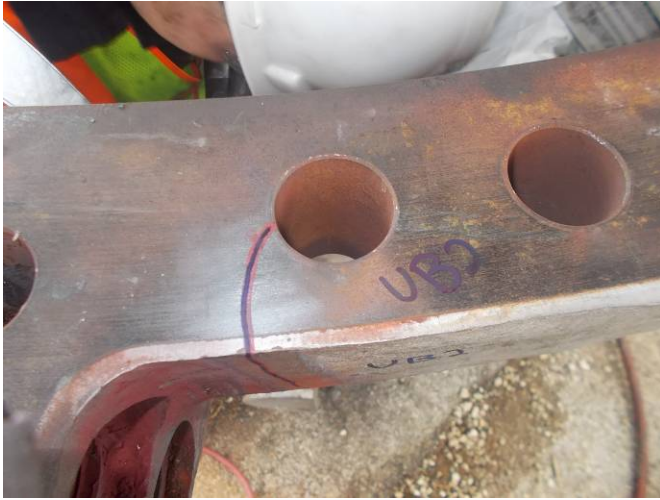
#3 Bolt hole on B side of upper shell flange

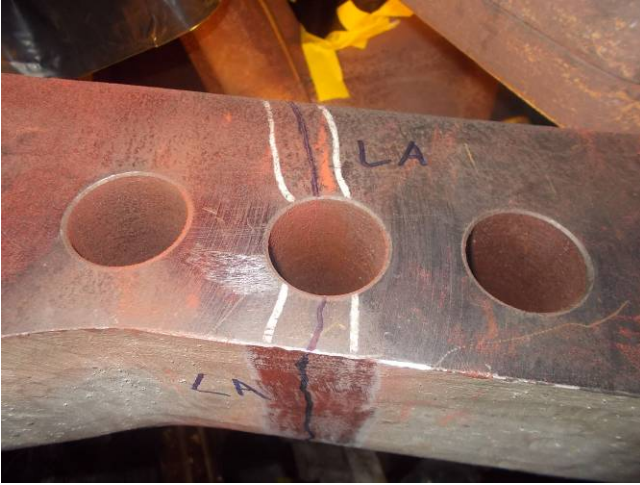
#4 Bolt hole on A side of lower shell

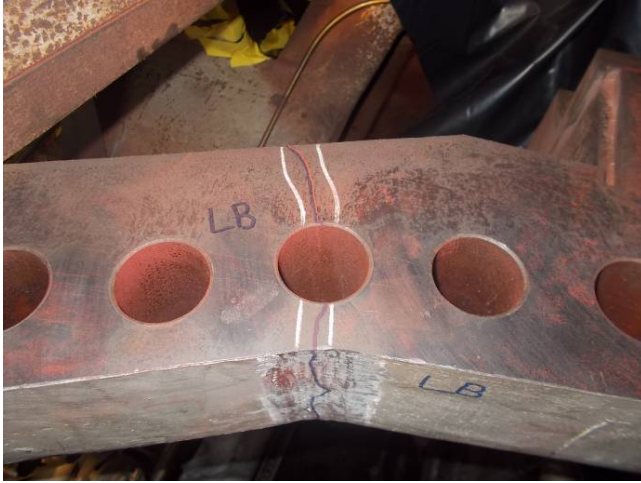
#5 Bolt hole on B side of lower shell
