### Goltens Miami Service GE No 3 block repair

Repaired August 2010 Clipper Caribe Houston

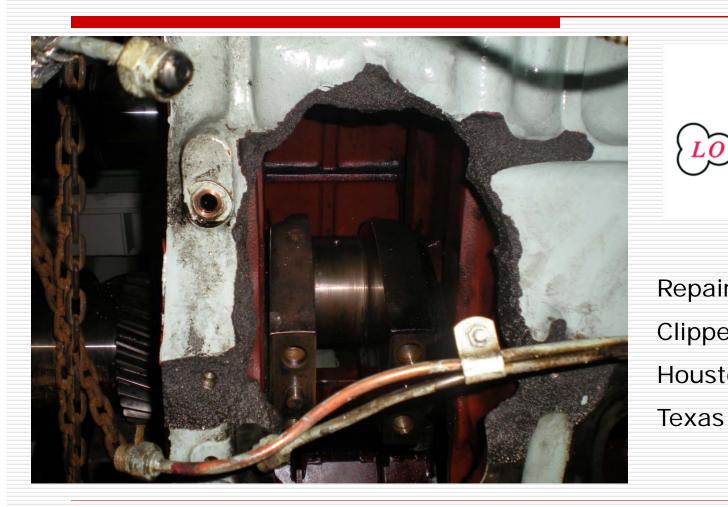
Mr. Ed Mulvihill traveled to Houston Texas to inspect the damaged engine block onboard the vessel for damage. Magnetic particle and dye-penetrate methods were used to inspect for additional damage and/or cracks. Found block broken out on side. Upon further inspection he found a piston spray nozzle mounting boss had broken off. No further damage was discovered. Collected all of the broken pieces and returned them to the LNS shop in California to be oven welded back together to form a single, solid piece to fit back into hole in the block. The welding process involved high temperature fusion welding to produce a single stress free piece that required a 1500 degree preheat. The sections were welded using gray cast iron welding rod. The repaired section was returned to the ship with Mr. Mulvihill. The damaged piston cooler mounting boss was repaired by installing a large C4 plug.

- The plug was installed by drilling and taping to install the special plug to replace the missing boss.
  The locating hole was then drilled for the pin.
  Next the edges of the hole were hand ground and the edges of the patch were ground to accept the repaired patch to fit snuggly into the
- This was a slow process as the patch needed to fit as perfectly as possible because we only had one chance to fit it in.

- Once the fitting was complete the joint of the patch to the block was filled and sealed using the LNS patented metal stitching process. (See next slide.)
- The upper section of the inspection window door opening was then machined flat to match the original surface.
- Once all of the pins were installed and the gaps filled in the inside and outside surfaces were hand ground to original contours.

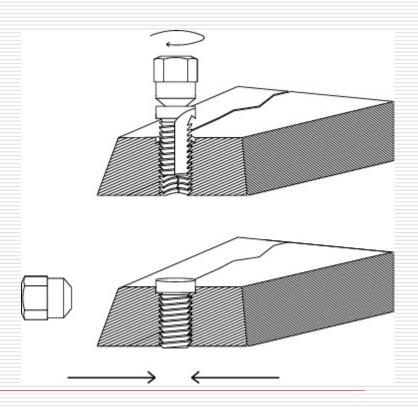
## CASTMASTER® Stitching Pins

castmaster stitching pins have the unique ability to draw the sides of a crack together when tightened into the drilled, Spotfaced and tapped hole.

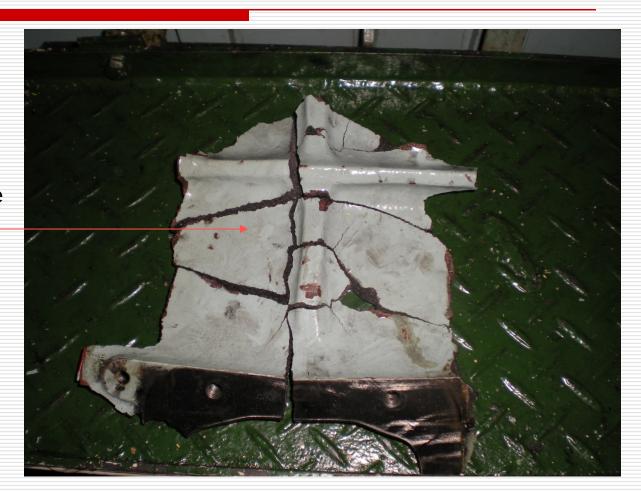
## Making patch for engine block

The broken pieces from the damaged engine block sent LNS to be fusion welded.

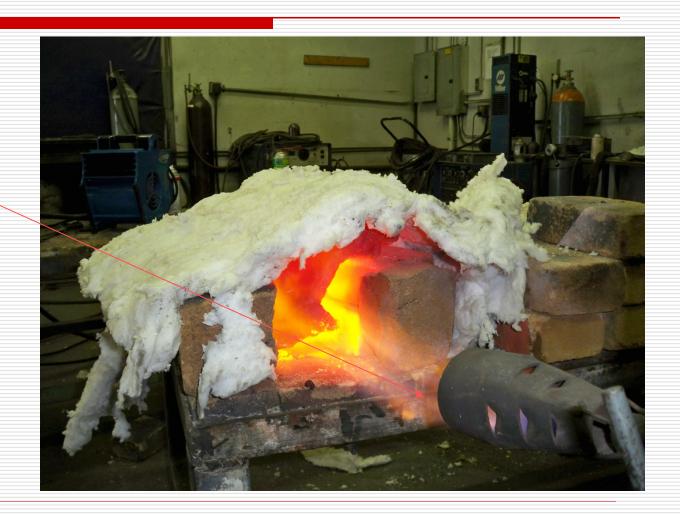
#### Fusion welding process pre-heat

Blow torch preheating broken pieces.

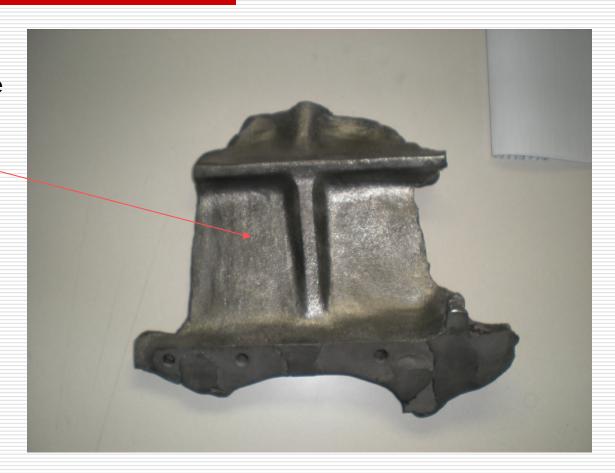
## Finished repaired patch

The patch after the Fusion welding Process.

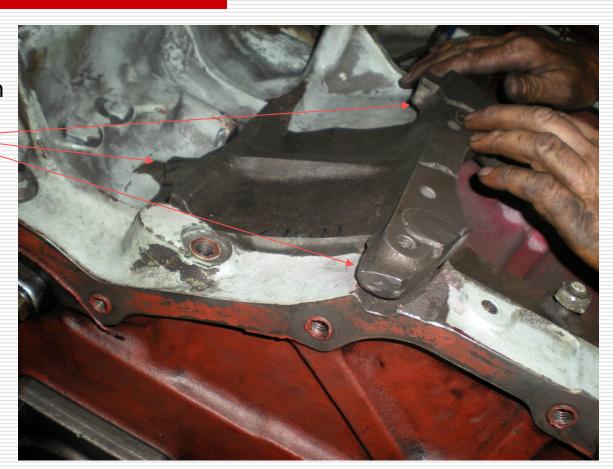
## Fitting the patch

Patch being fitted in Damaged area of Engine block.

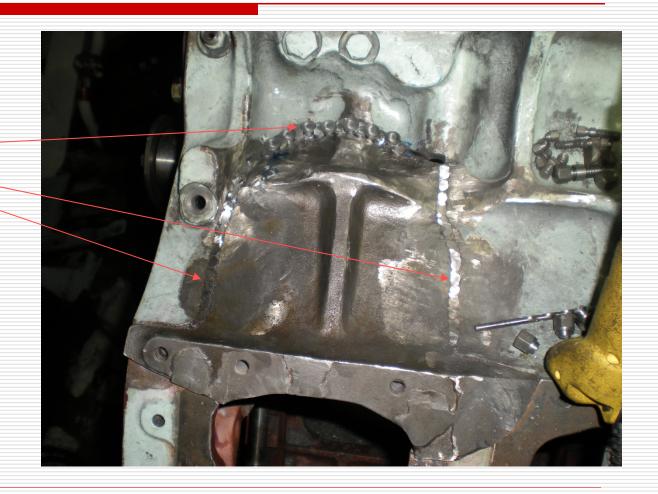
## Installing the stitching pins

CASTMASTER stitching pins were installed along the crack.

These special stitching pins have our patented Spiral hook threads that add strength and high pressure seal.

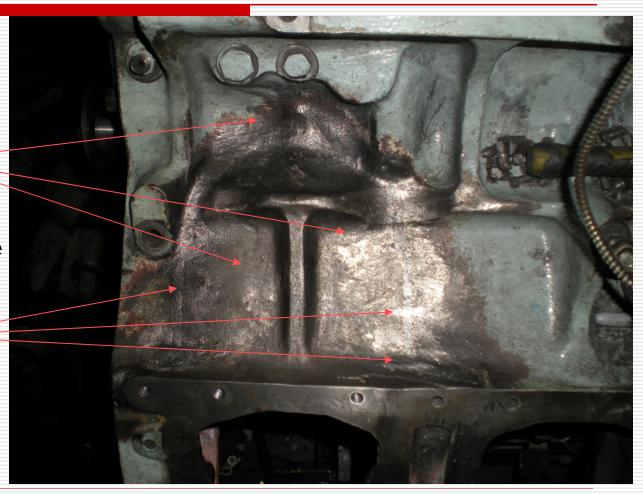
#### Finished repair on blow-out hole

Repair complete and no sign of the cracks.

L15 Locks where Installed to add Additional Strength.

- Four L15 Locks were installed to add additional strength close to the inspection window. (see slide 16 for Lock information)
- Two of the 10mm bolt holes were plugged and re-drilled in the proper locations for the window door.
- Drill and tap 4 each 10mm bolt holes.
- The area was cleaned and as much shavings as possible were removed from the inside surfaces of the block and the surrounding work area.
- ☐ The equipment was packed and prepared to ship to LNS.
