MAN V18 Crack repair

Repaired July 2010

Scope of Work

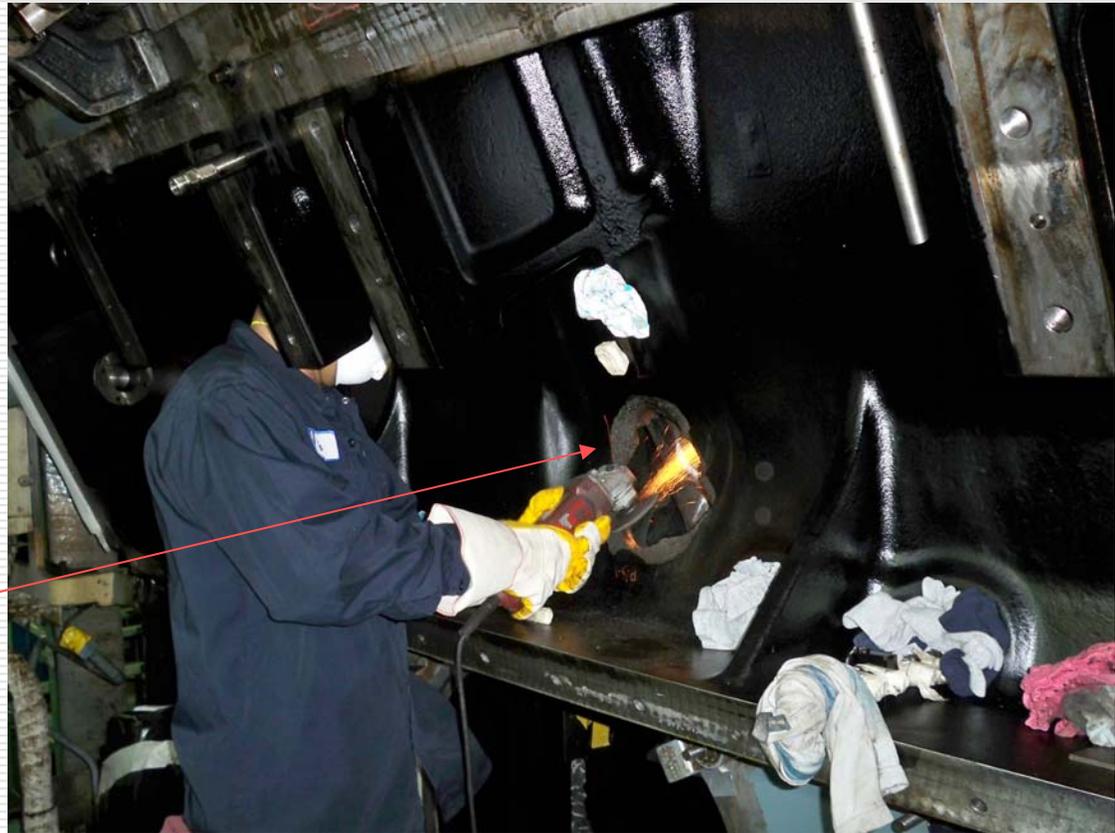
Damaged Cam box

Grinding out the edges around the blow-out in the Cam box. This creates the straight edges for the patch.

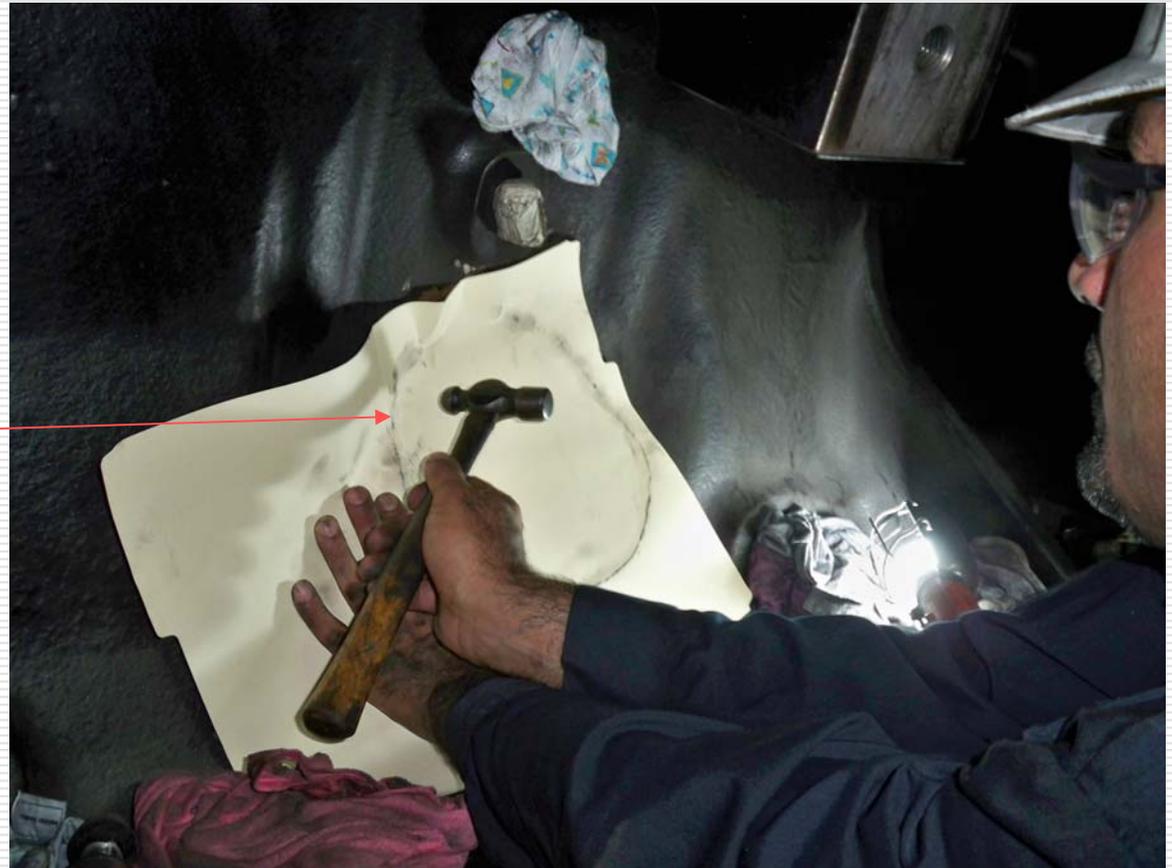
Making patch for Cam Box

Tracing out the template to manufacture the patch for the blow-out hole.

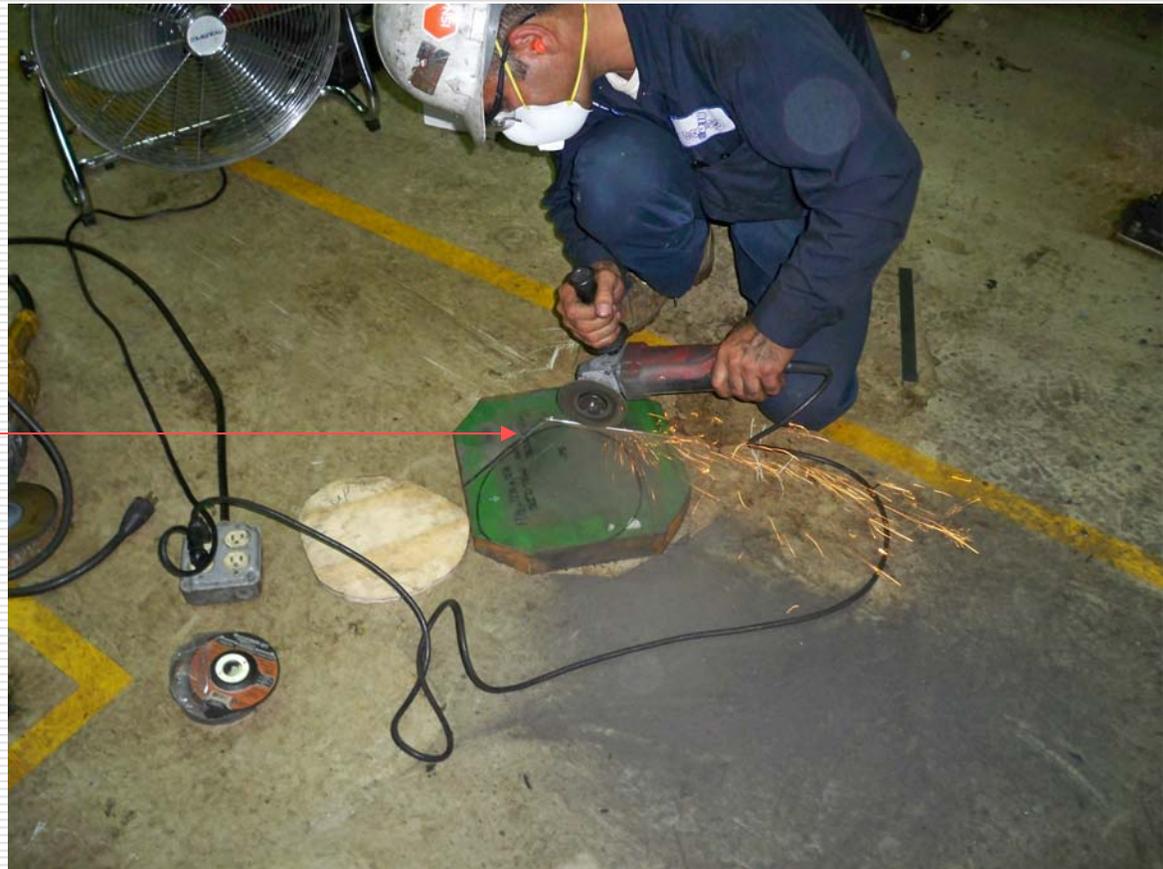
Manufacturing the patch

Once the template is traced on the new section of cast iron the piece is cut to size with a portable cut off wheel.

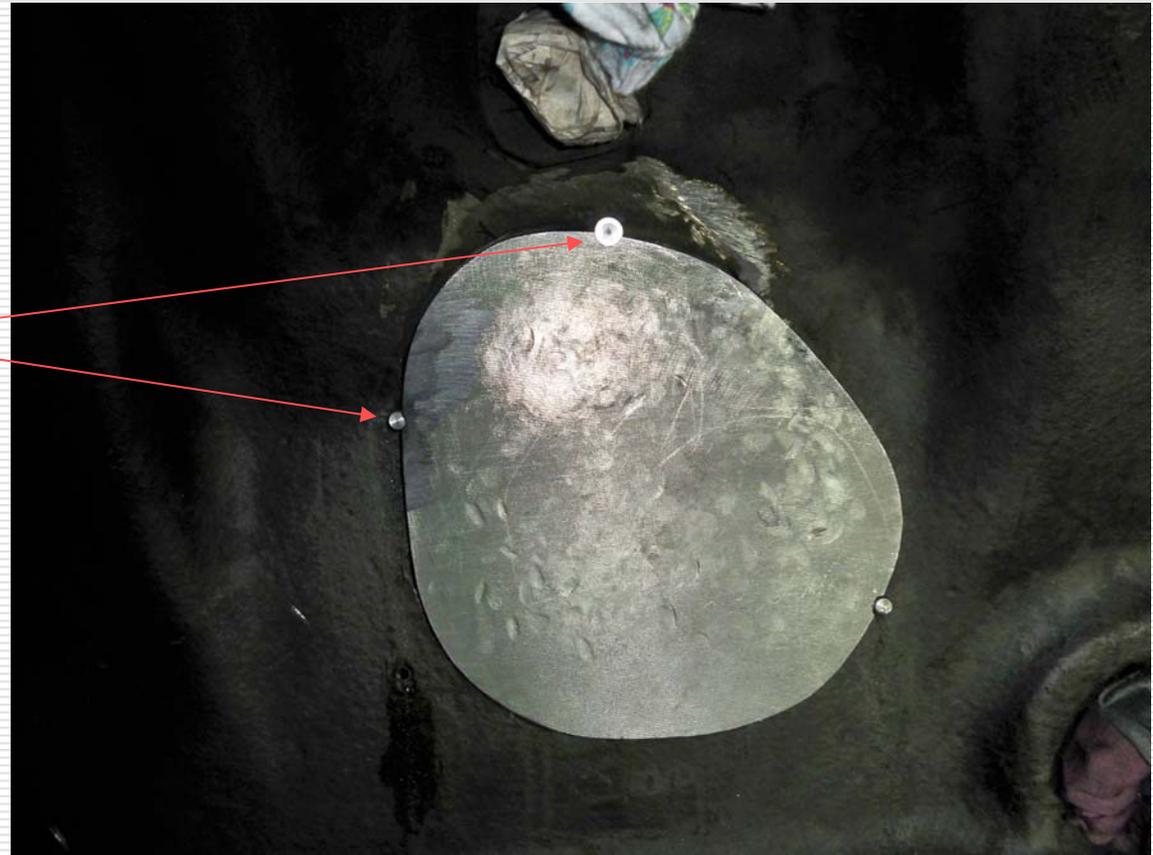
Fitting the patch

Patch was fitted
in blow-out hole
in Cam box using
three Castmaster
pins to hold in
place.

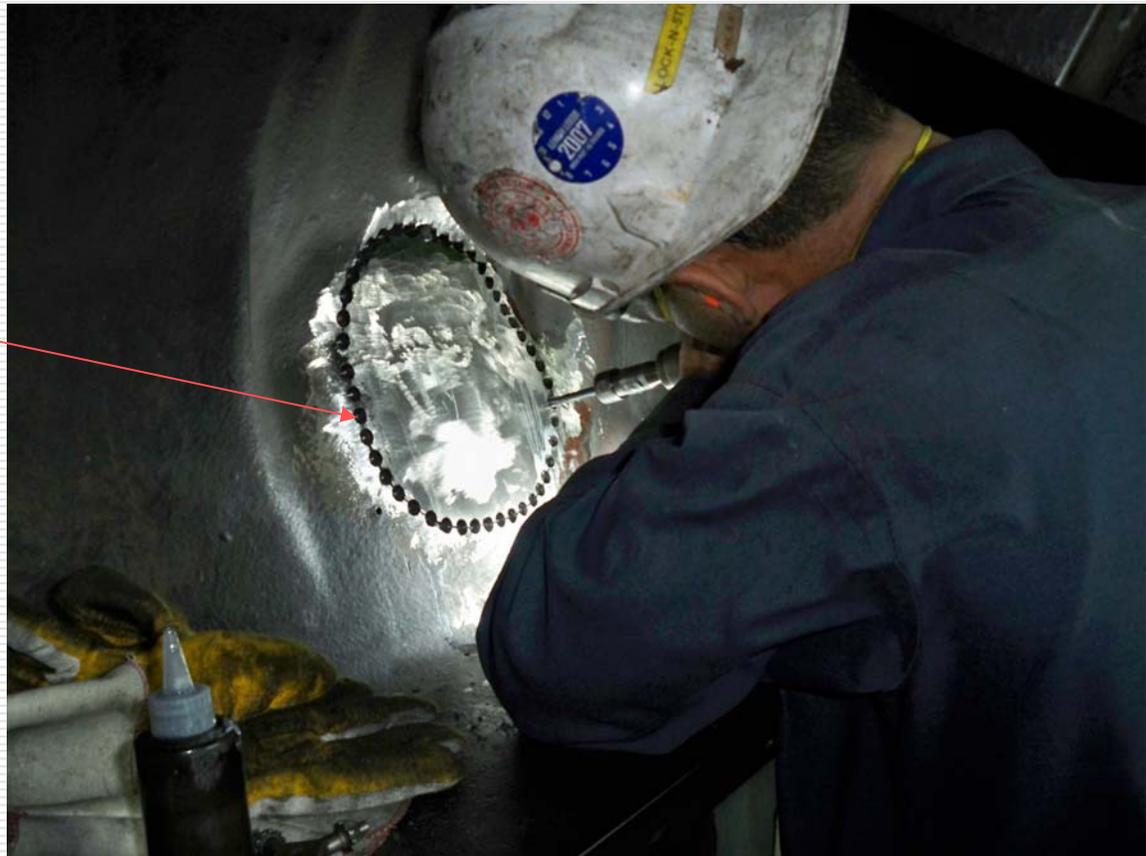
Installing the stitching pins

C3 CASTMASTER stitching pins were installed along the crack.

These special stitching pins have our patented Spiral hook threads that add strength and high pressure seal.

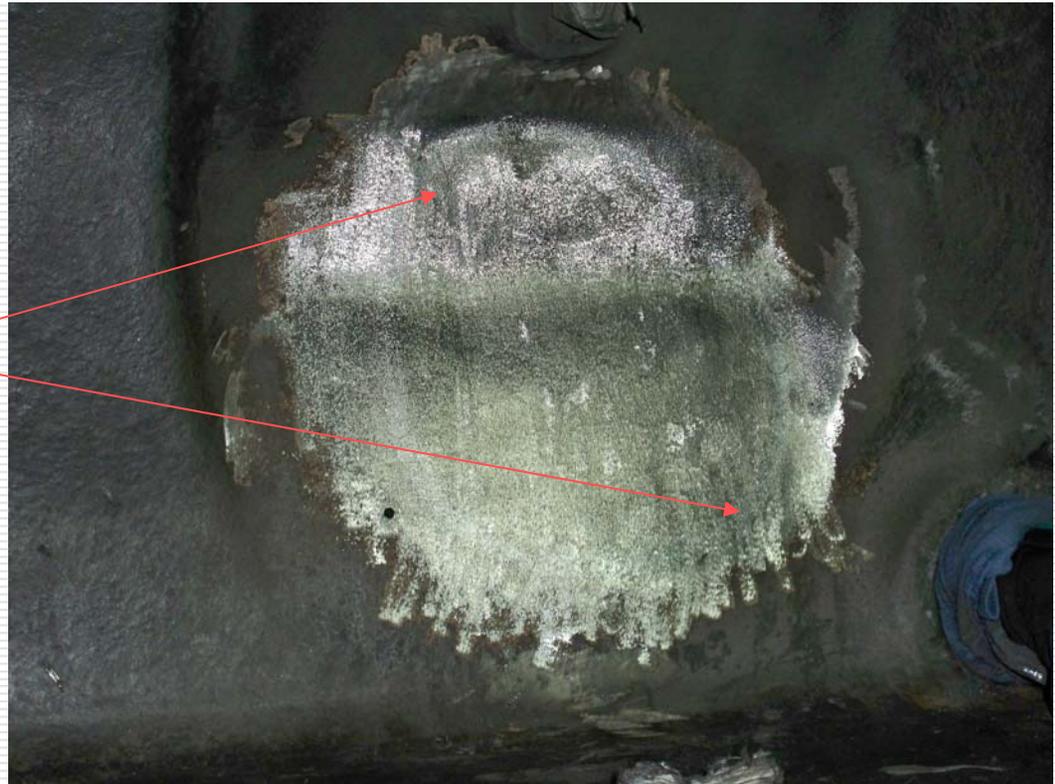
Finished repair on blow-out hole

Once the repair was completed there is no sign of the crack or the patch.

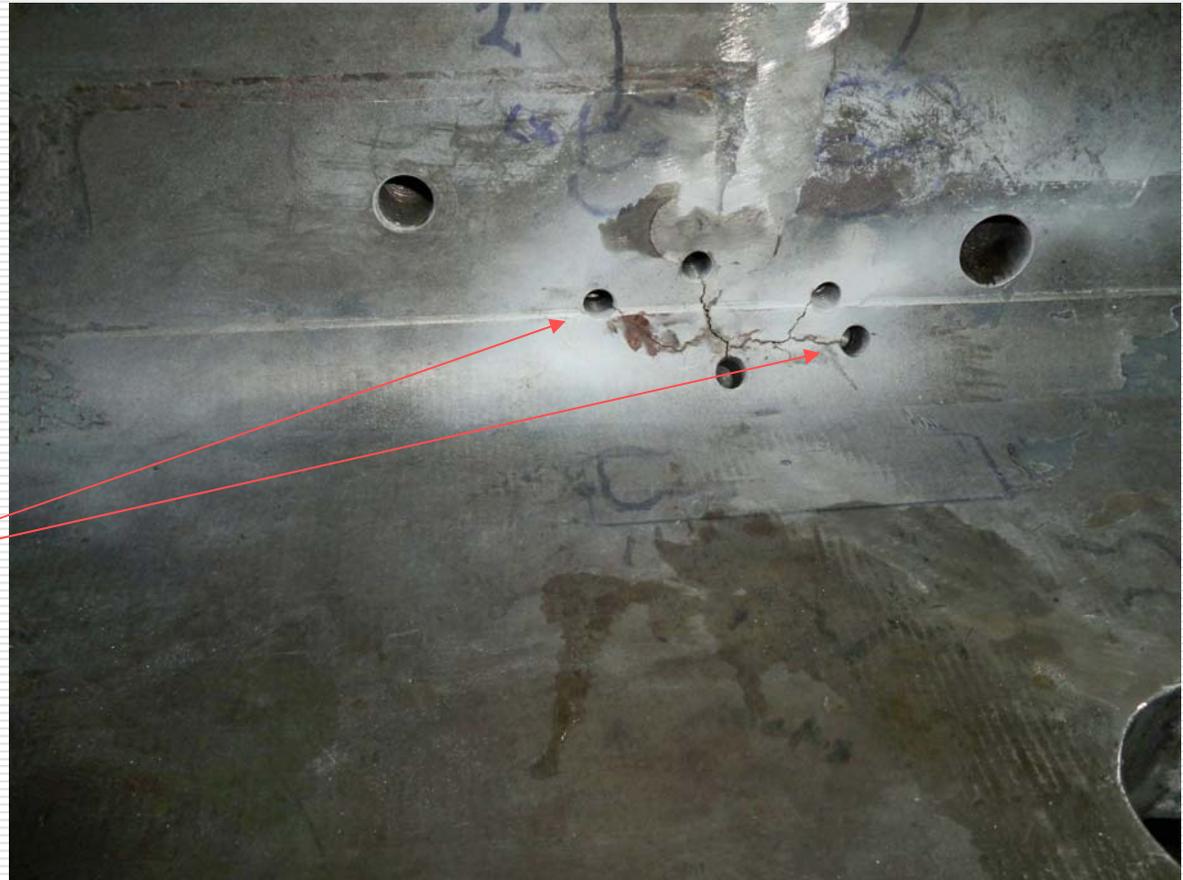
Damaged area around Inspection Door.

Here you will see the crack damage below the inspection door during the stitching process.

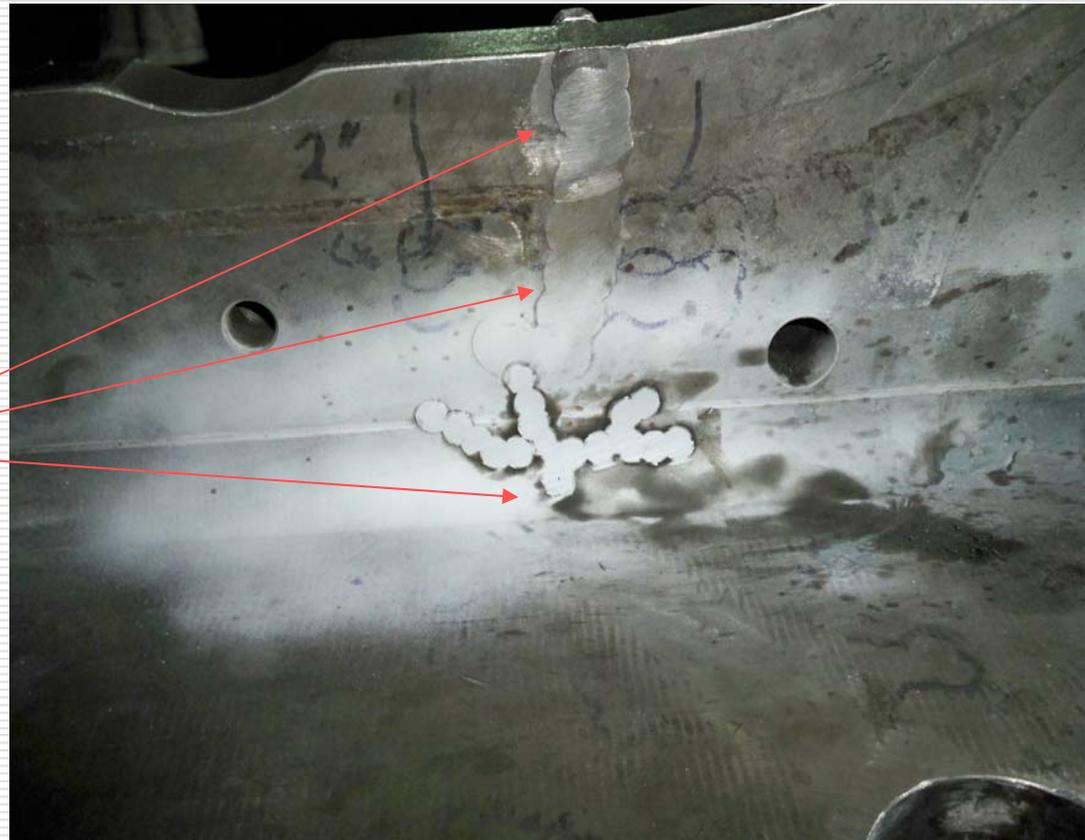
Stitching completed on Inspection door

Castmaster stitching pins are installed along the cracks.

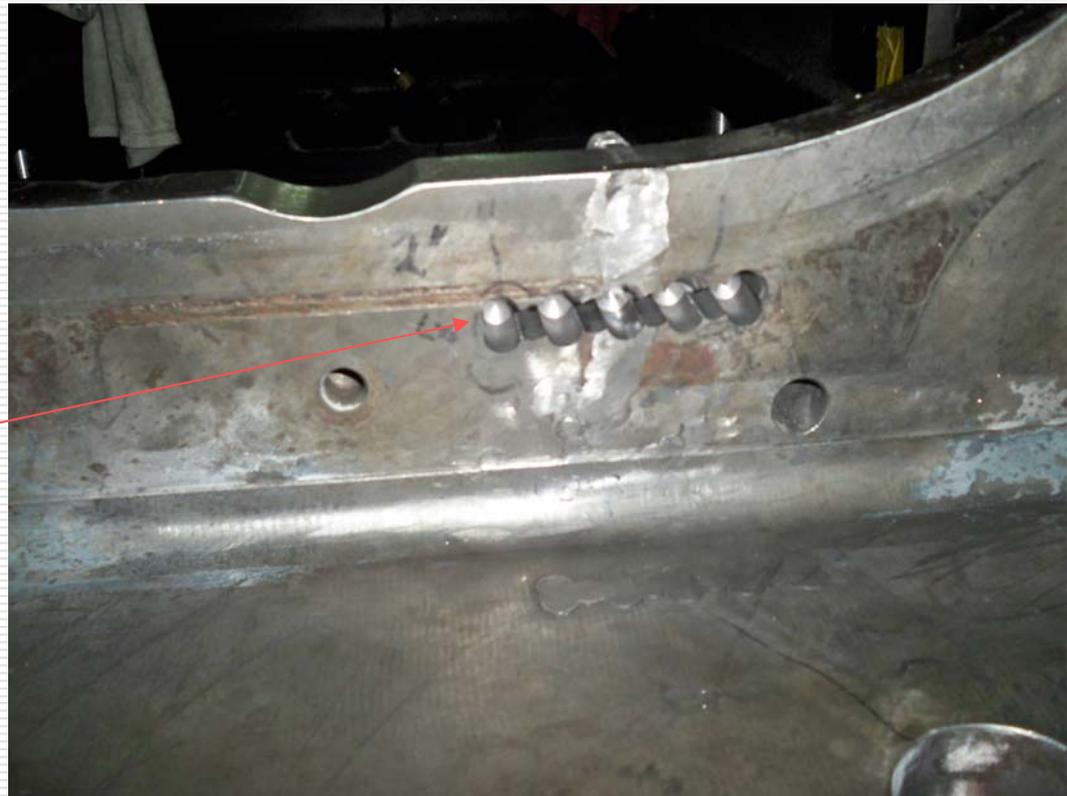
Installing L40 Locks

Using a precision drill jig to drill the pattern for a L40 lock to add additional strength across the repair.

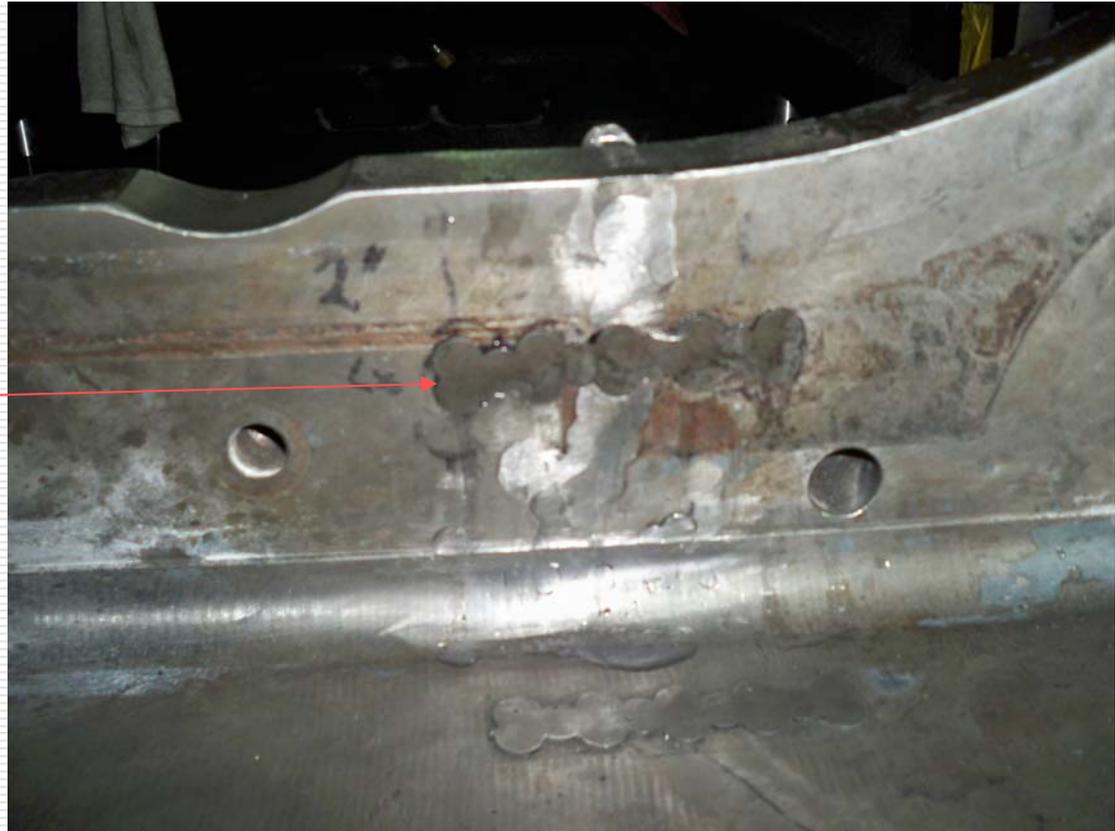
L40 lock installed

The L40 lock is now installed and ready to be machined and ground flush.

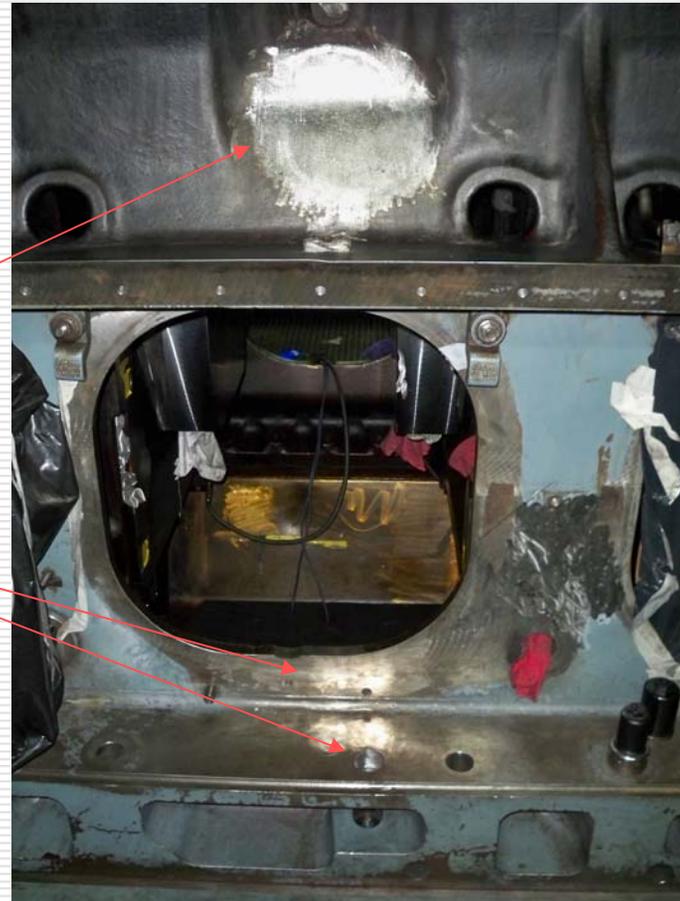
Completed repair of Cam box and Inspection door

- Here you see the repair of the Cam box blow-out and the lower wall of the Inspection door and landing area repairs.

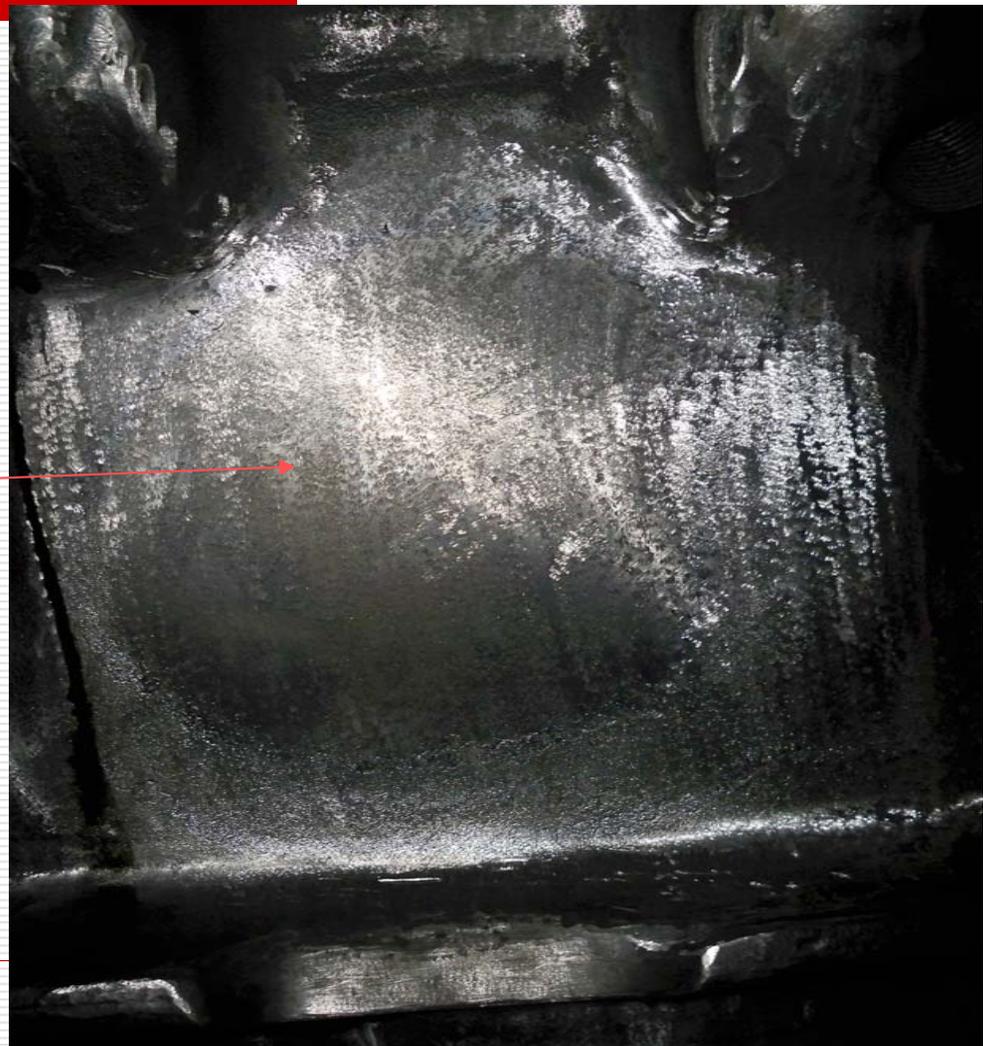
Finished pictures of the repair

- Finished repair inside Cam box.

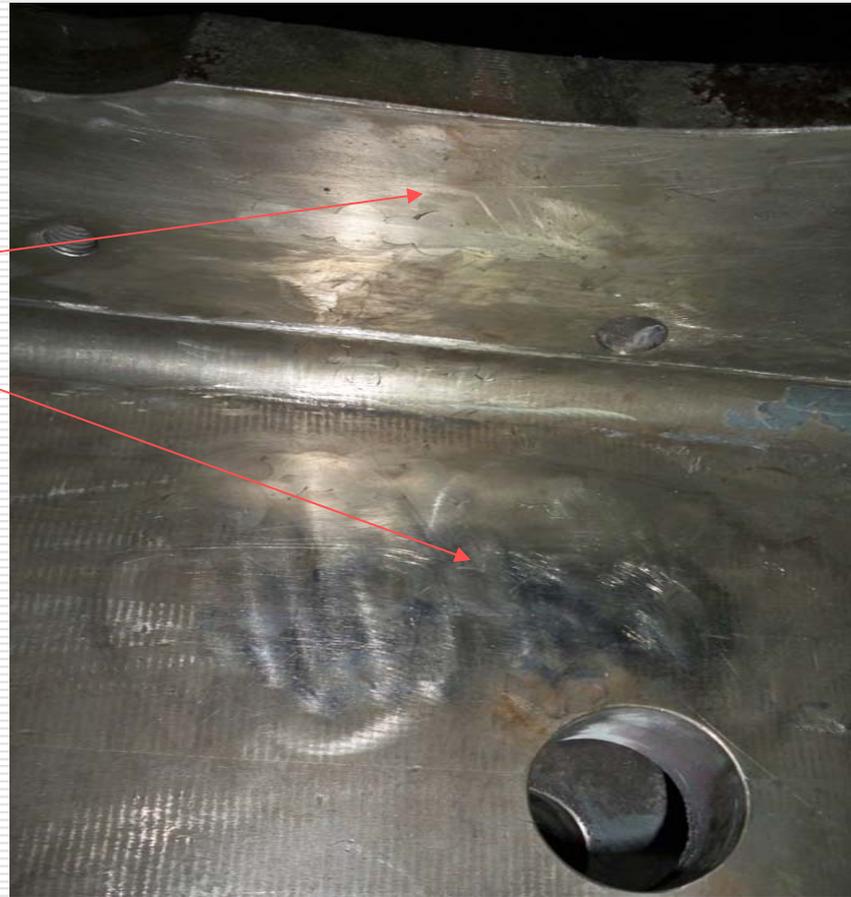
Lower wall and floor

- Lower inspection wall and landing.
