## Repairs to # 4 cylinder on K Topaz Main Engine

Date; Sept. 12, 13 and 14, 2004

Location; New Orleans, LA, USA

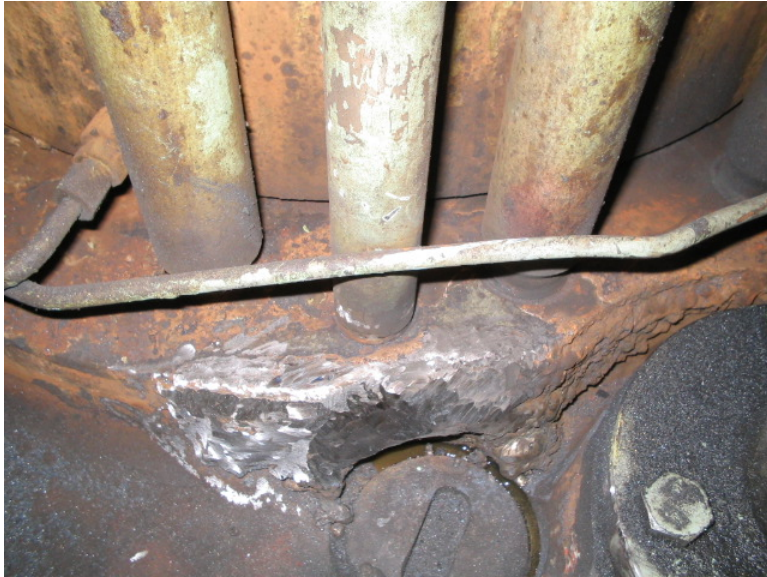
The initial damage that was found during the inspection of the included a non visible crack extending parallel to the surface caused by bolt torque and the close proximity to the water feed hole. The exposed edge of the fracture had previously been welded upon to slow down the leak in order to sail into the Mississippi River to make repairs.

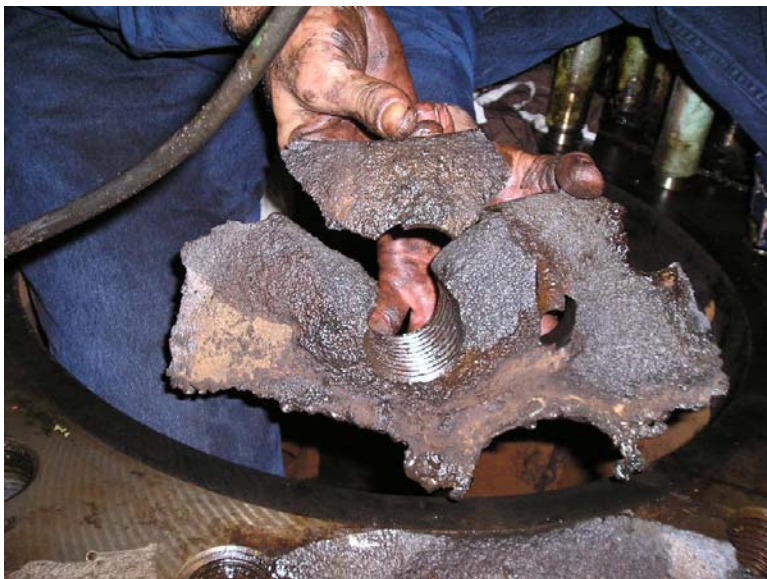
Upon arrival of the repair crew Sunday Sept. 12, 2004, they discovered that the damaged area had failed completely to the extent that the entire surface area had lifted and broken off. This made the repair significantly more difficult.

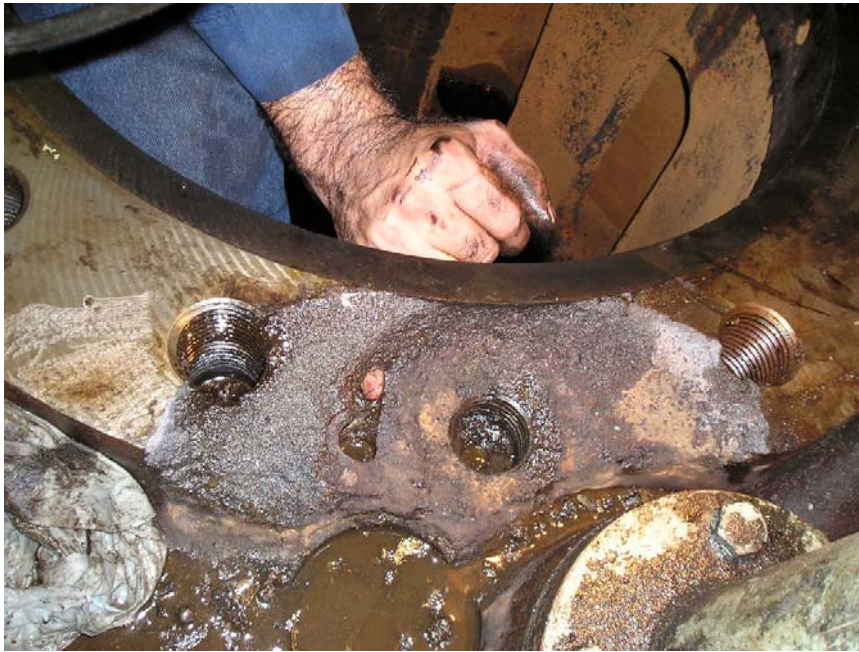
This shows the extent of the seriousness of the new damage that the repair crew was faced with.

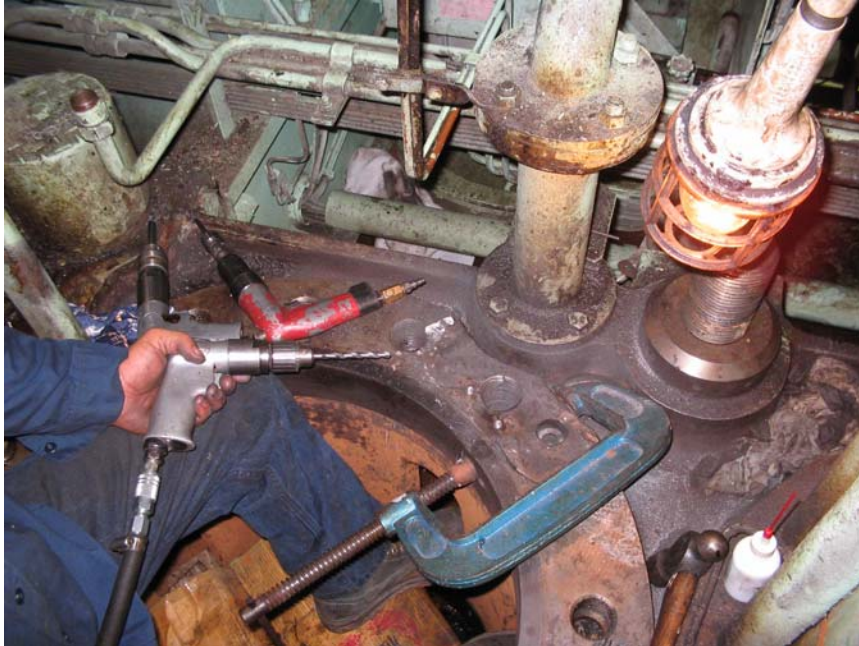
This damage measured approximately 300mm X 125mm X 50mm deep.
