# Nuovo Pignone 6B Gas Turbine Shell Crack Repair

Repaired Dec. 2009

Torino, Italy

Cofely Italia S.p.A.

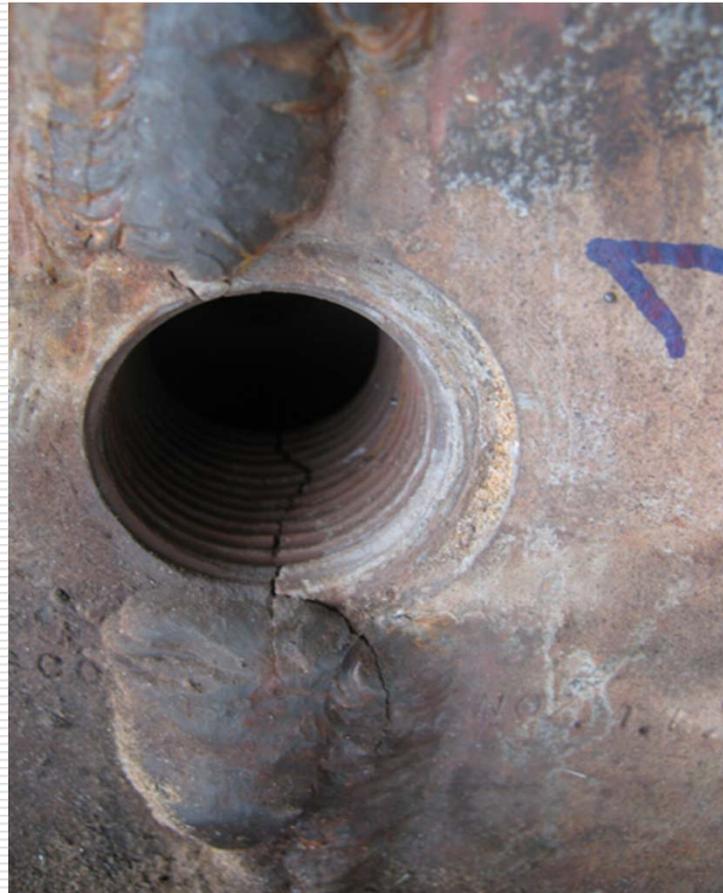
# Cracked Bore Scope Access Hole

Owner had attempted a weld repair which failed.

The weld was only on the surface with no preparation or grooving.

This turned out to be good as the weld was easily ground off and all of the parent steel was intact.

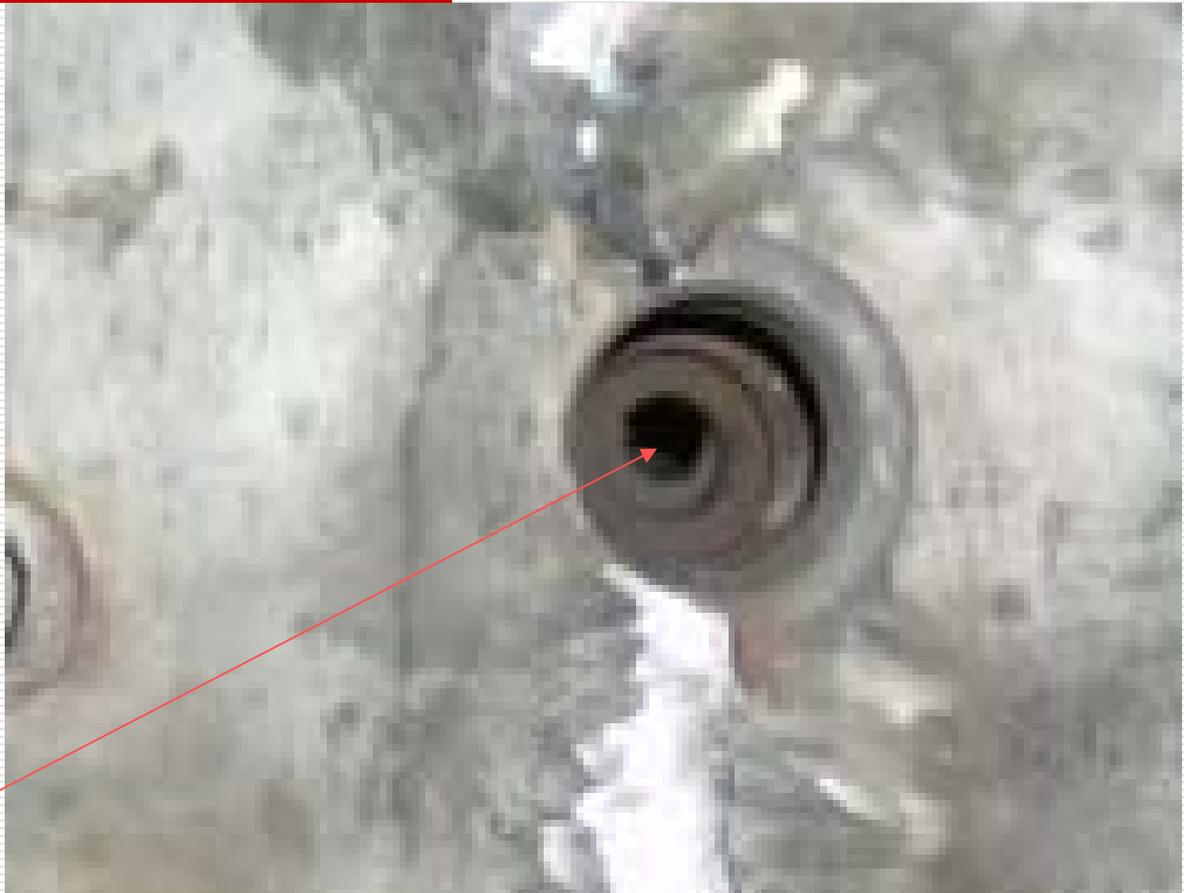
# Cause of the Crack is Found

The cause of the crack appears to be misalignment of the holes of the diaphragm and the shell that allowed combustion heat to escape past the bore scope hole plug.

After repairing the cracks and threads the lower hole was slightly oversized to allow the plug to seat into the smaller hole in the diaphragm.
