Sacramento City flood control pump, capacity 5 Million gallons per day

The pump discharge port flange cracked during replacement of the gate valve

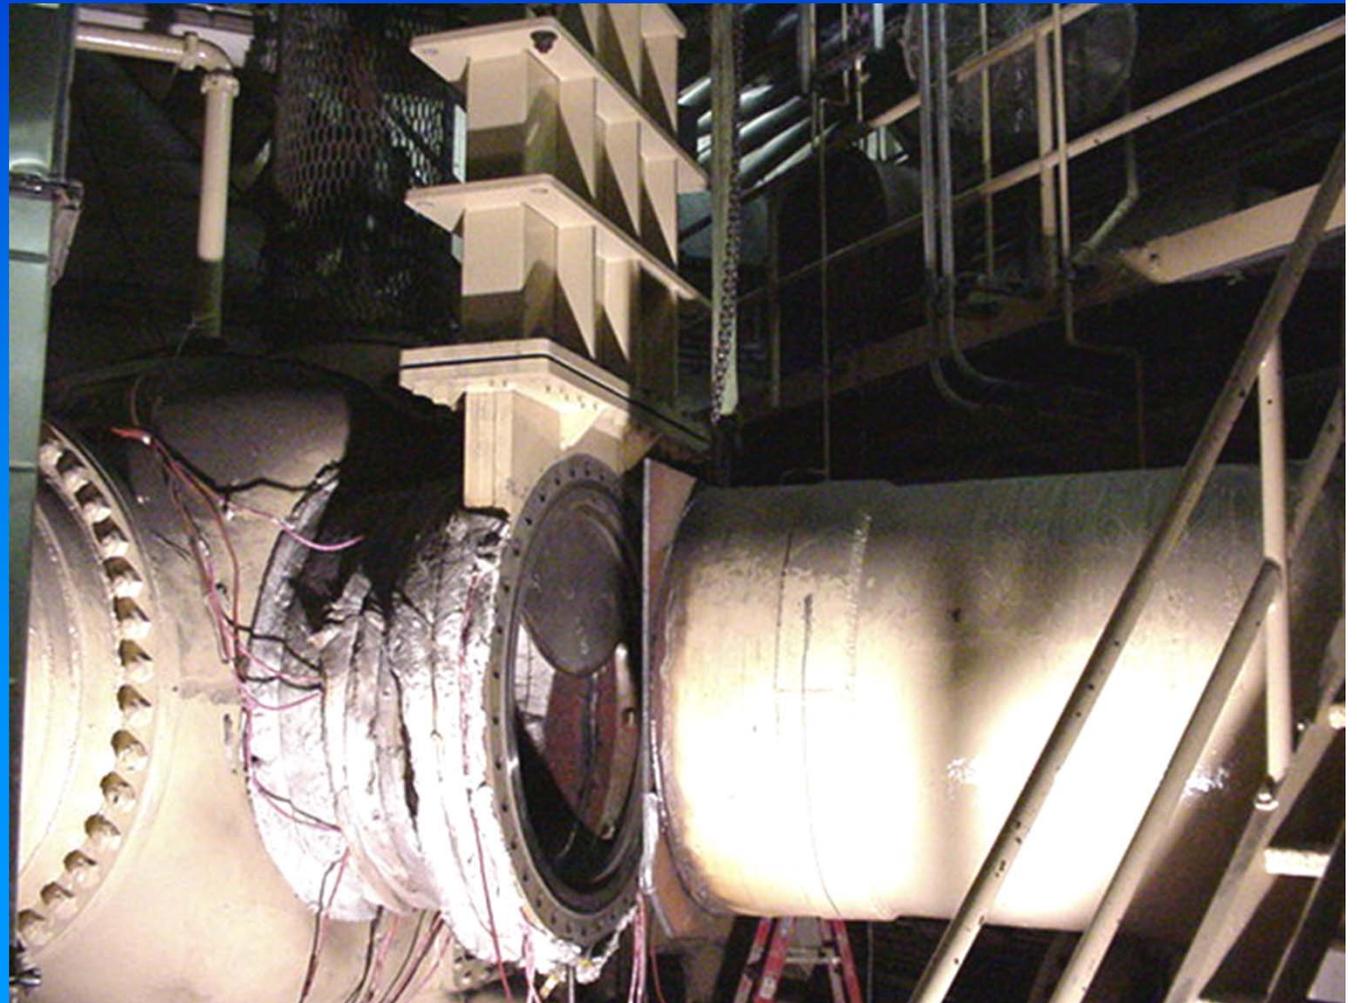
The new gate valve had a raised hub on the gasket surface that caused the crack. A raised hub flange should never be bolted to a cast iron flat faced flange or cracking will occur.

The crack was in the corner of the port/flange area.

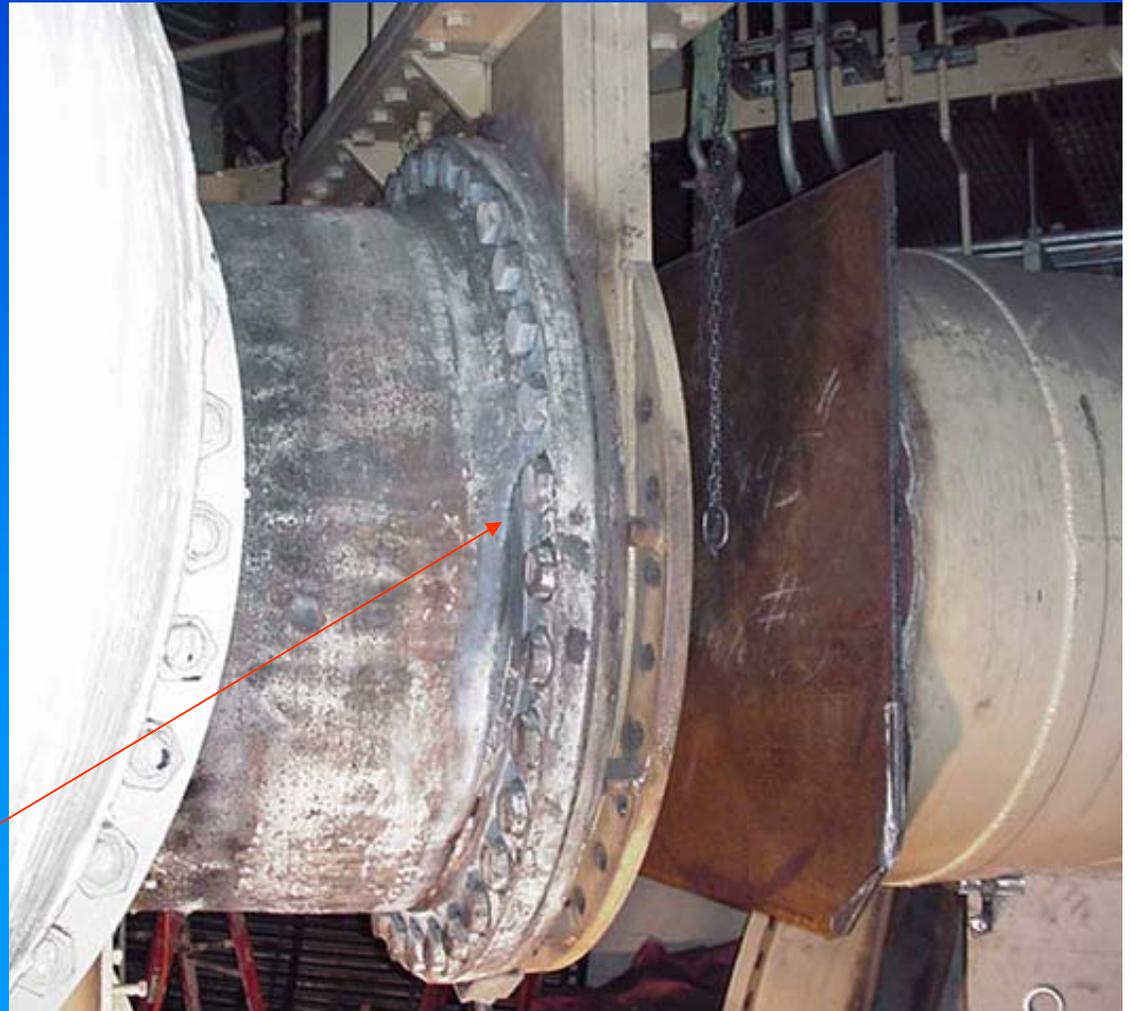
The contractor attempted to arc-weld the crack with 99% nickel rod

The contractor had never heard of metal stitching so he consulted with the welding rod suppliers, manufacturers and even AWS for a procedure to weld the casting. Very sophisticated methods were used to comply with pre-heat and post-heat instructions. The weld attempt had a zero chance of success from the beginning.

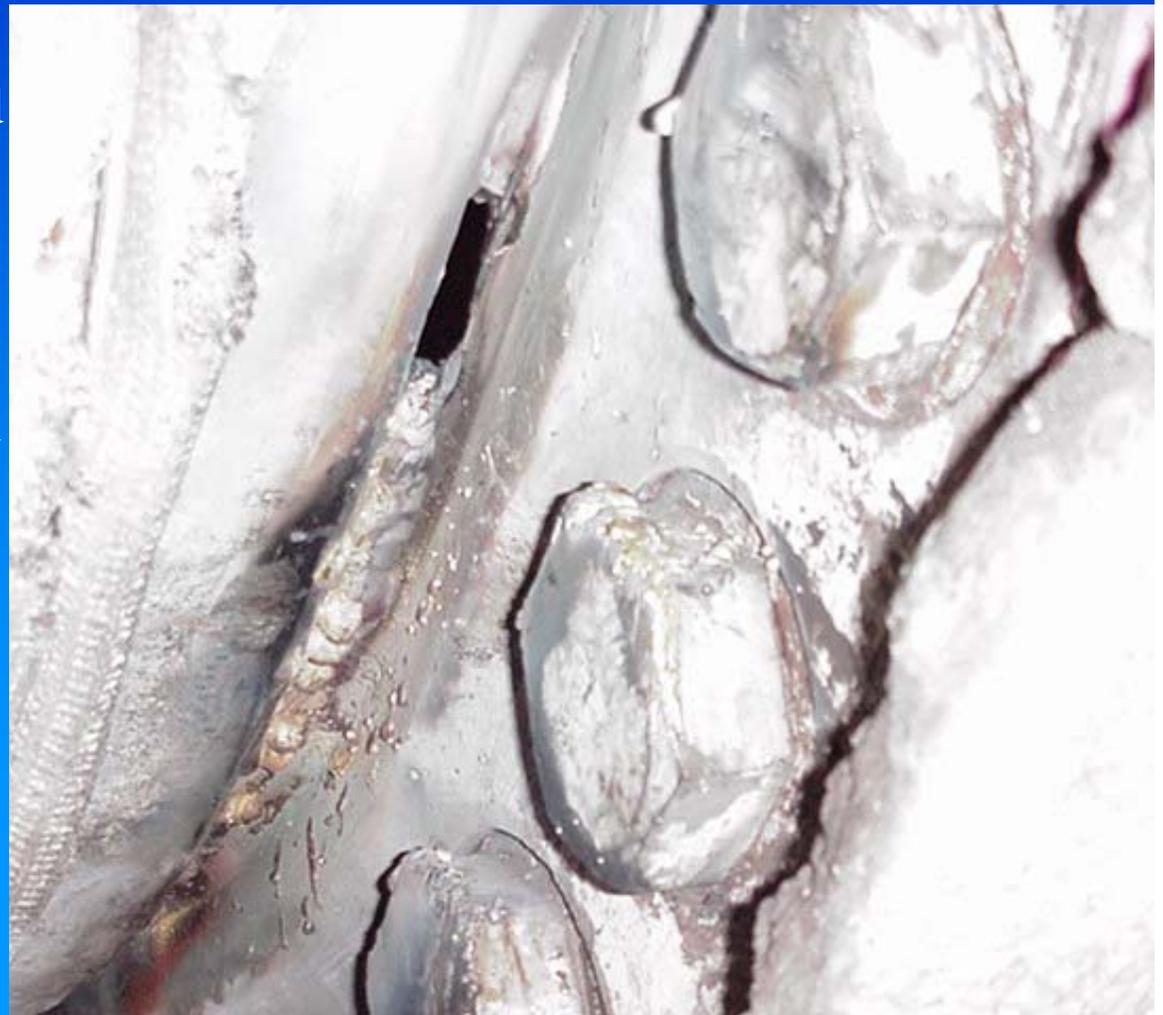
The crack was Vee'd out from both sides

The more they welded, the more it cracked.

Even though it was preheated to 500°F., there were more inches of crack after two weeks of welding.

Arc welding causes the cast iron next to the weld to crack and get very hard. The casting wall is 2" thick and the Vee was over 2" wide. Stitching the crack was **impossible**.
