Sea Escape Casino Vessel FT Lauderdale, Florida 2001

Wartsila 8 cyl. diesel generator

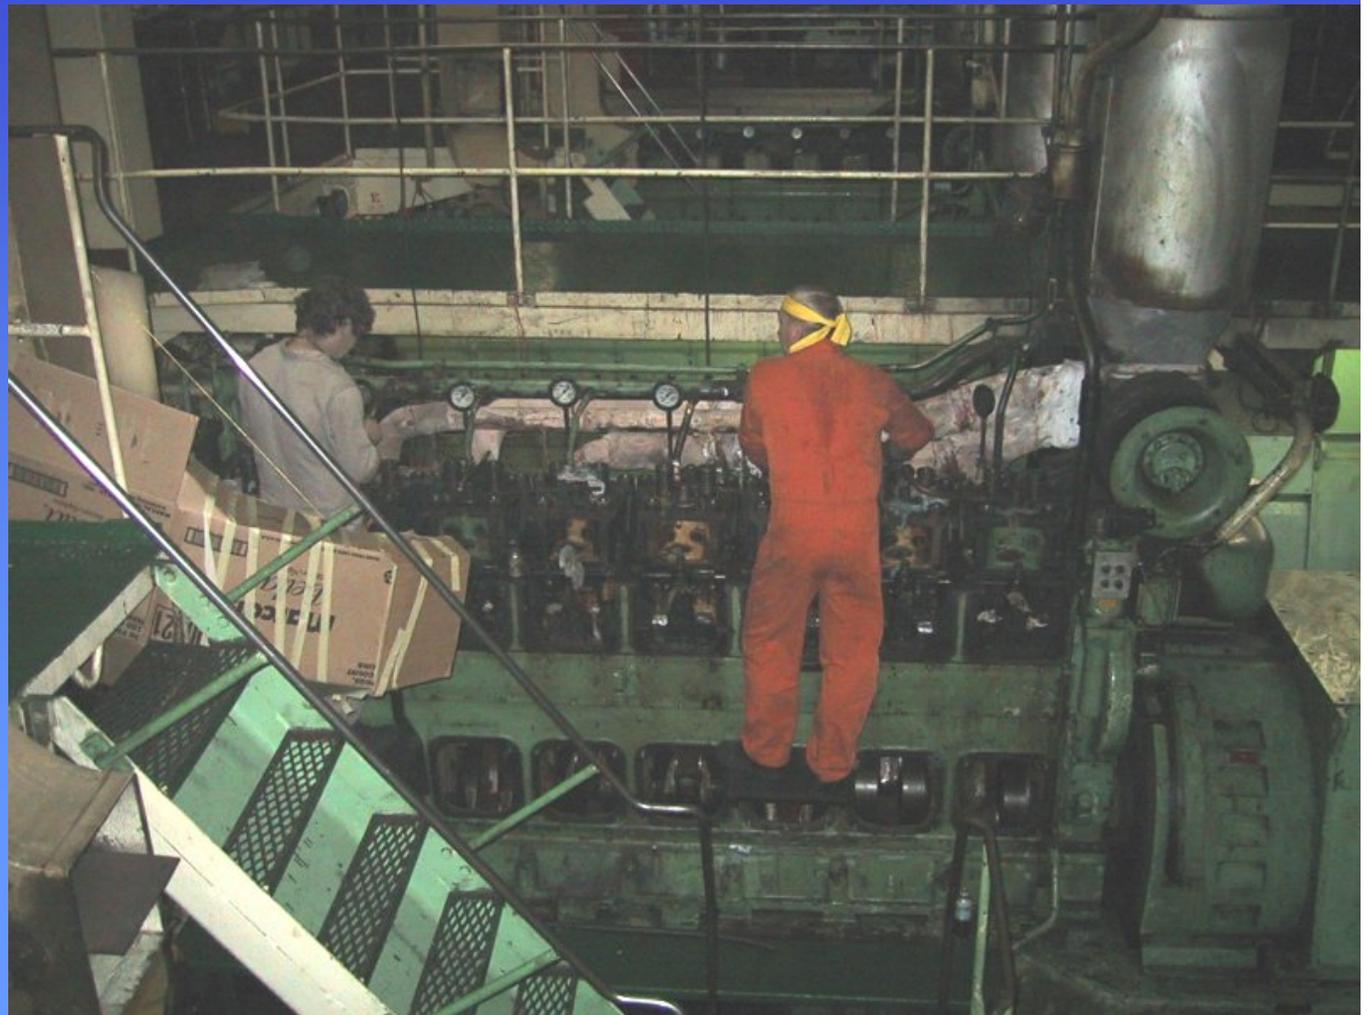
The damage was caused by a seized piston.

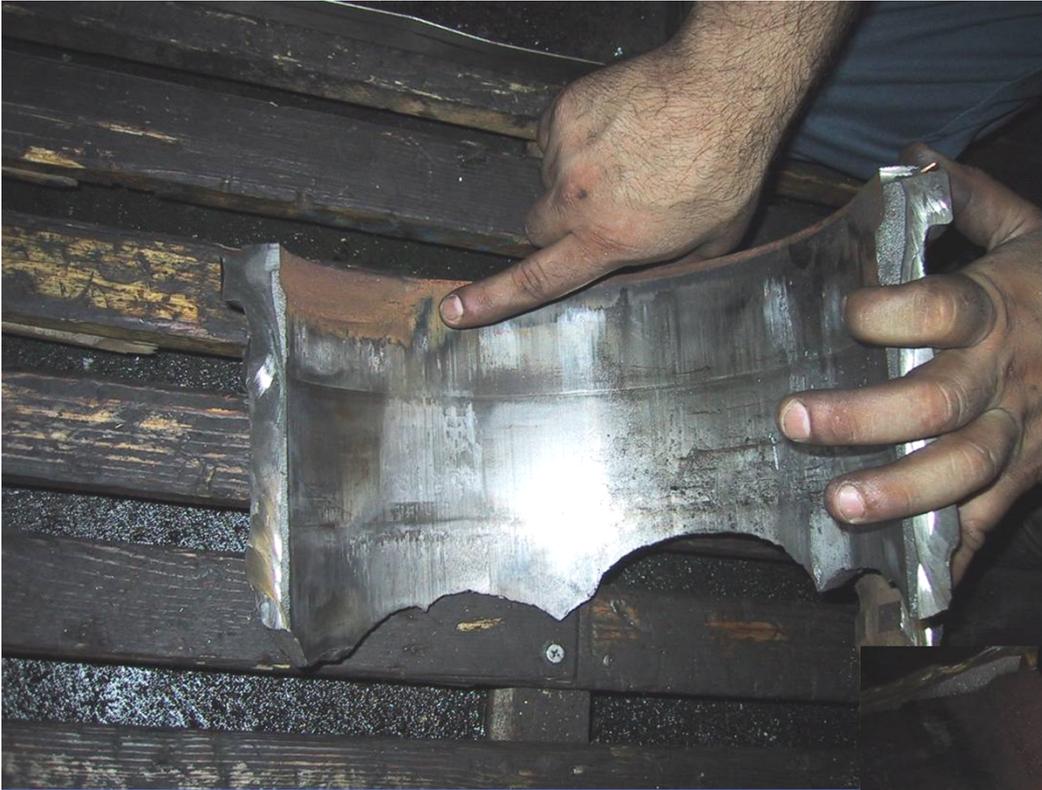
The piston split at the wrist pin and the connecting rod smashed out the bottom liner bore and cracked the outside water jacket.

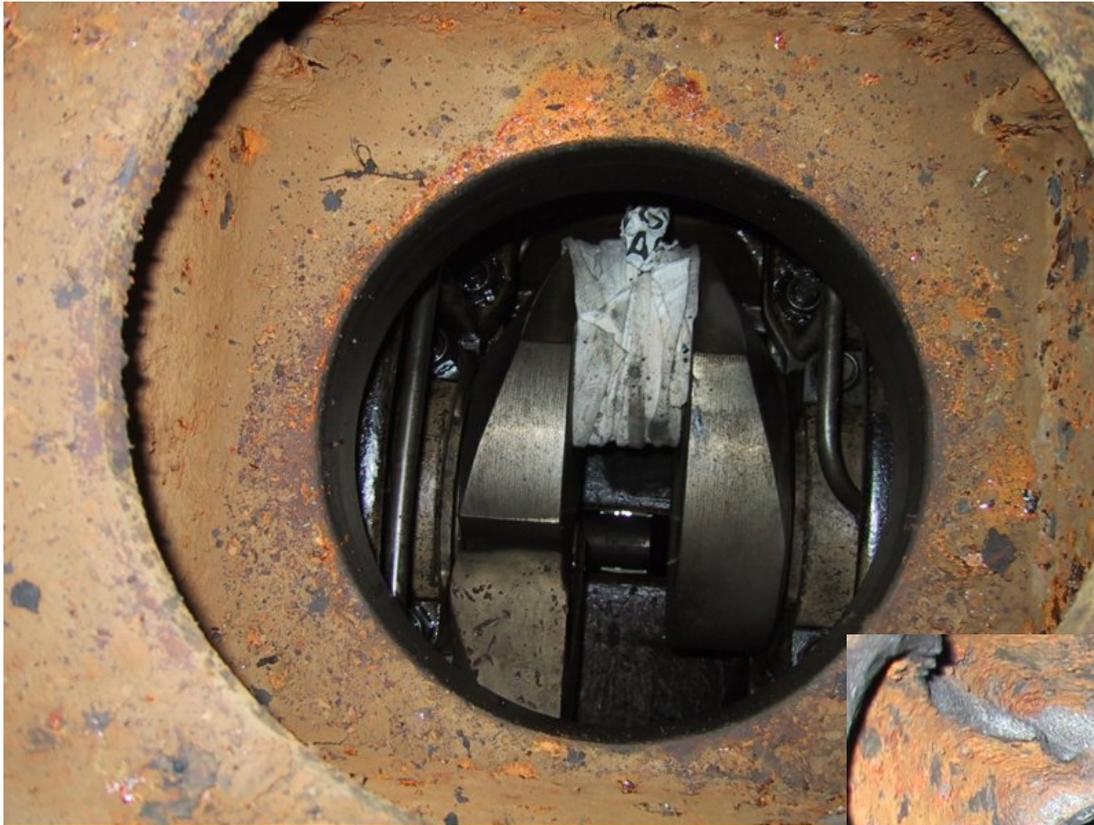
The lower liner bore was supposed to look like this

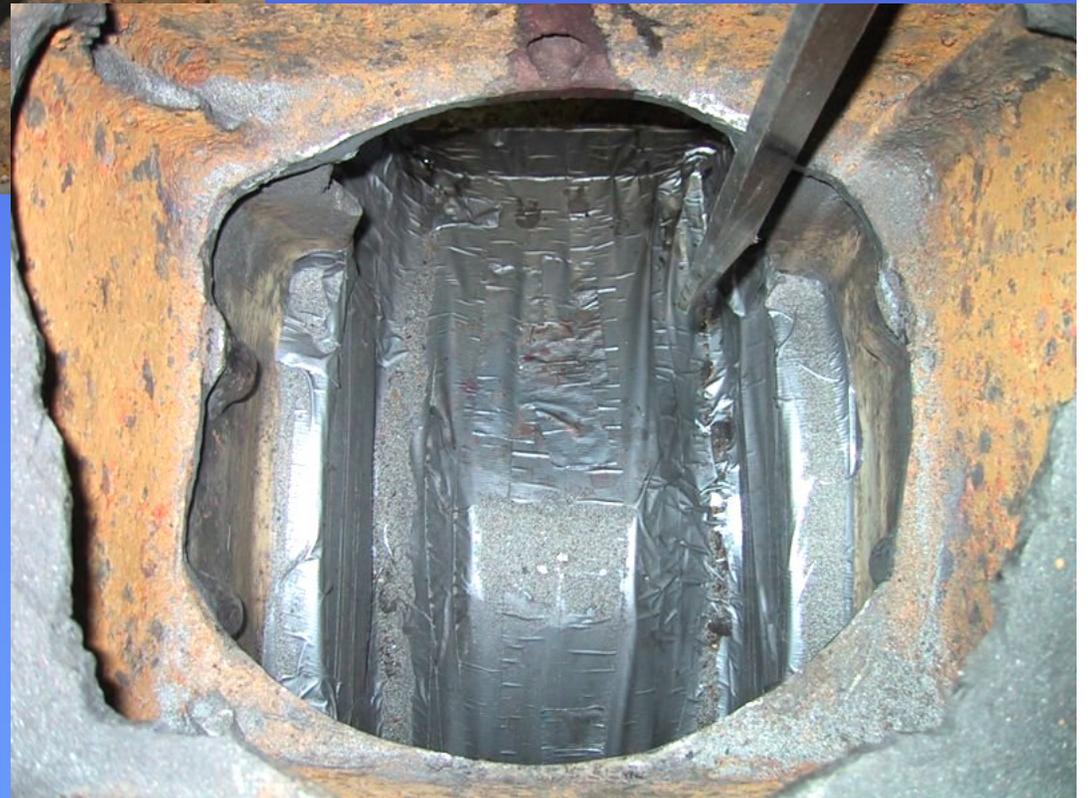
After the crash the entire lower bore was gone

The outside of the water jacket
was also severely damaged
