Motor Service Hugo Stamp, Inc. Shughart #7 cylinder block

Repaired October
2011

USNS Shughart

Violet Docks, LA

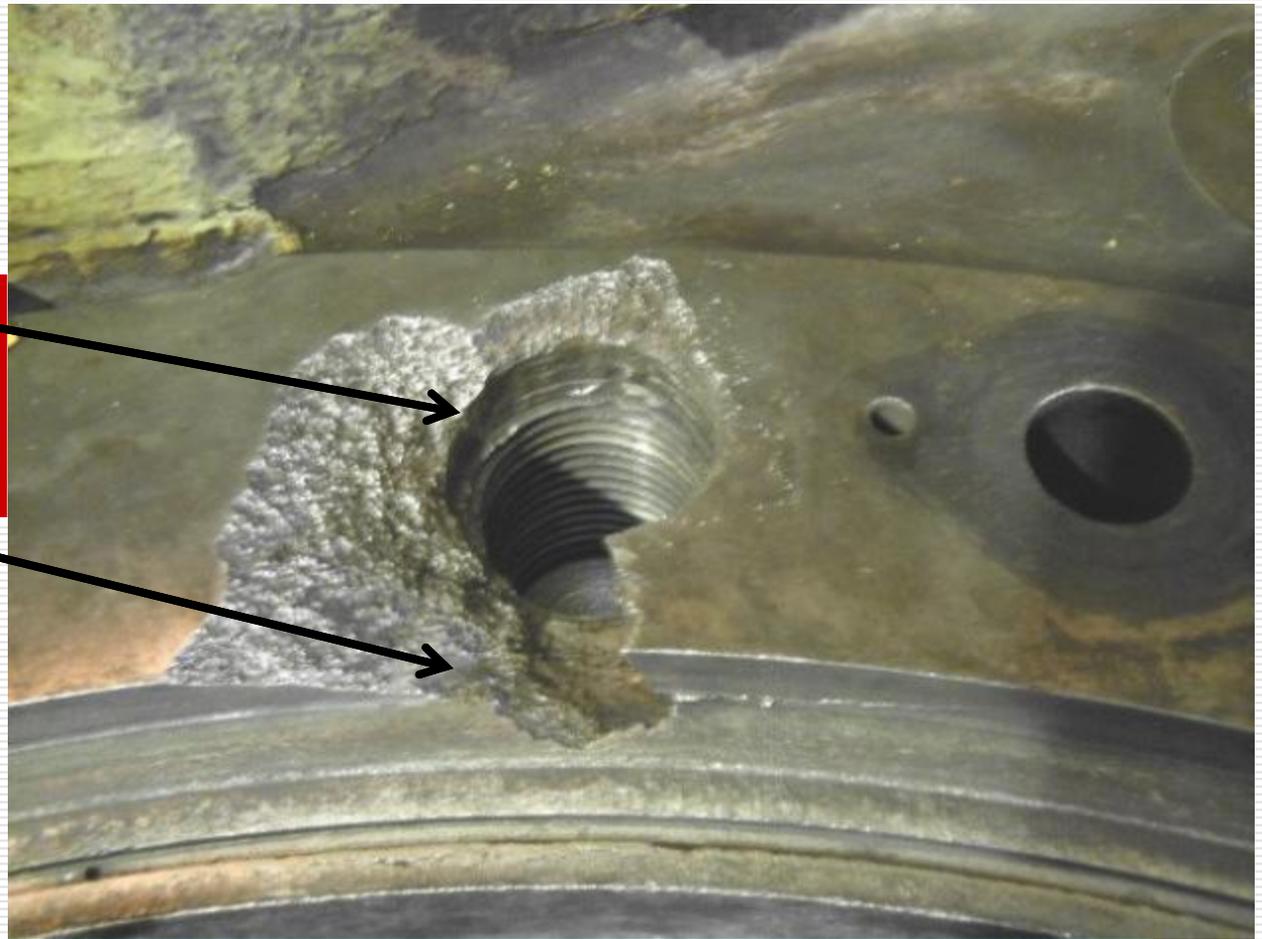
Damaged area

Damaged 68mm
bolt hole with
damage into the
liner landing.
