Final Repor

Date <u>10-16-12</u>

Part 302 B Crank Case

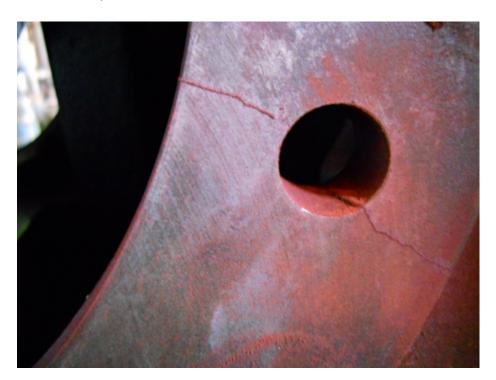
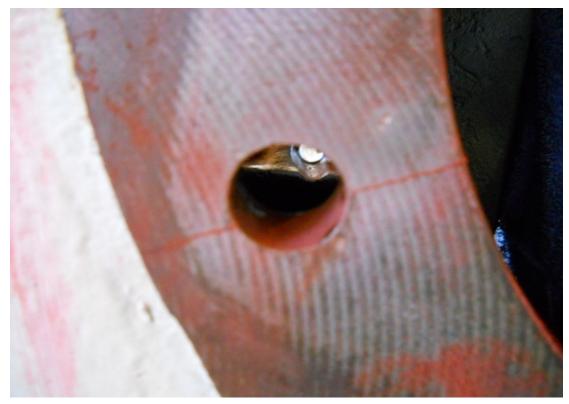
Inspection – Magnetic particle test performance on 302B Crank Case to identify cracks and length of crack.

Found—Inspection shows 7 inches of crack and 3 bad bolt holes.
