Crack repairs to an embossing machines fabricated steel frame

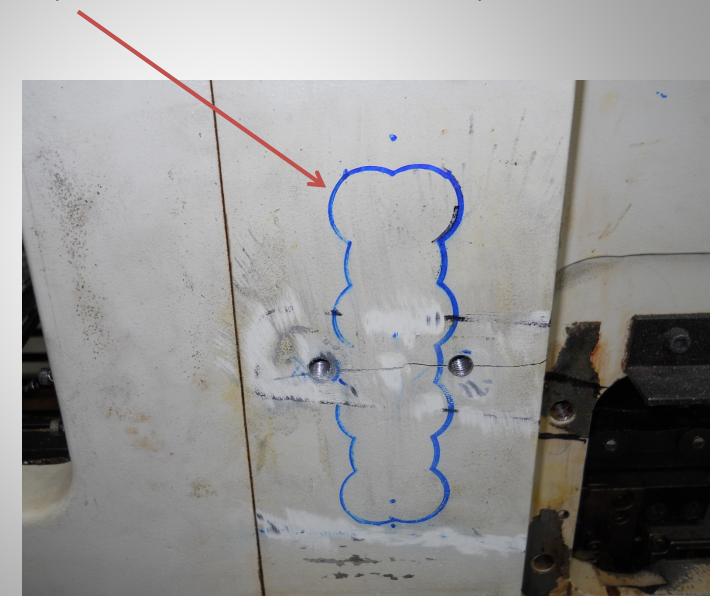
Laying-out the Lock pattern which will add additional strength across the repair. This crack was formed by the cyclic strain that stretches the frame on every stroke.

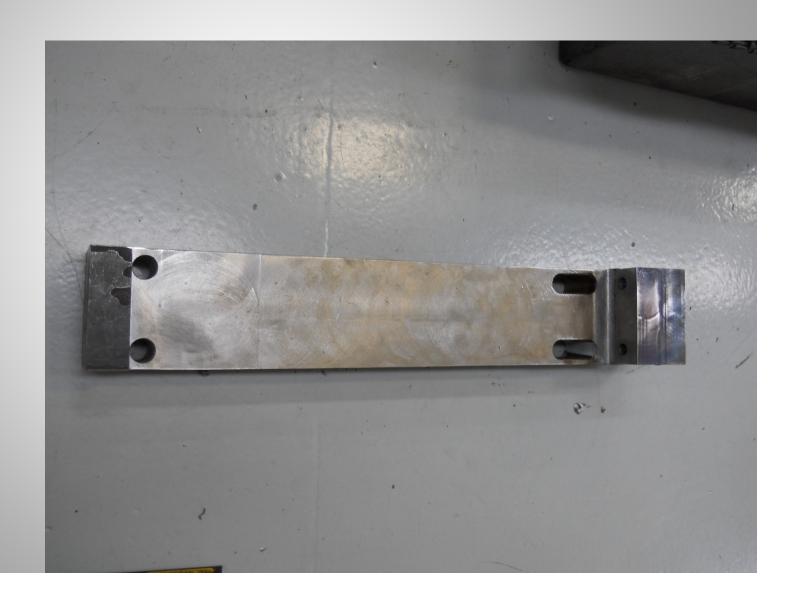
Reinforcement bracket which will be mounted over the side of the frame on the press. The crack occurred under normal operating conditions. This meant that the repair would need to be stronger than new. This is a common failure on this type of machine.
