Pedregal Power Company MAN V18 thread repair

Repaired August, 2010
Pacora Power Station
Panama City
Panama

Scope of Work

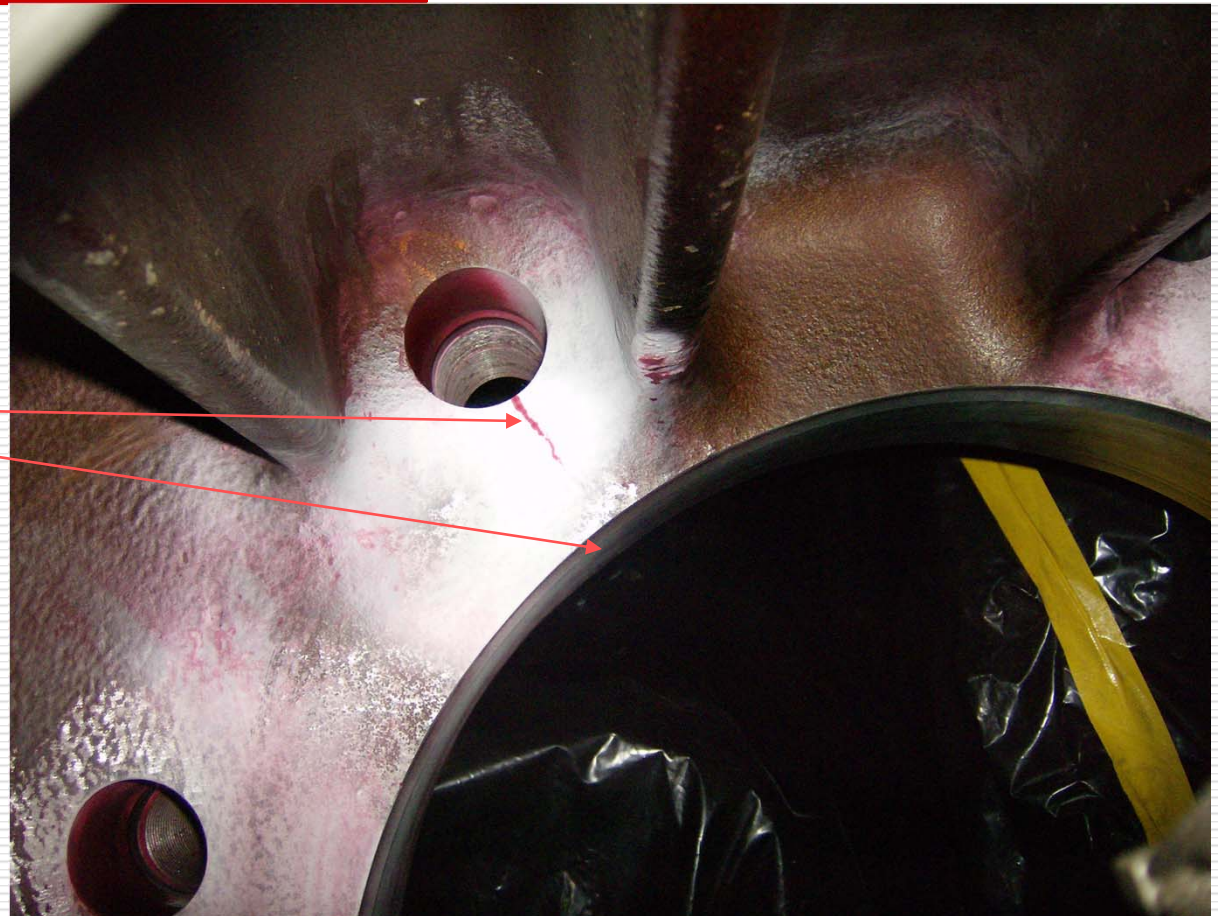
Damaged lower bore A9

Cracks found
in lower
bore stud
hole.

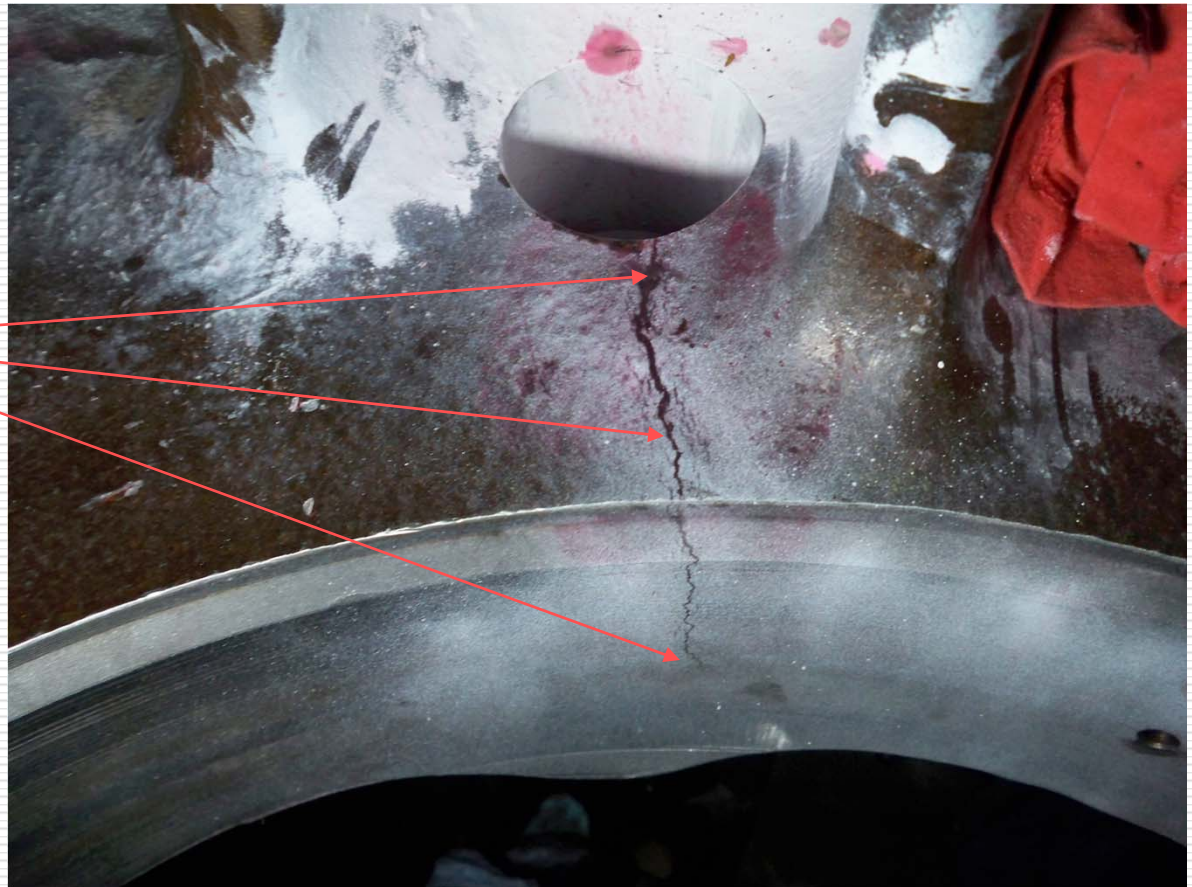
Upper bore damage A9

Crack thru the
bore and the
stud hole.

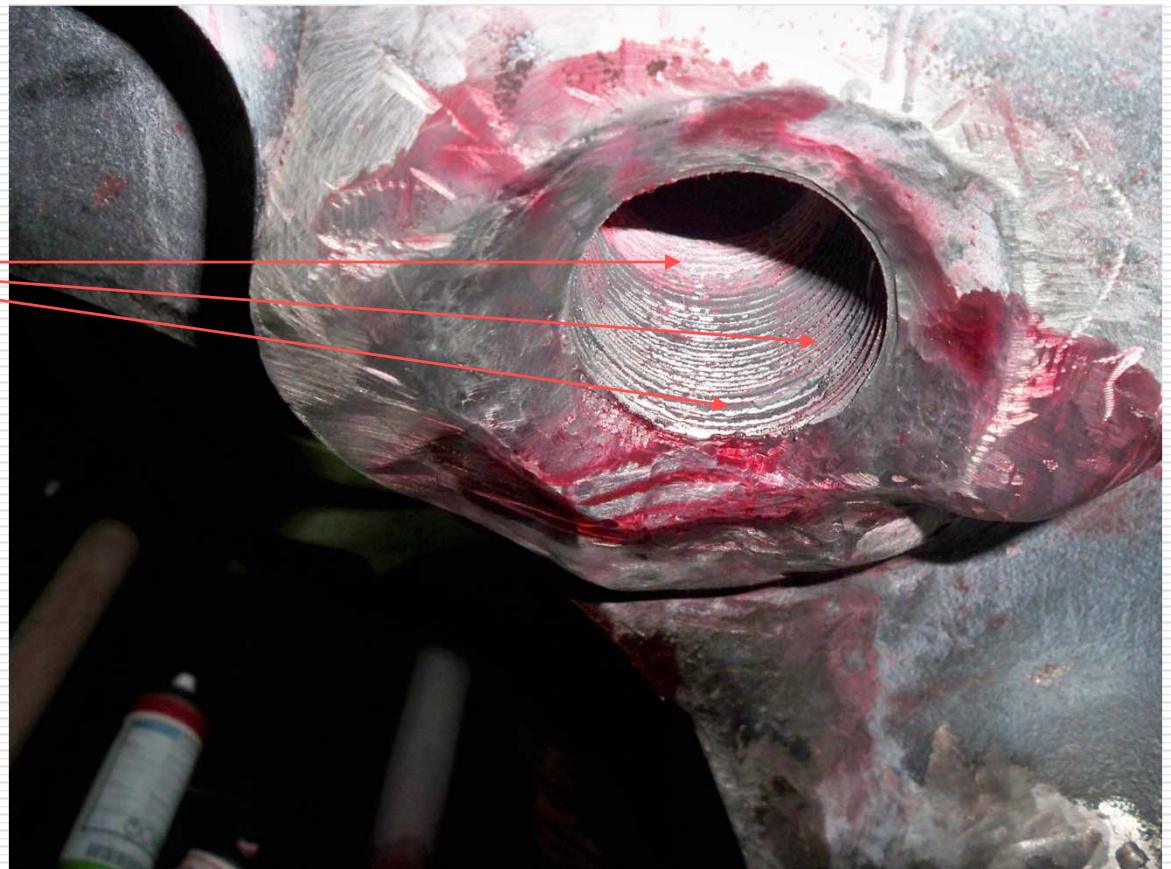
Bottom stud hole thread damage

Damaged threads
at lower
stud hole.

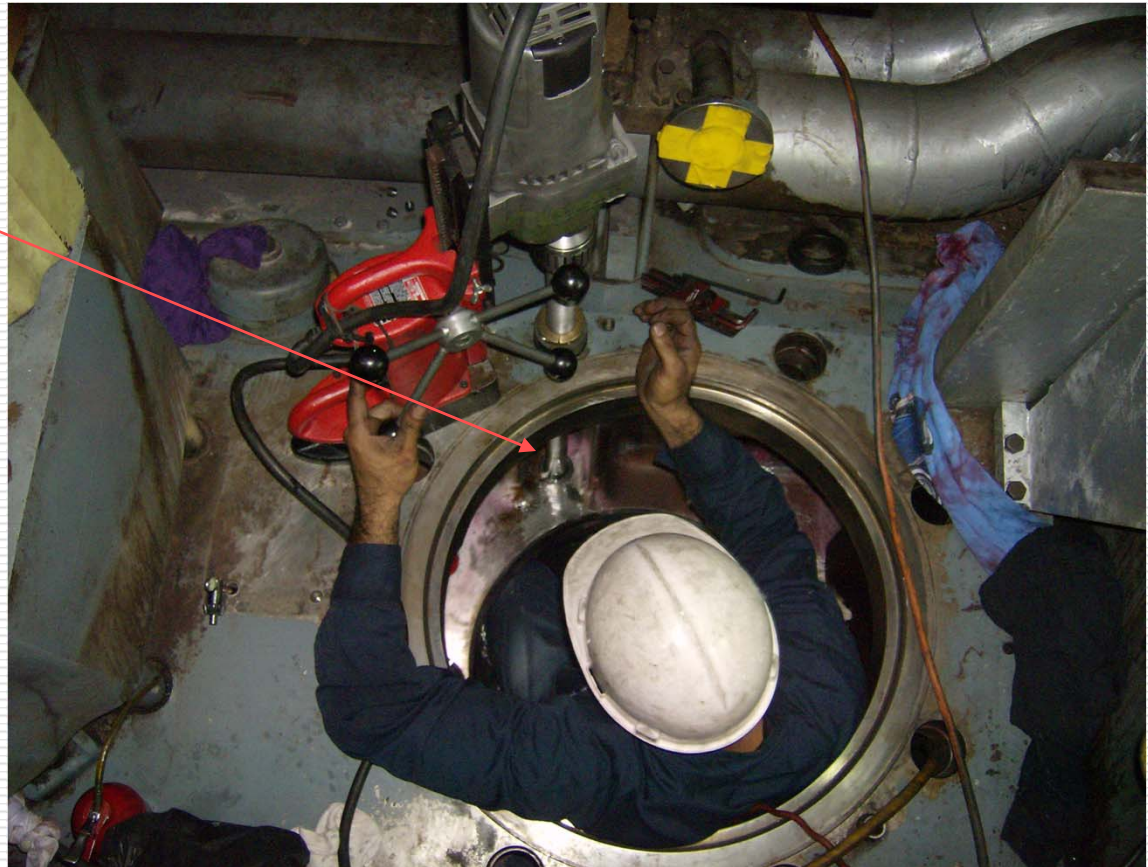
Tapping hole

Mag Drill set
up tapping
FT18 hole.

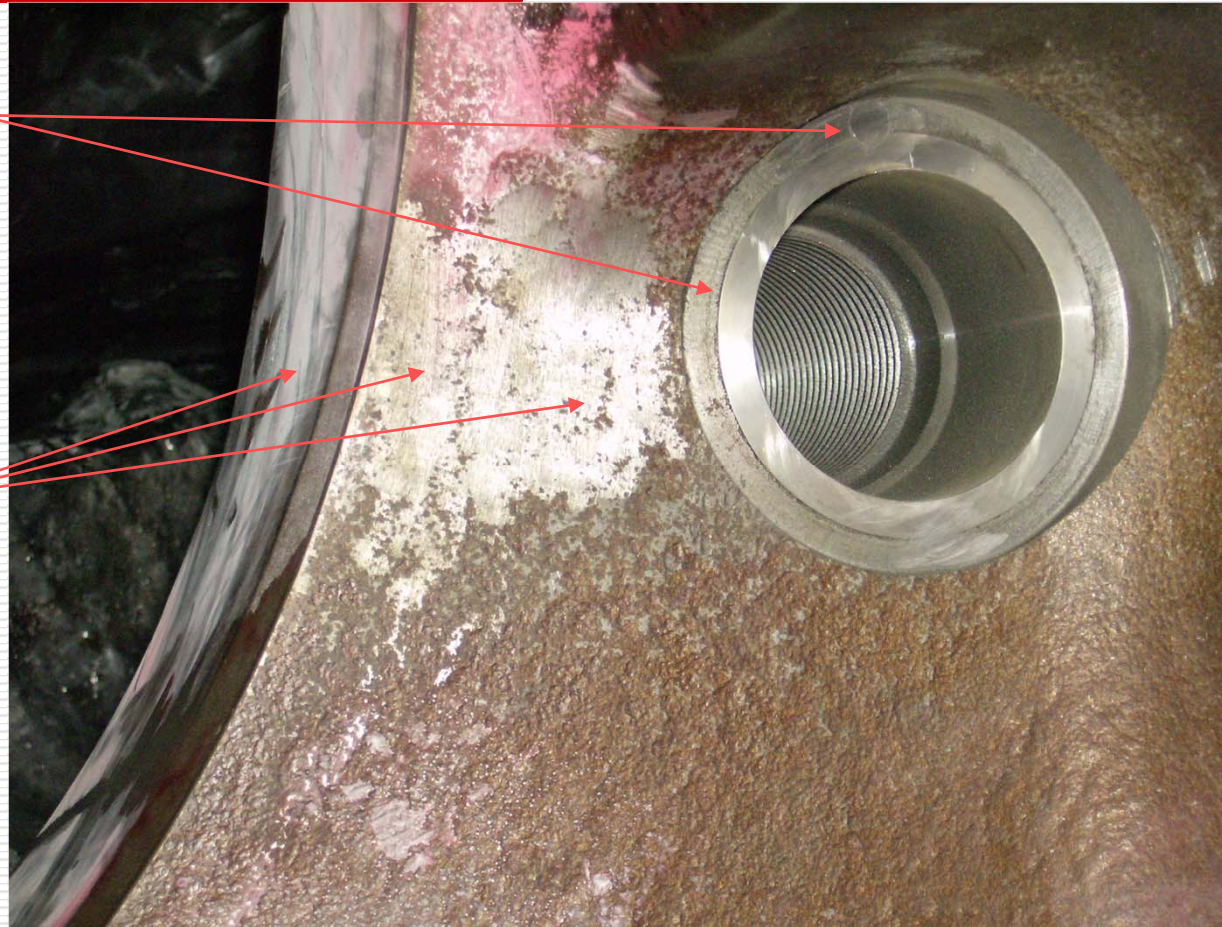
Finished repair

Insert installed
With locking pins.

Crack repaired
using our
Patented
Castmaster
Stitching pins.
