Steam cylinder repair and on-site machining final report

Customer Whitepass and Yukon Railroad Phone (907) 612-0184
Contact Ed Hanousek Address Skagway #1 Shops Rd
City, State, Zip Skagway Alaska 99840 Date October 13, 2013

Part Railroad Locomotive #73 Steam drive Cylinder
Serial number 266114 Inspected by Ed/Scott

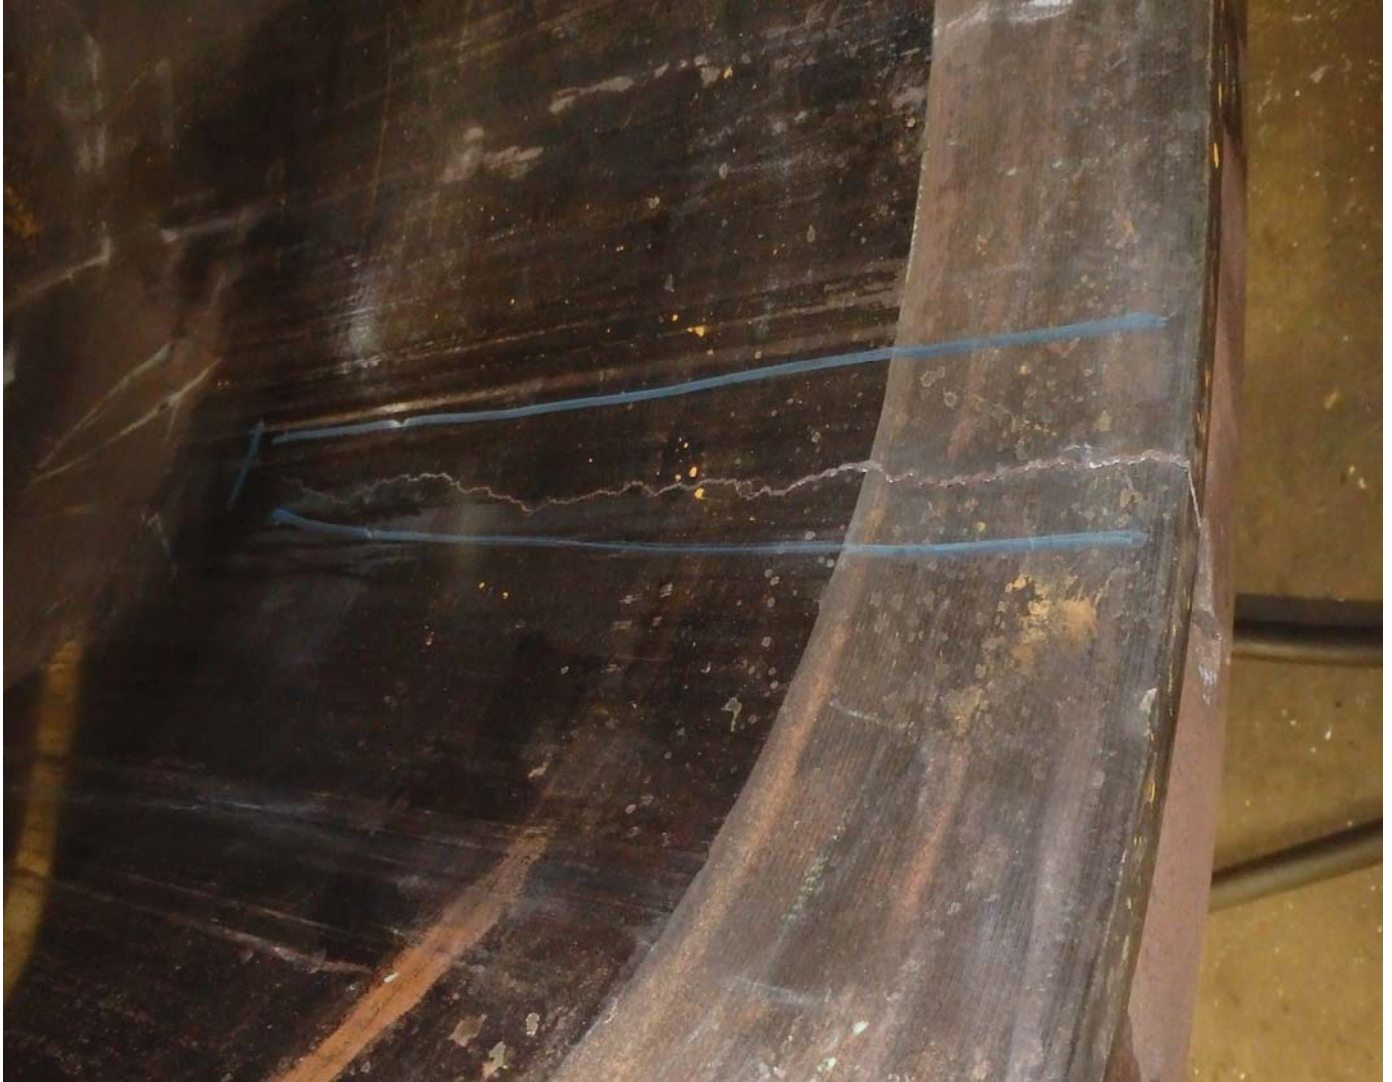
14. Damage found: A thirteen inch crack from inside the cylinder to the outside face and through a 1"-8 bolt hole was cause by the impact of the piston into the head
