Damaged Cooper frame TESORO, Martinez, CA

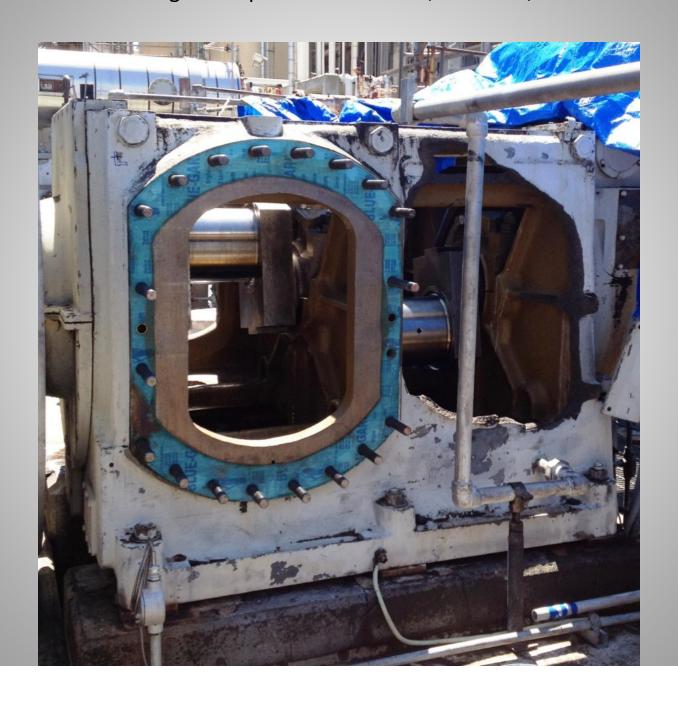
Frame damage that was seen on initial inspection on-site

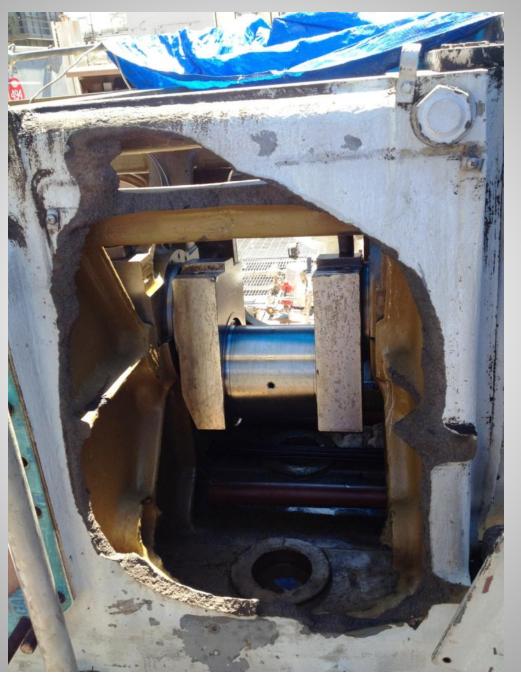
Blown out pieces are sent to *LOCK-N-STITCH* Inc. to be used as templates also to use the good pieces that will be furnace brazed back together

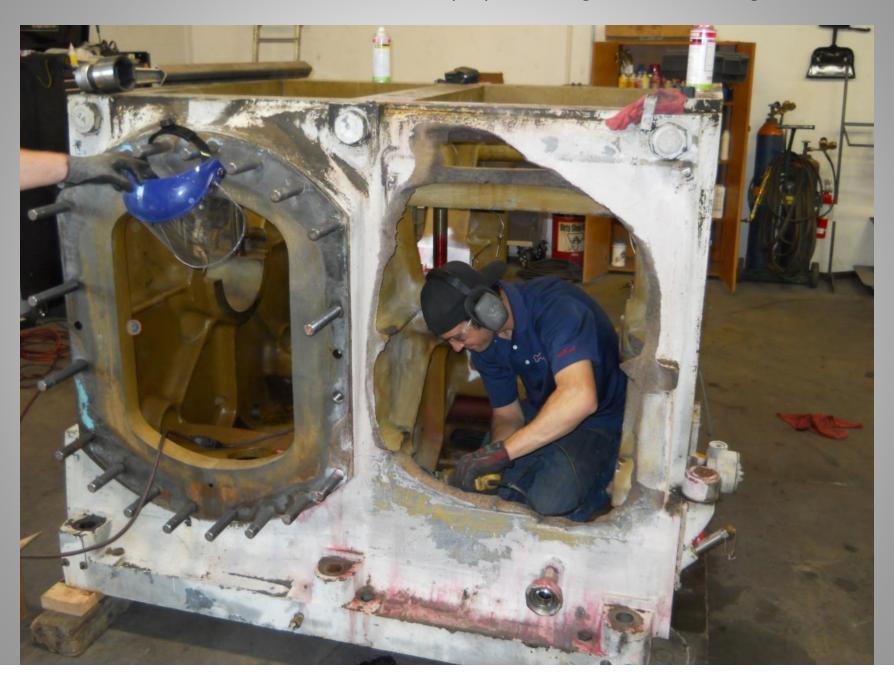
All damaged areas will need to be ground parallel to accept new casting that will be metal stitched

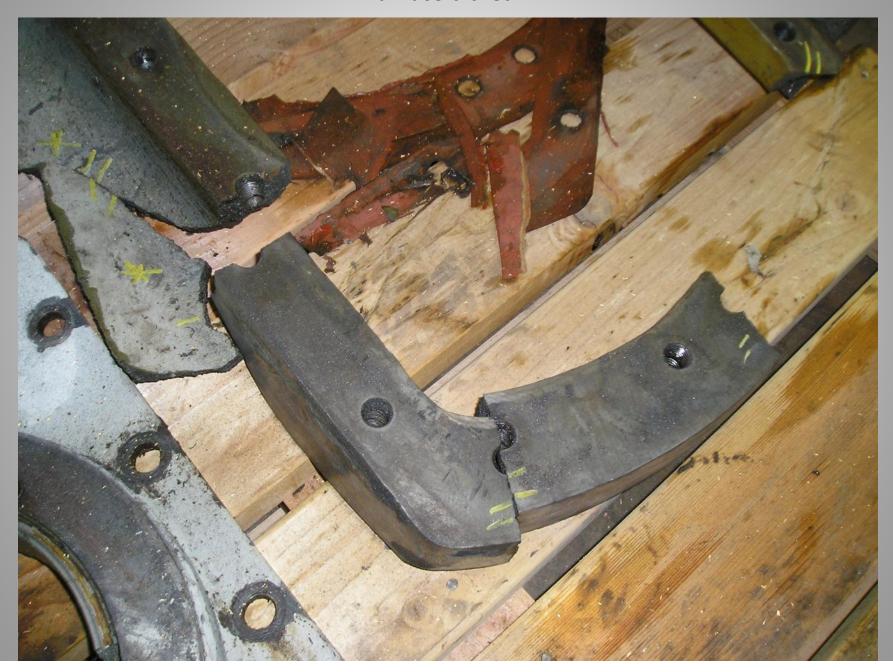
Fitting broken flange pieces and furnace brazing

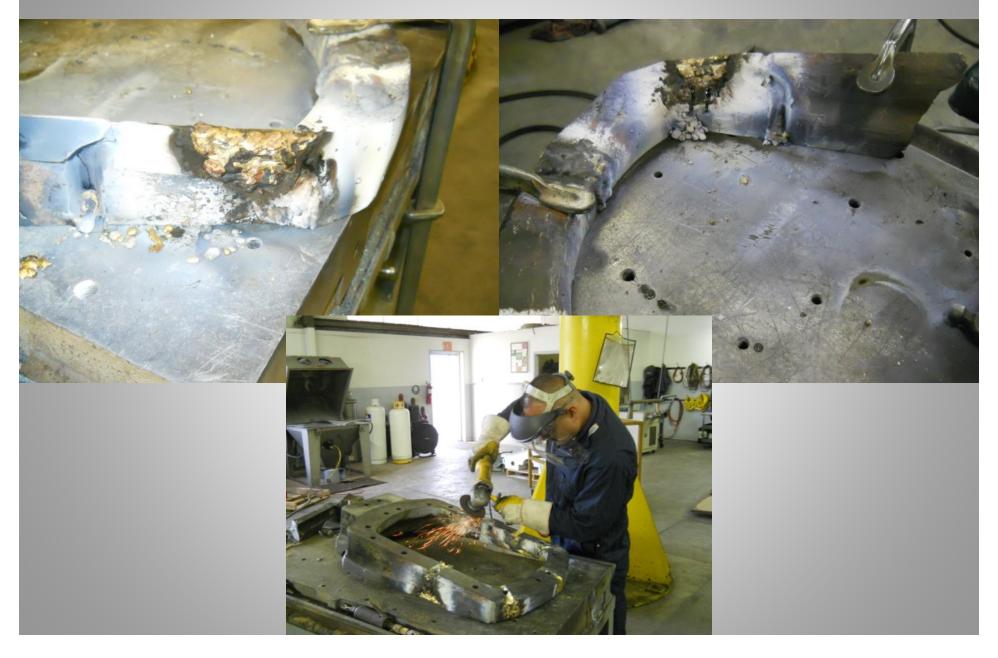
Flange is completed and ready to be welded 1 ½" plate

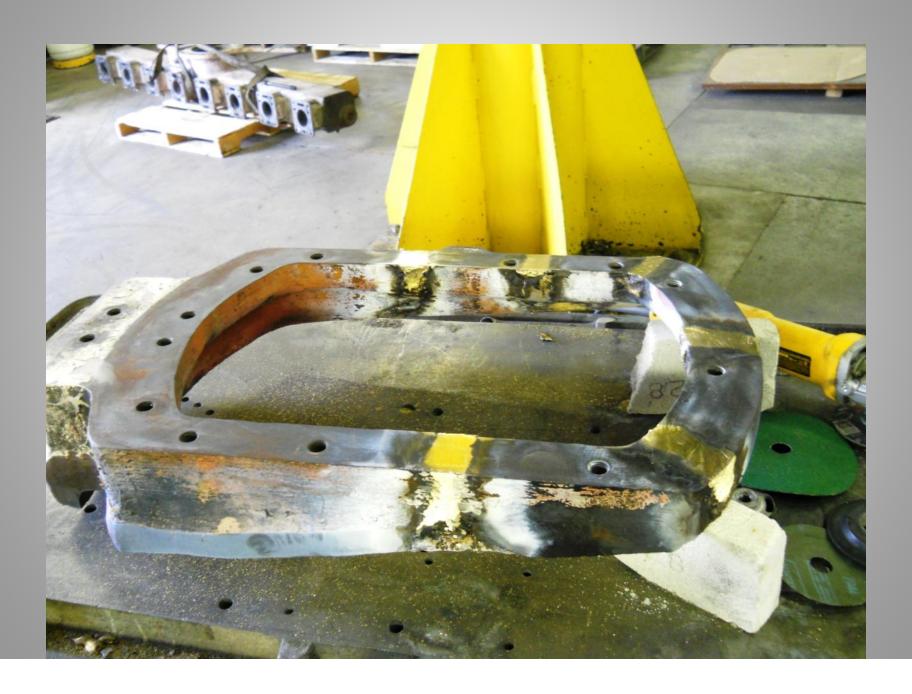
Making template for casting to be welded to flange and then metal stitched into frame

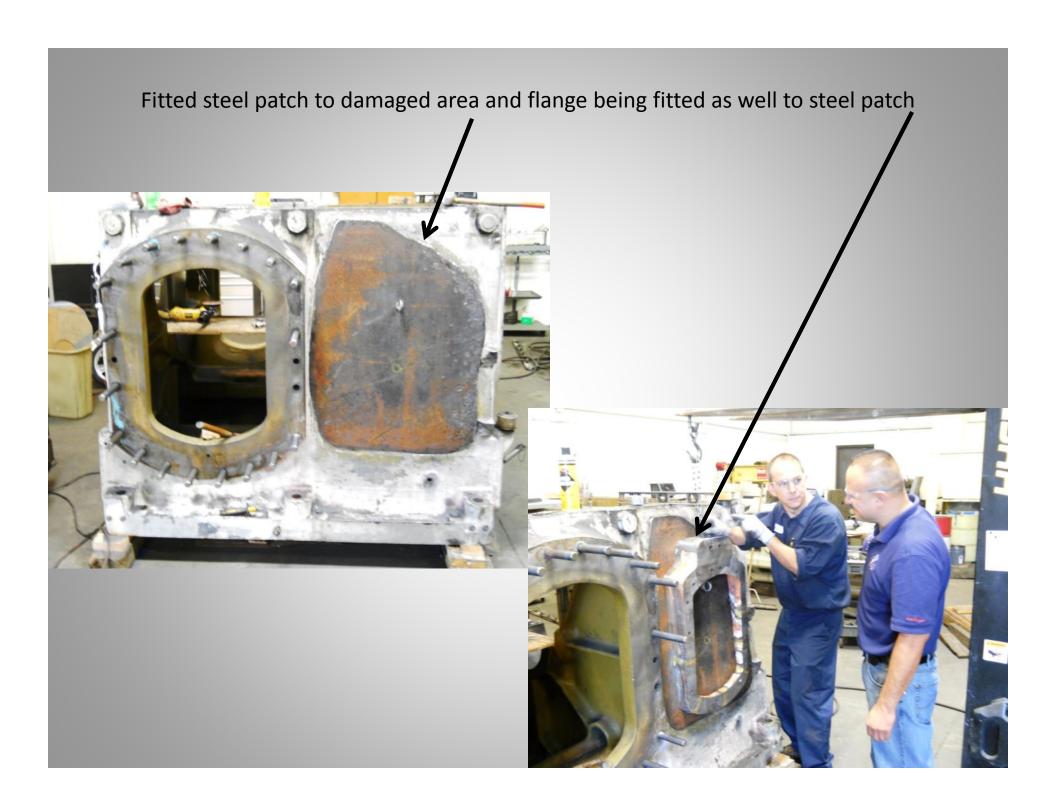
Flange marked out and hole cut out of steel plate for flange opening. Flange is now ready to be welded to steel plate

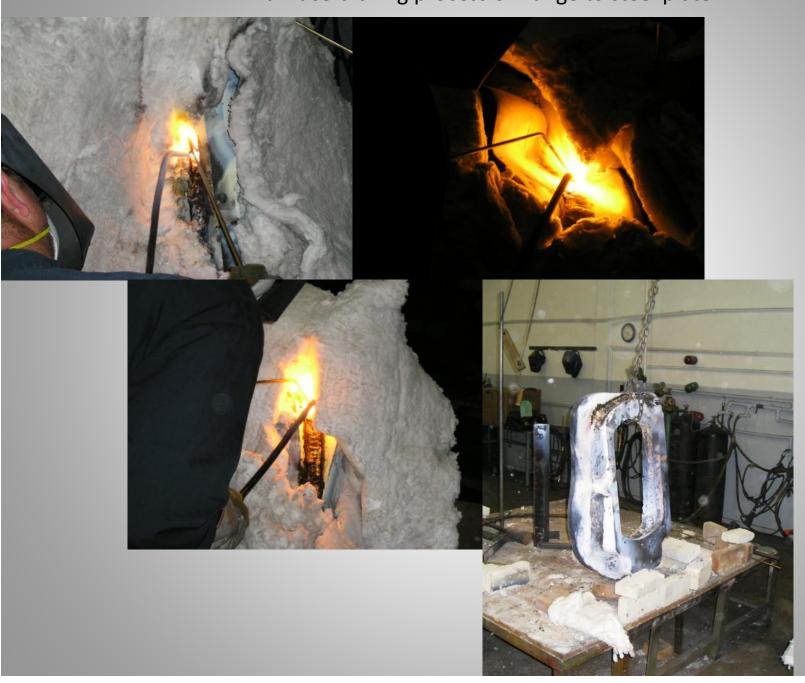
Flange is completed and ready to be metal stitched into the frame

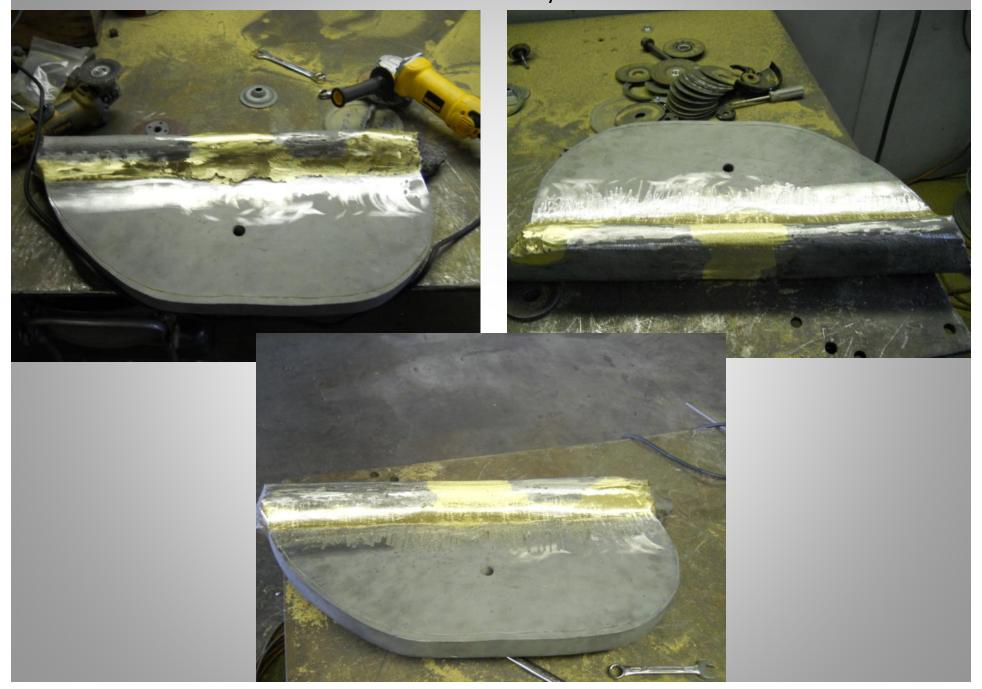
Floor patch has been fitted

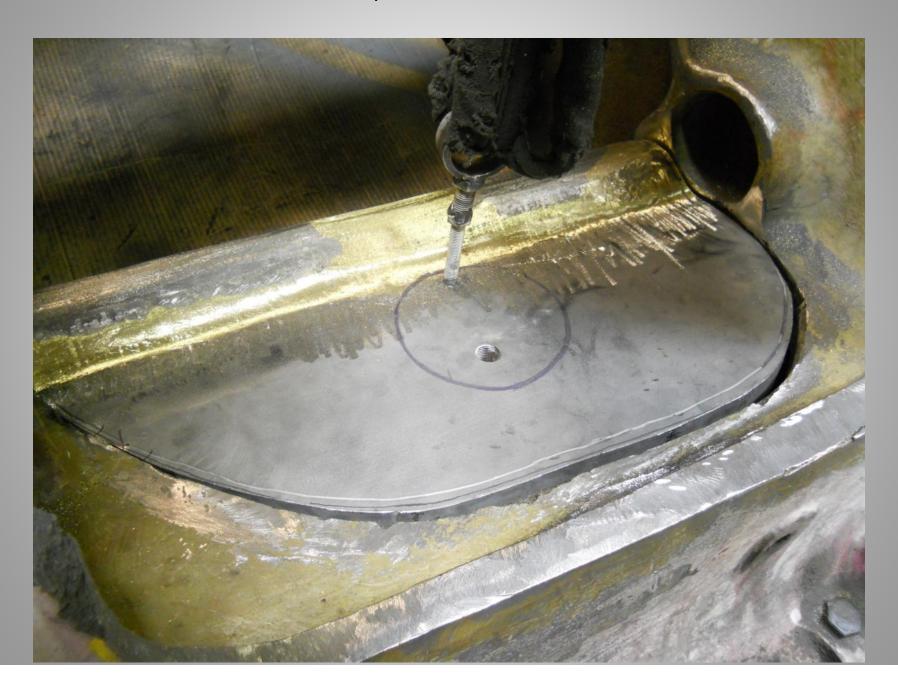
Using a Mag base Drill to install the FP7 plugs

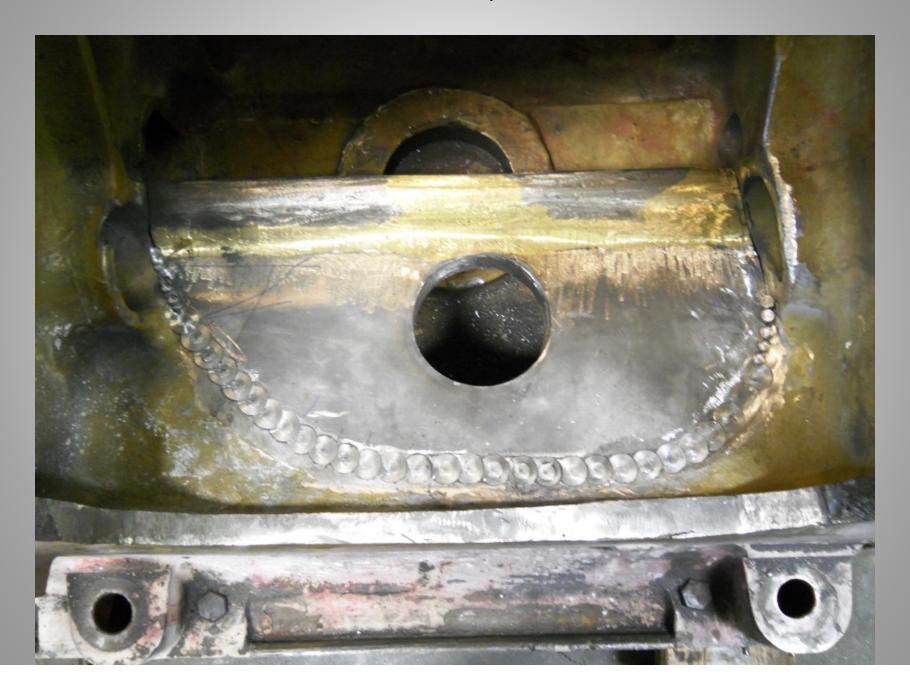
Completed floor repair

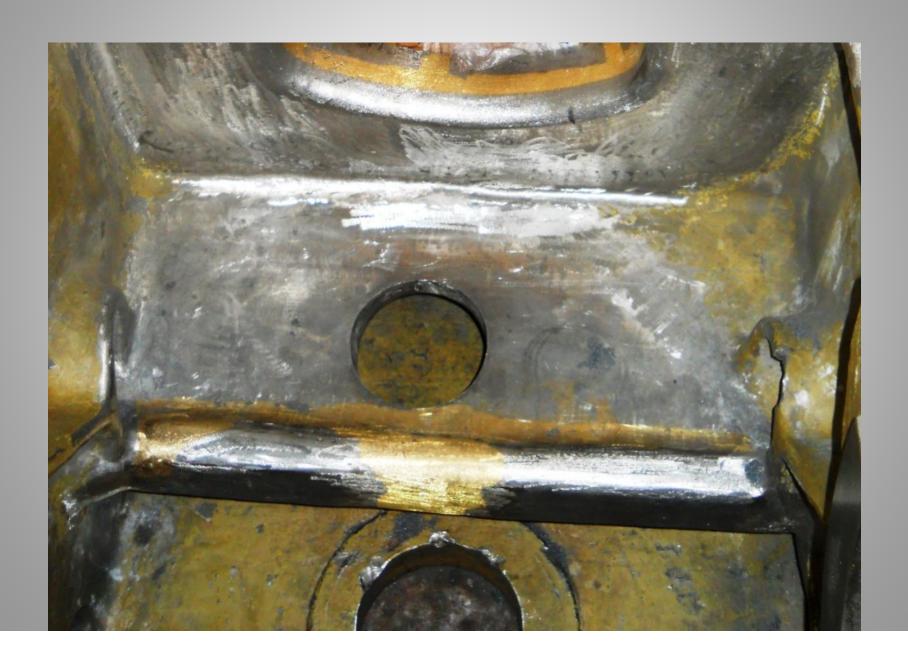
Before the main outside flange can be metal stitched all the eternal damage must be checked and repaired. This makes the accessibility that much easier. Here you see two of the main bearing wall gussets being metal stitched into place

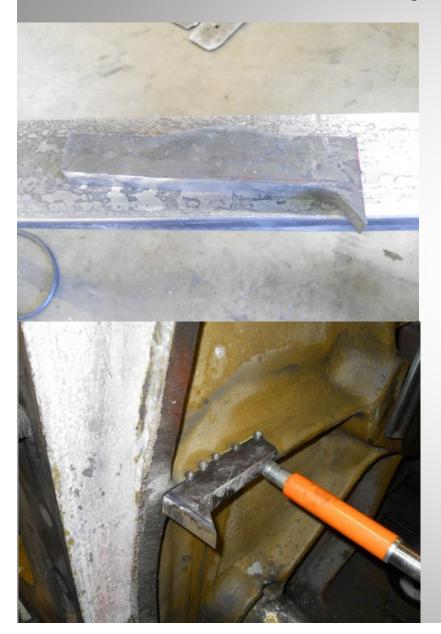
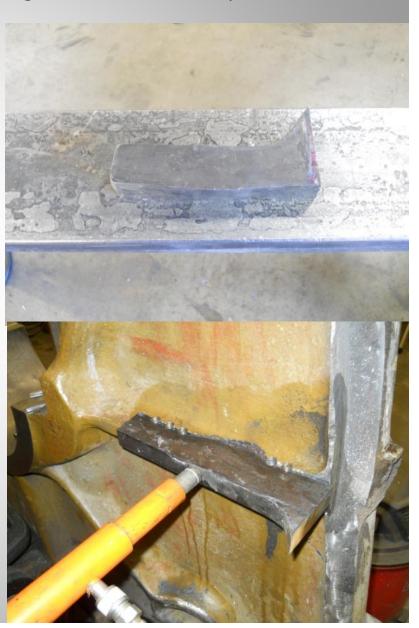
Both main bearing wall gussets are repaired

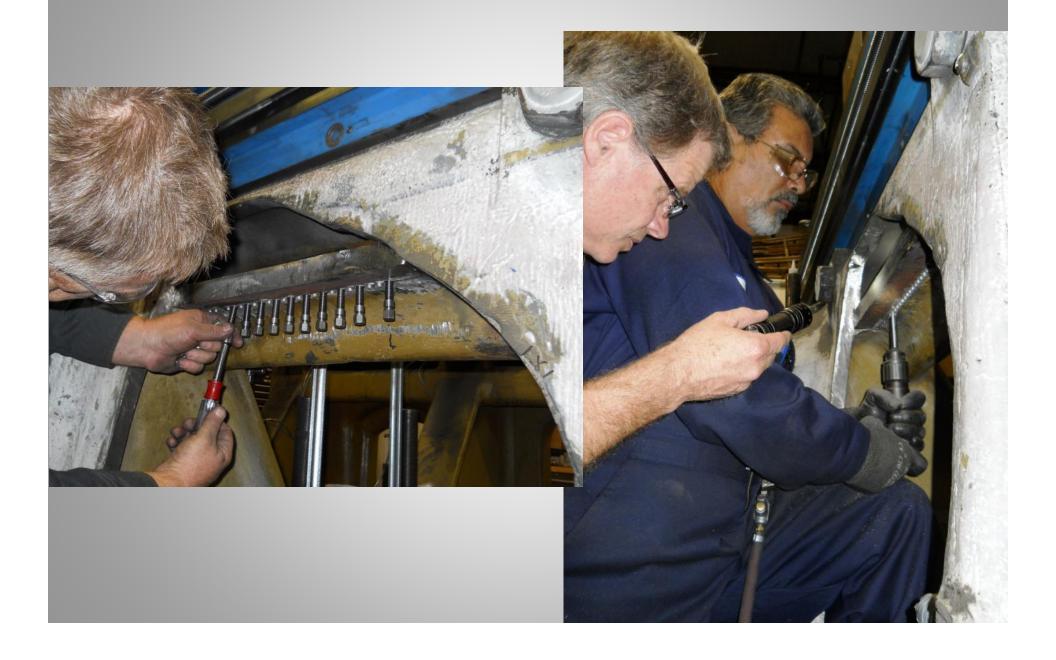
Using the 7' Bed Mill to mill off the front of the new casting so it sits flush with the casting

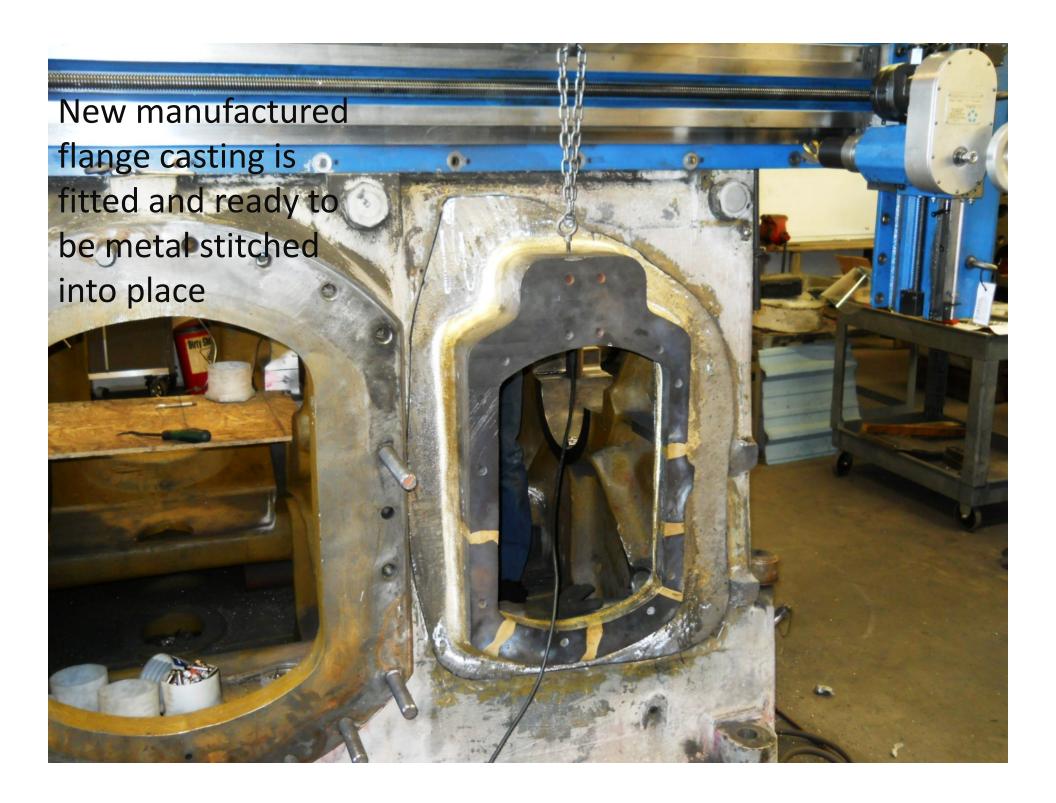
Flange has a couple stitching pins in place to hold it in place. Using the Mag base Drill the stitching begins until the entire joint is sealed with overlapping stitching pins

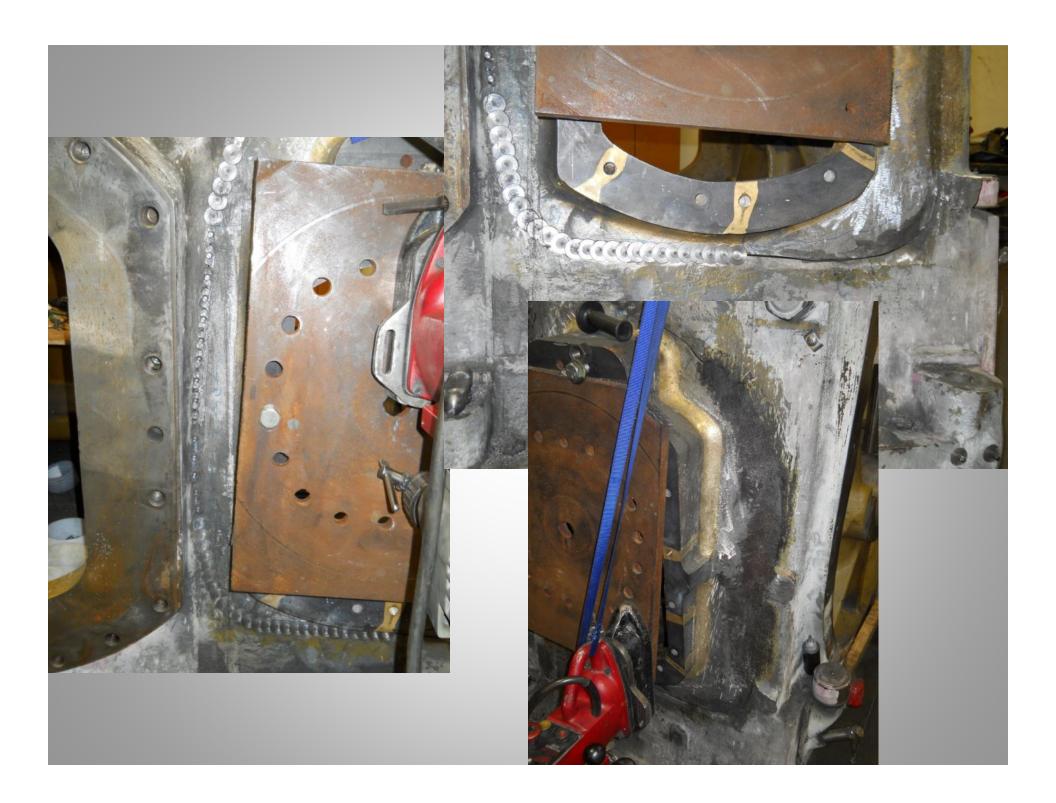
L20 Locks are being installed every inch to additional across the repair. These Locks have a total of 19,775 PSI per location

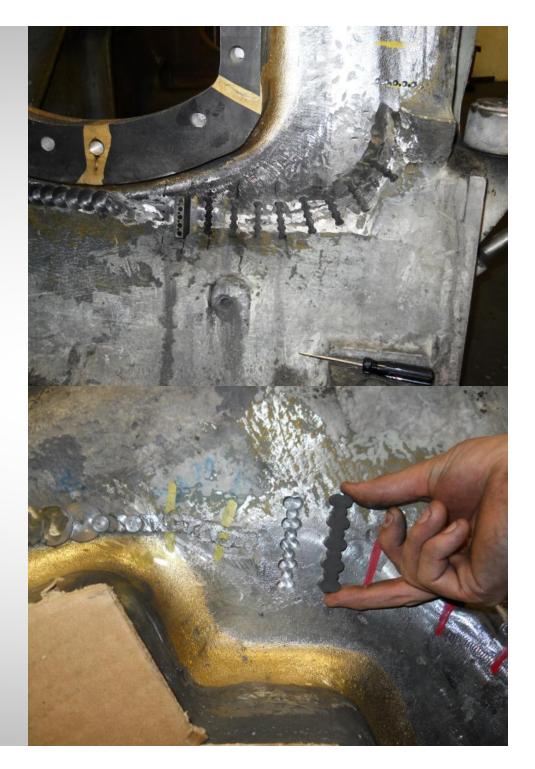
Metal stitching and Locks installed is completed. Ready to be hand finished and flange surface machined.

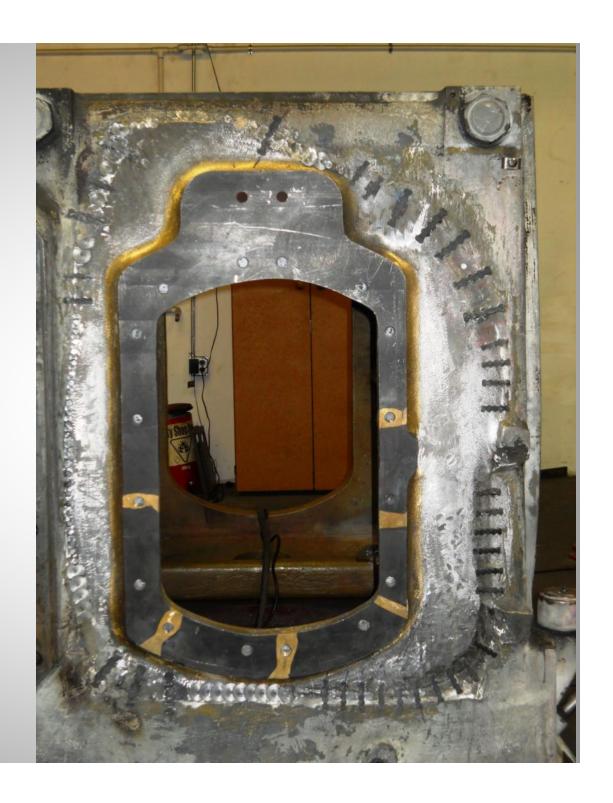
Outer gusset flanges repaired

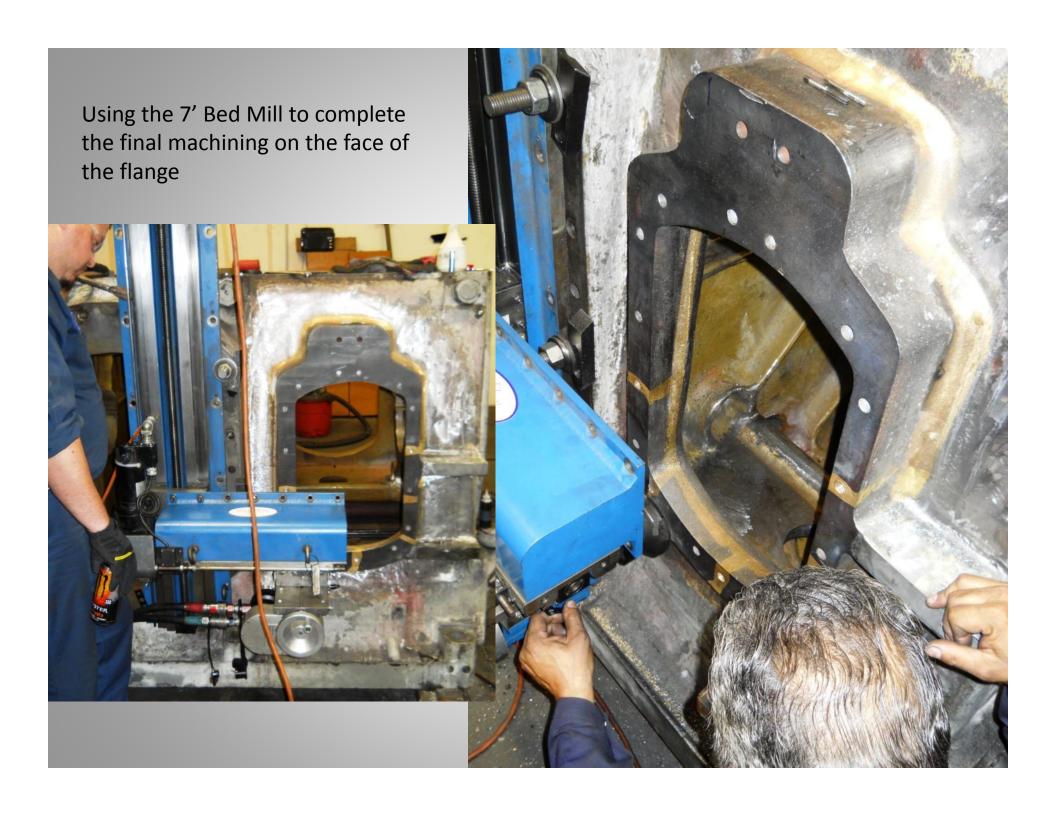
All repairs where Mag Checked to make sure that all damage was repaired

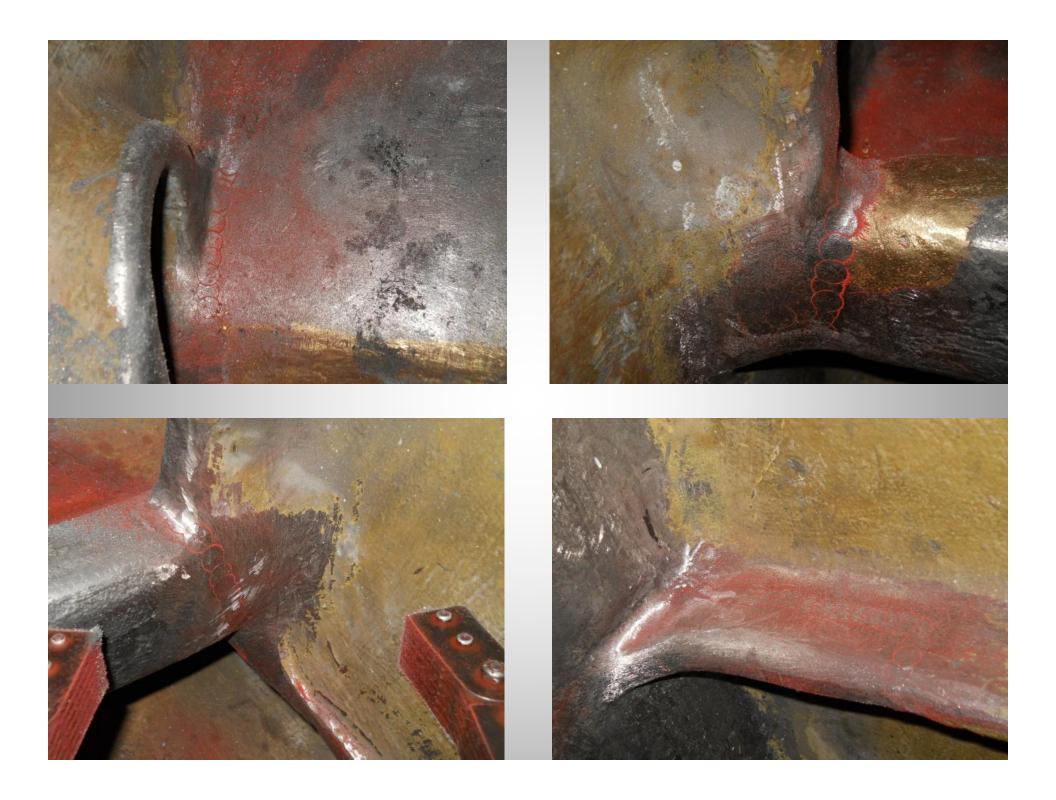
Pressured washed and ready for paint

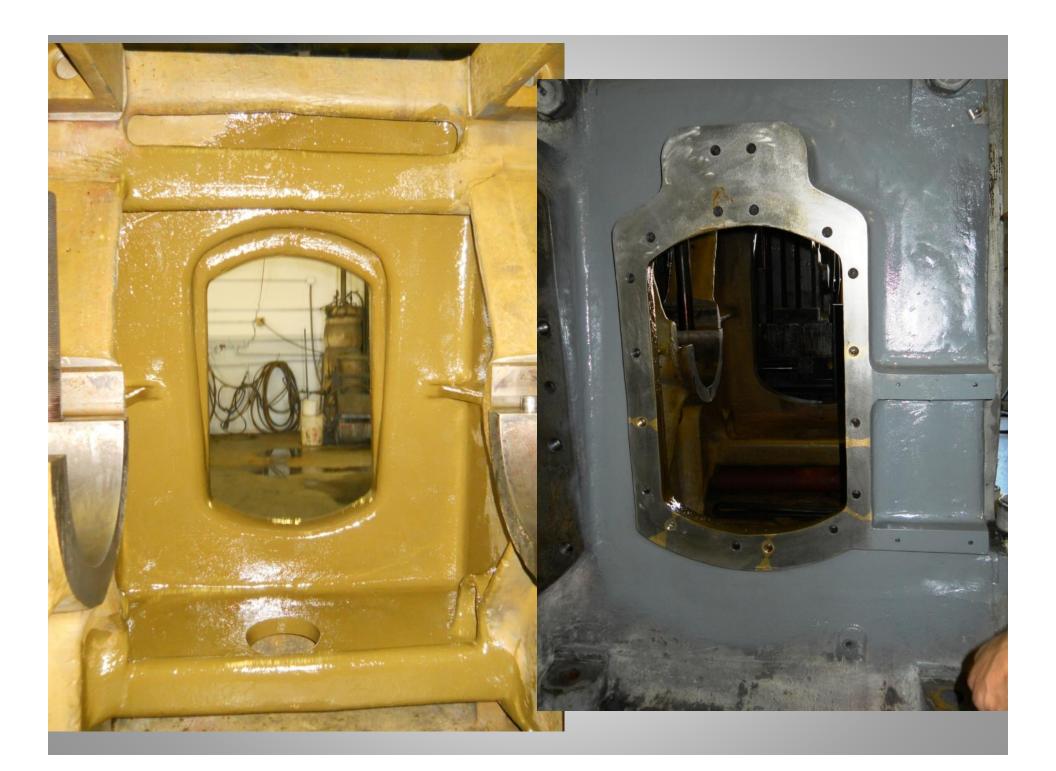
Repair completed in 15 days 24 hours around the clock
