Repair Final Report

Part Tugboat Rotary Port Side Steering Pod Housing
Work Completed by Alaa and Scott

Tugboat Rotary Port Side Steering Pod Housing repair

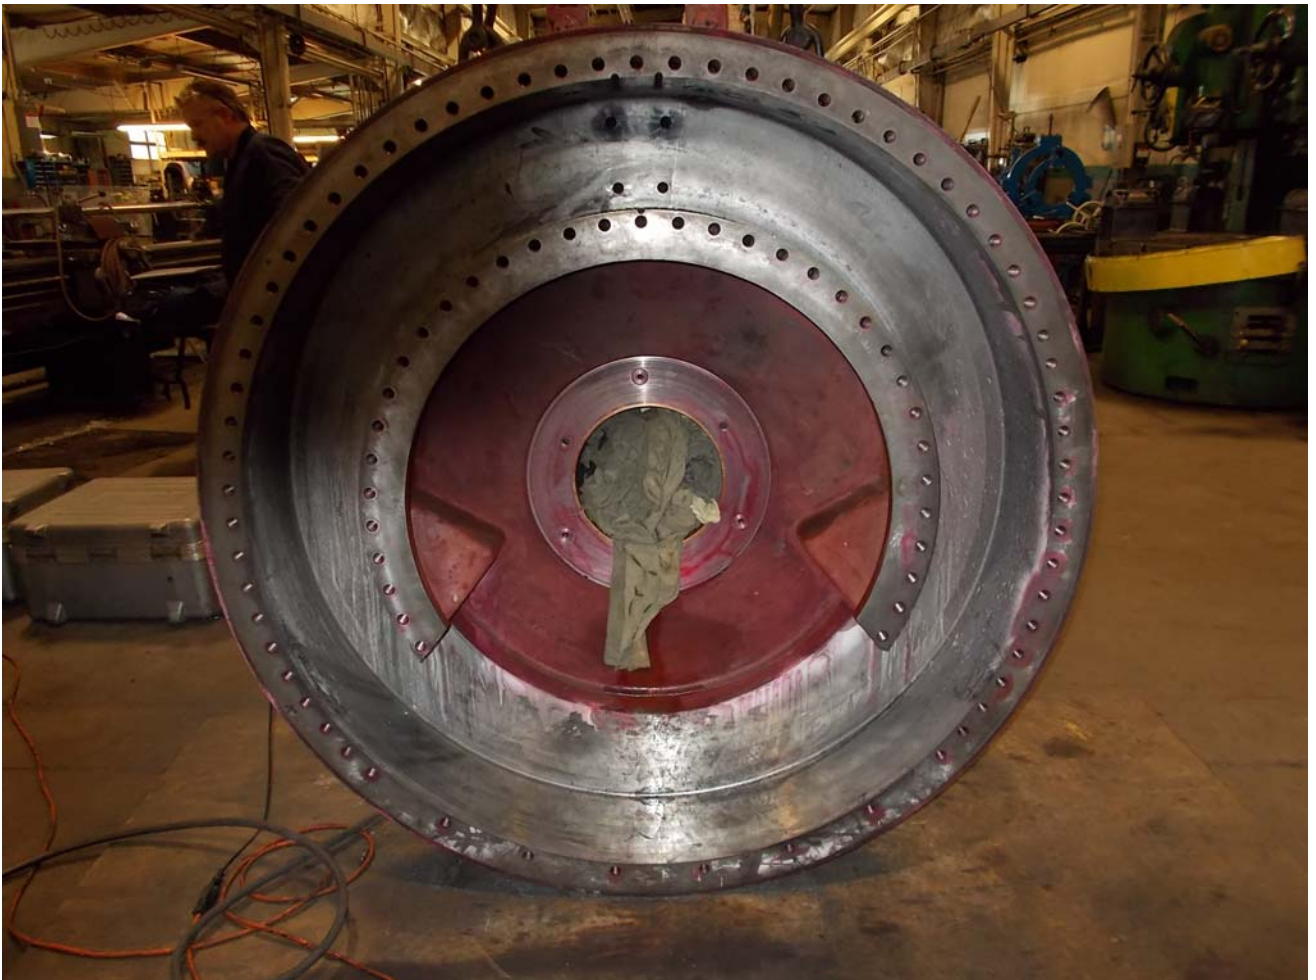
The bore on the steering pod was worn and a new Repair Sleeve was necessary to repair the bore.

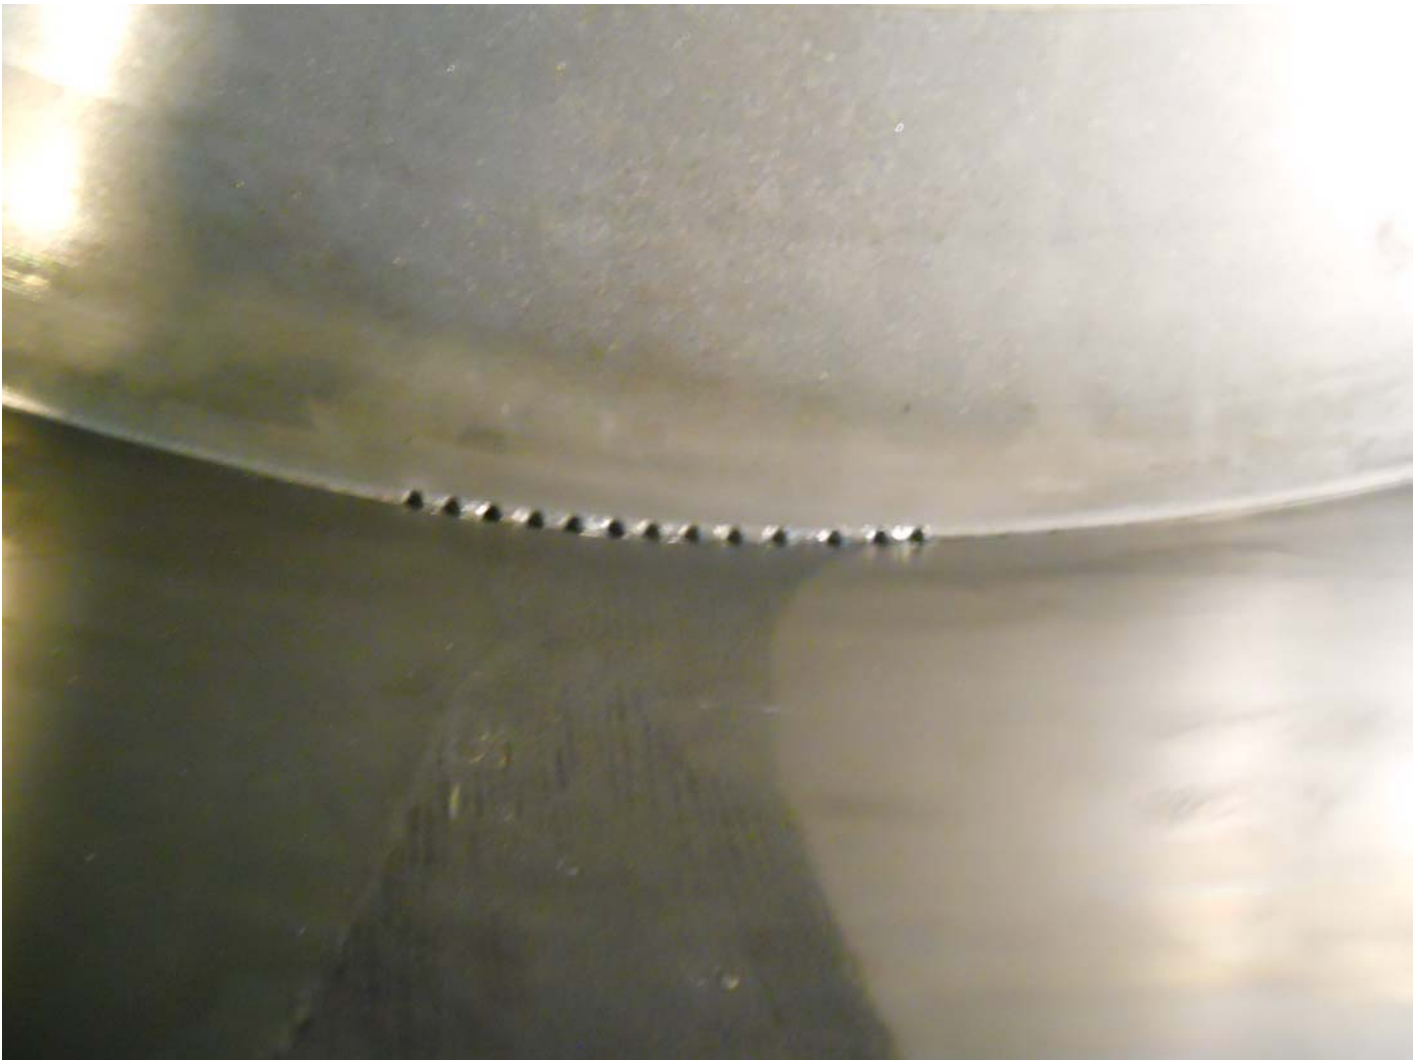
7. Stitching required inside the radius area where a low spot occurred when machining new sleeve. First Row of holes was drilled to receive L8 stitching pins.

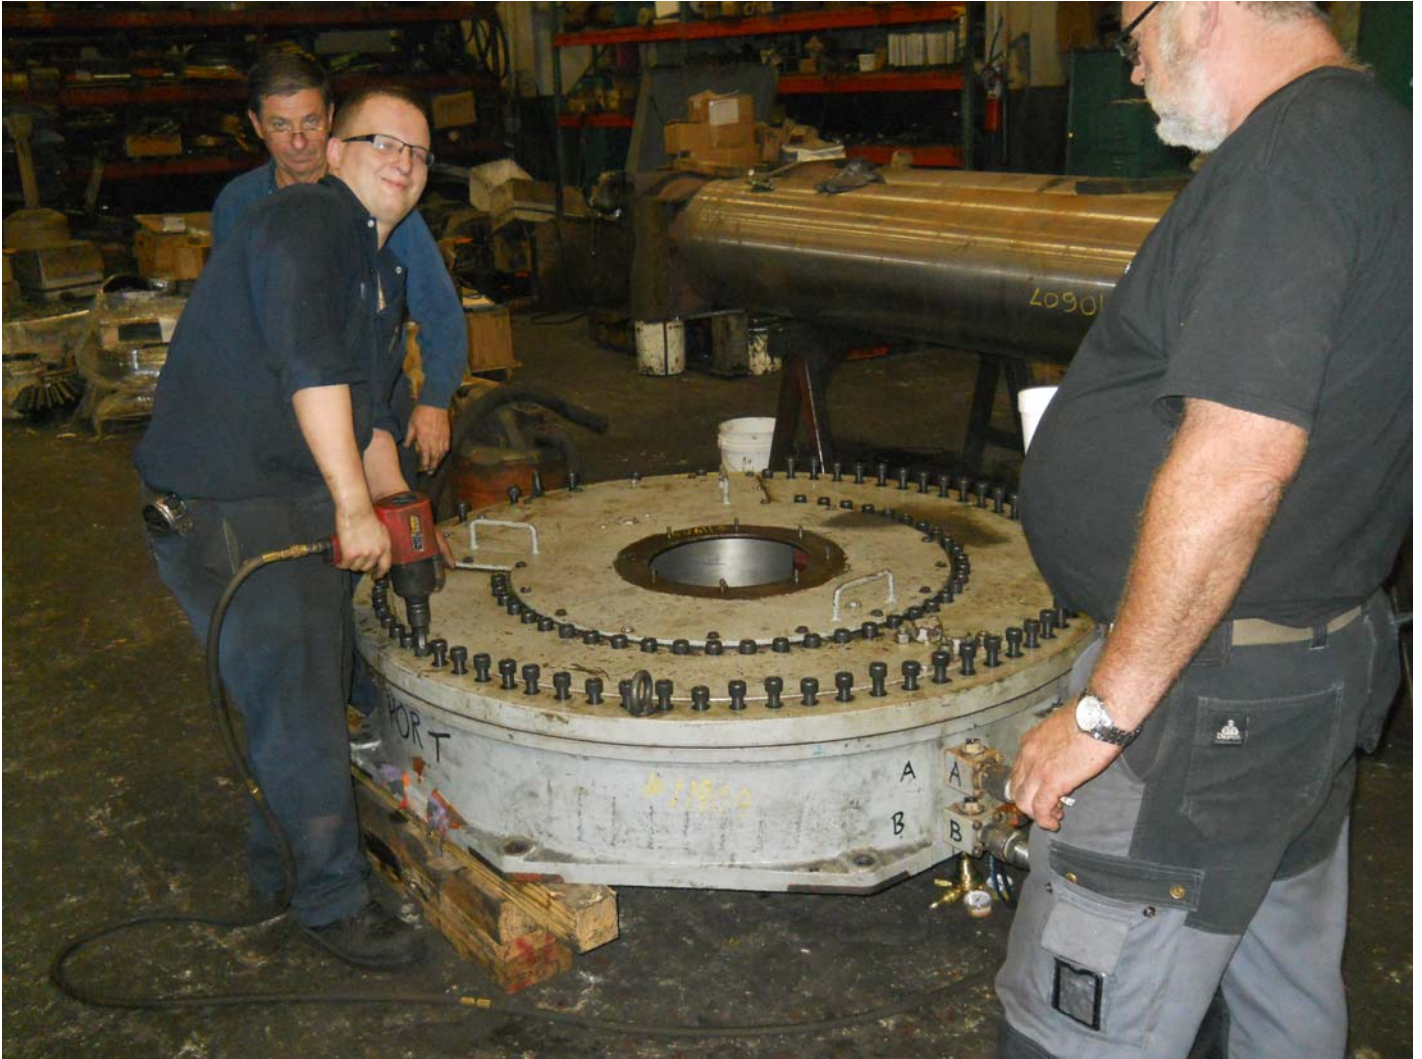
10. Steering pod was pressure tested to check for any leaks.
No leaks were found.

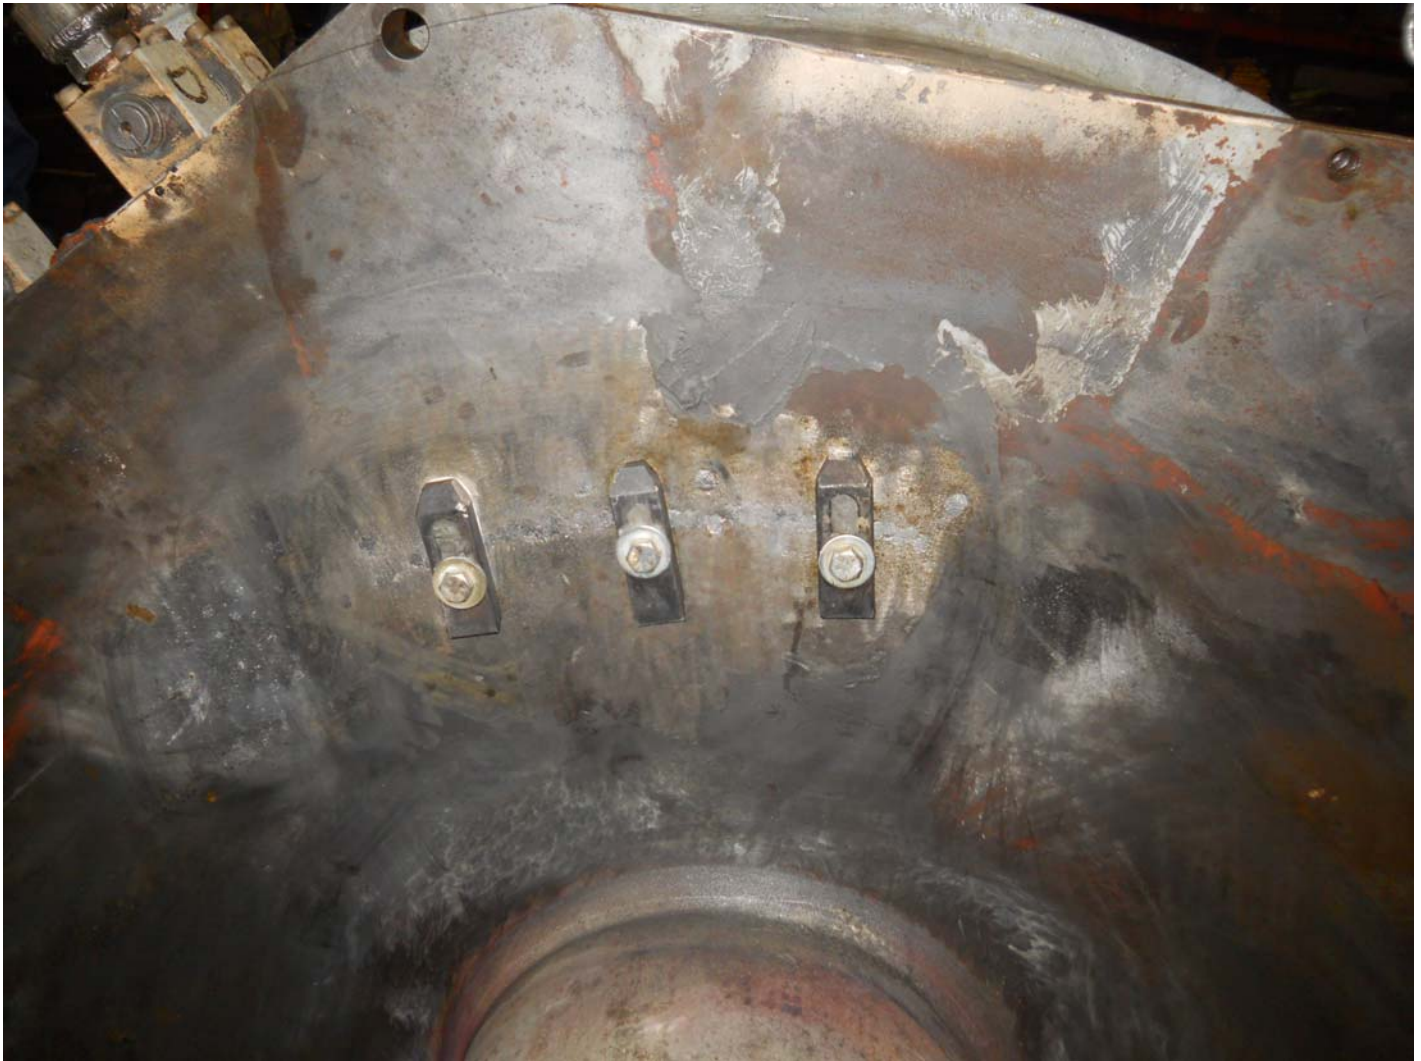
11. Leak was found in a prior repair. Extra stitching pins were installed and

supports were added for reinforcement.
