5.9 Cummins #53 cracked block reinforcement.

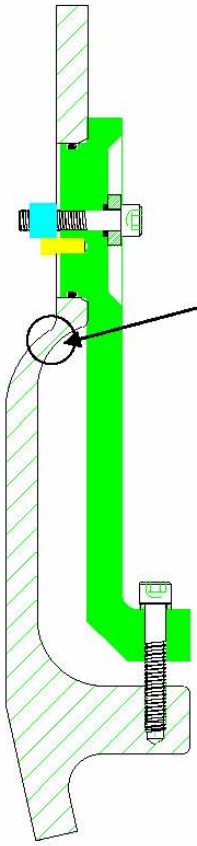
Side view of the reinforcement bracket

The reinforcing bracket requires drilling and tapping two 5/16" holes into the block near the motor mount directly below the center core plug hole. The upper part of the bracket installs into the core plug hole after removing the plug. This causes the bracket to span the thinner section of the block thereby adding strength to the area.

The bracket is held in place by two self locking clamping tabs that rotate into place behind the inside wall of the block when the socket head cap screws are tightened.

Tightening of the lower bolts creates the clamping load that adds strength across the thinner area of the block.

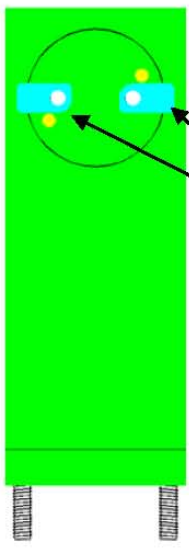
What we have concluded is interesting. First we have found no sign of a casting flaw. What we did find is the area that cracks is thinner than the surrounding cast iron to the extent that it is the thinnest part of the entire side of the block. The thin area was caused by a slight vertical core shift. This is a very common problem with casting complicated parts like cylinder blocks and heads. It only became an issue in this case because of the shape of the outside wall of the block. Just below the core plugs (freeze plugs) the side of the block turns under and then goes straight again. The area that turns under is close to a 45 degree angle. If the core shifts upward this area gets thicker and if it shifts downward the area gets thinner but everything else stays the same.

The problem for the 5.9 #53 Cummins engine blocks occurs during the warm up period and not during high load periods. Heat causes thermal expansion. Thermal expansion can develop enough pressure to cause cracks in cast iron. We see it frequently. If the cylinder walls get hot faster than the lower section of the outside wall of the water jacket, strain will occur because all of these parts are connected together at some point. The passenger side of the block has less mass and is therefore not as strong as the driver's side of the block.

Thin area where cracks generally occur

We have developed a bracket that is easily attached to the side of the block to add additional strength to the area where the cracks form. The bracket can be added to a block to prevent a crack from forming. However, it is impossible to tell if a crack has started to form on the inside. We have seen cases where there are small cracks that have started on the inside that had not yet propagated through to the outside. We have not yet seen any cases where a crack has formed after the bracket has been installed but need to caution you that it could occur. If it does, the bracket can be easily removed, the crack stitched and sealed, and then the bracket can be reinstalled. This would require disassembling the turbo and exhaust manifold from the engine again.

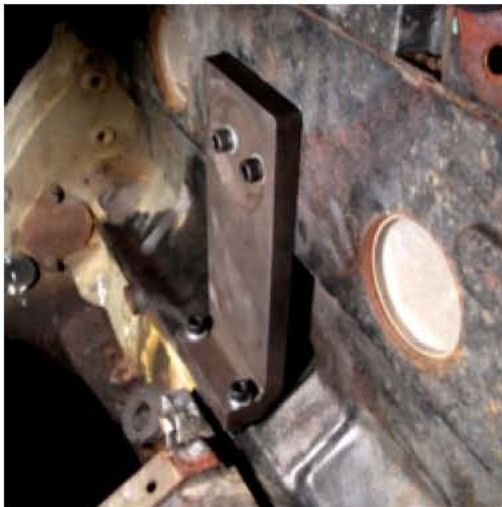
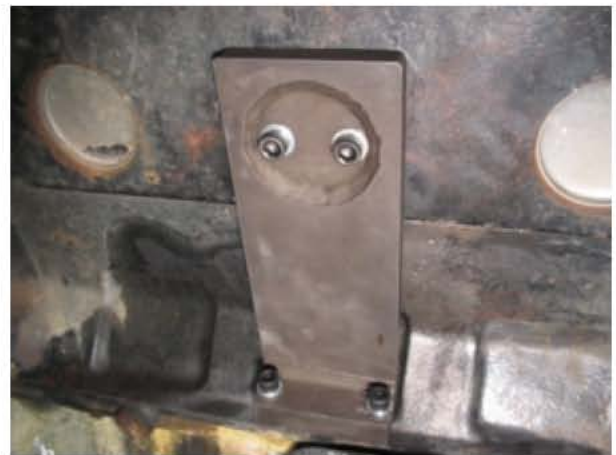
Back view of the reinforcement

Clamping Tabs
