Cooper-Bessemer LSV reconditioning guidelines

Restoring the block, liners and cylinder heads to factory relational dimensions Understanding the dimensional relationship of the wear surfaces of the head, to the liner, to the block

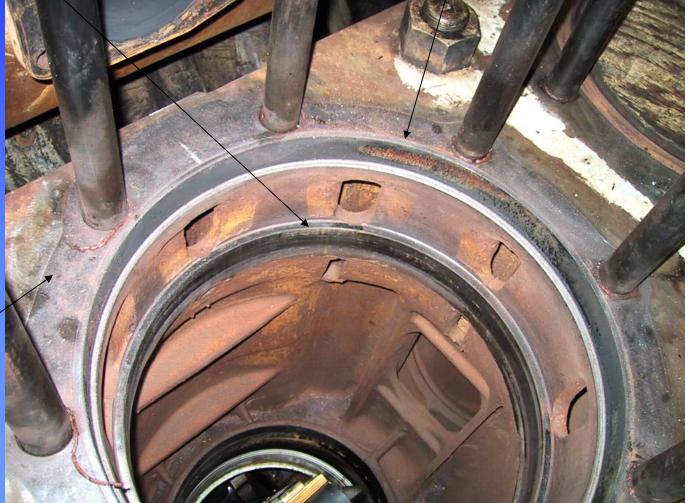
Liner height registration step.

Outer head gasket seal surface

This wear pattern where the cylinder head has been contacting the deck surface indicates that the liner was sitting below the fire deck surface.

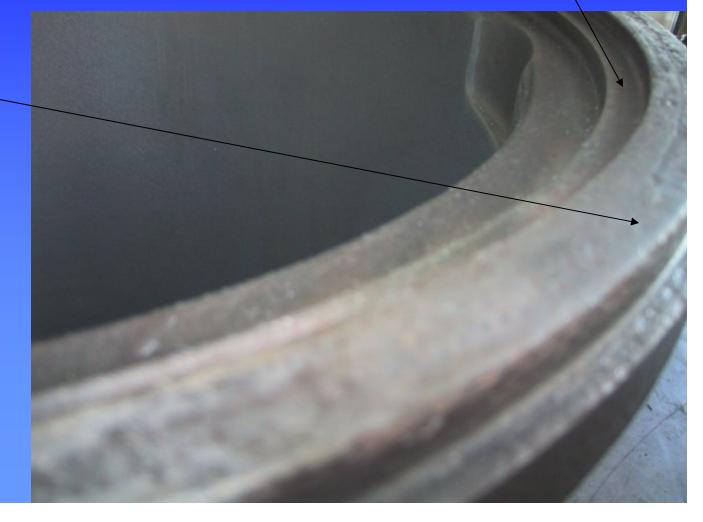
Inner head gasket seal surface

Intermediate head gasket seal surface

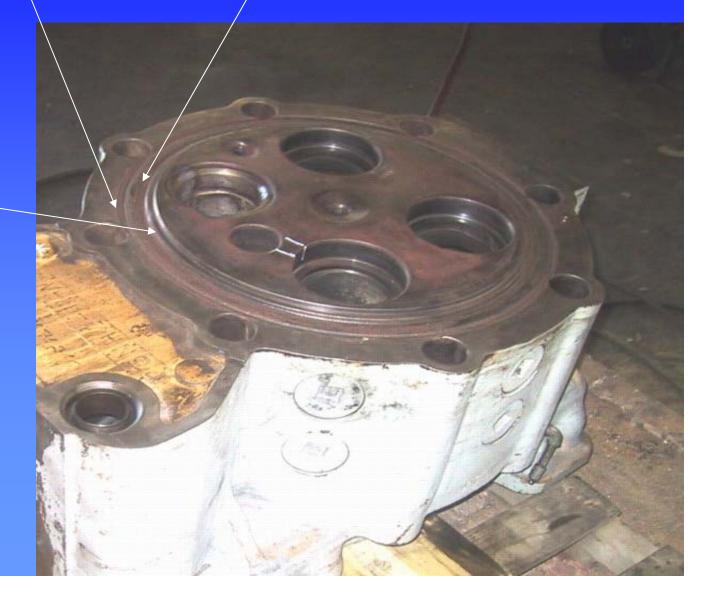
Outer gasket groove

Intermediate gasket groove

Inner head gasket surface
