Cracked boat engine block

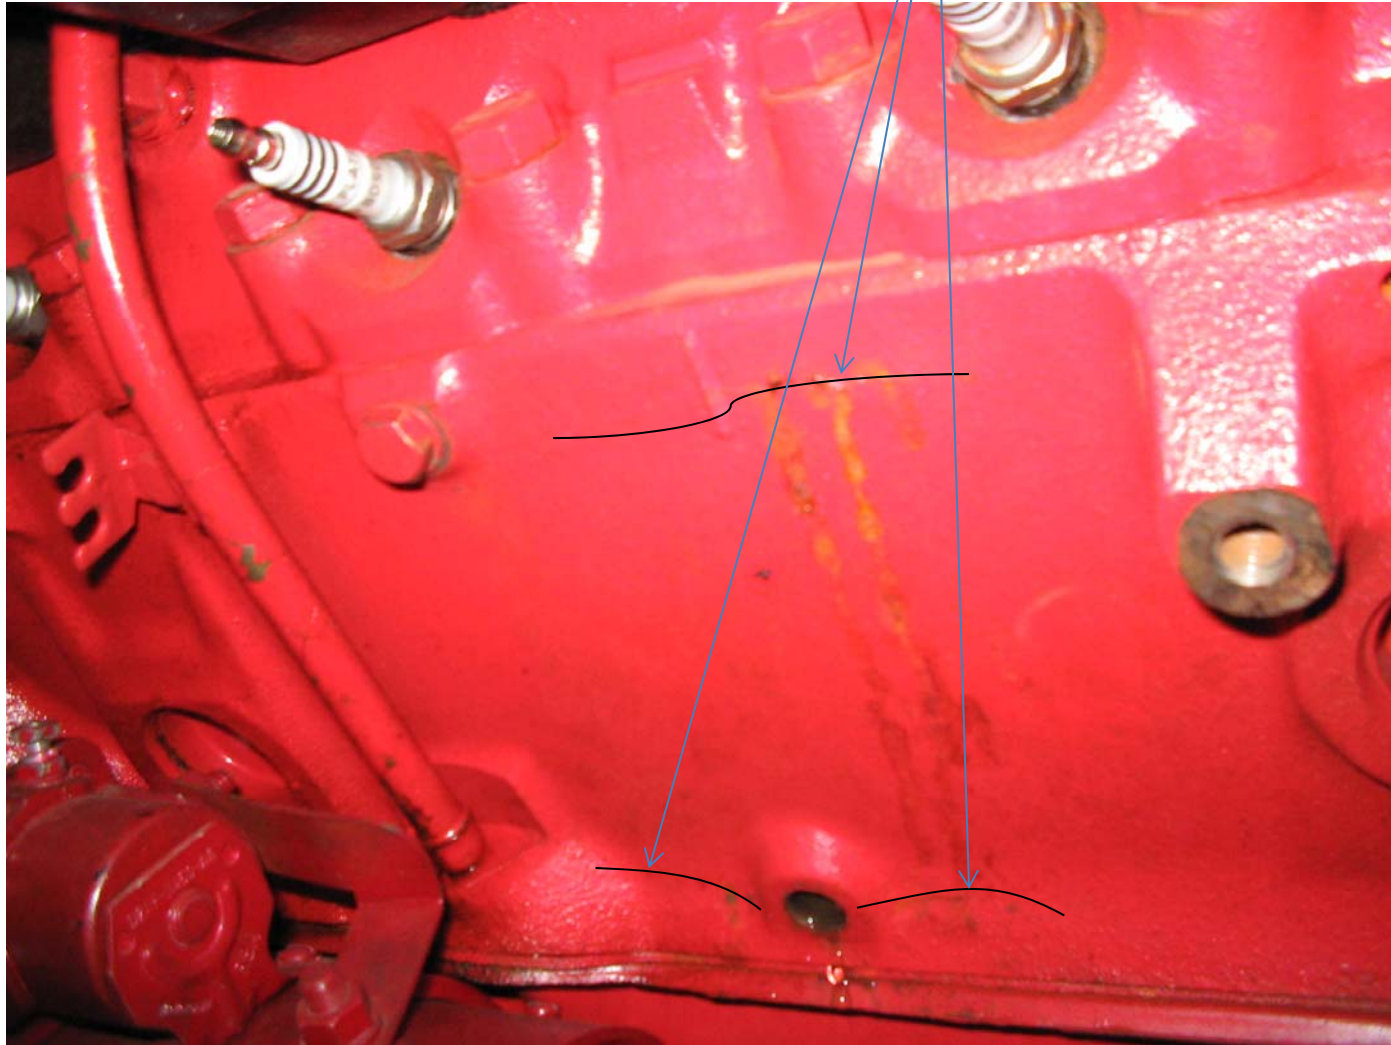
Cracks
