Compressor cross-head guide bolt hole repairs with Full-Torque thread repair inserts

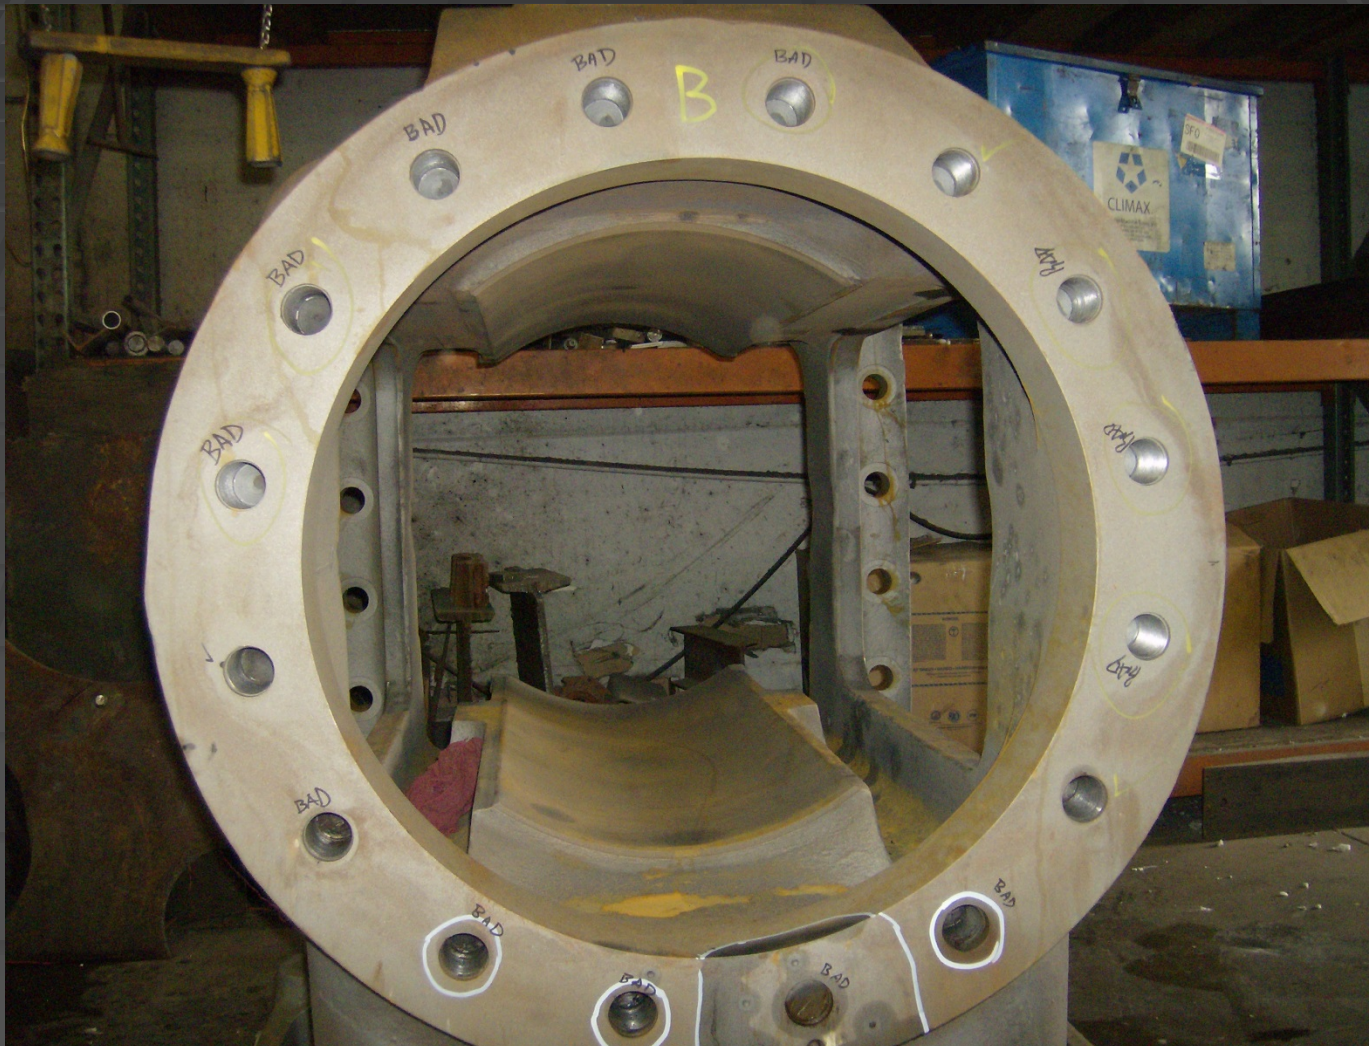
Failed prior repair attempt

- Bolt hole pull-out due to poor stud design

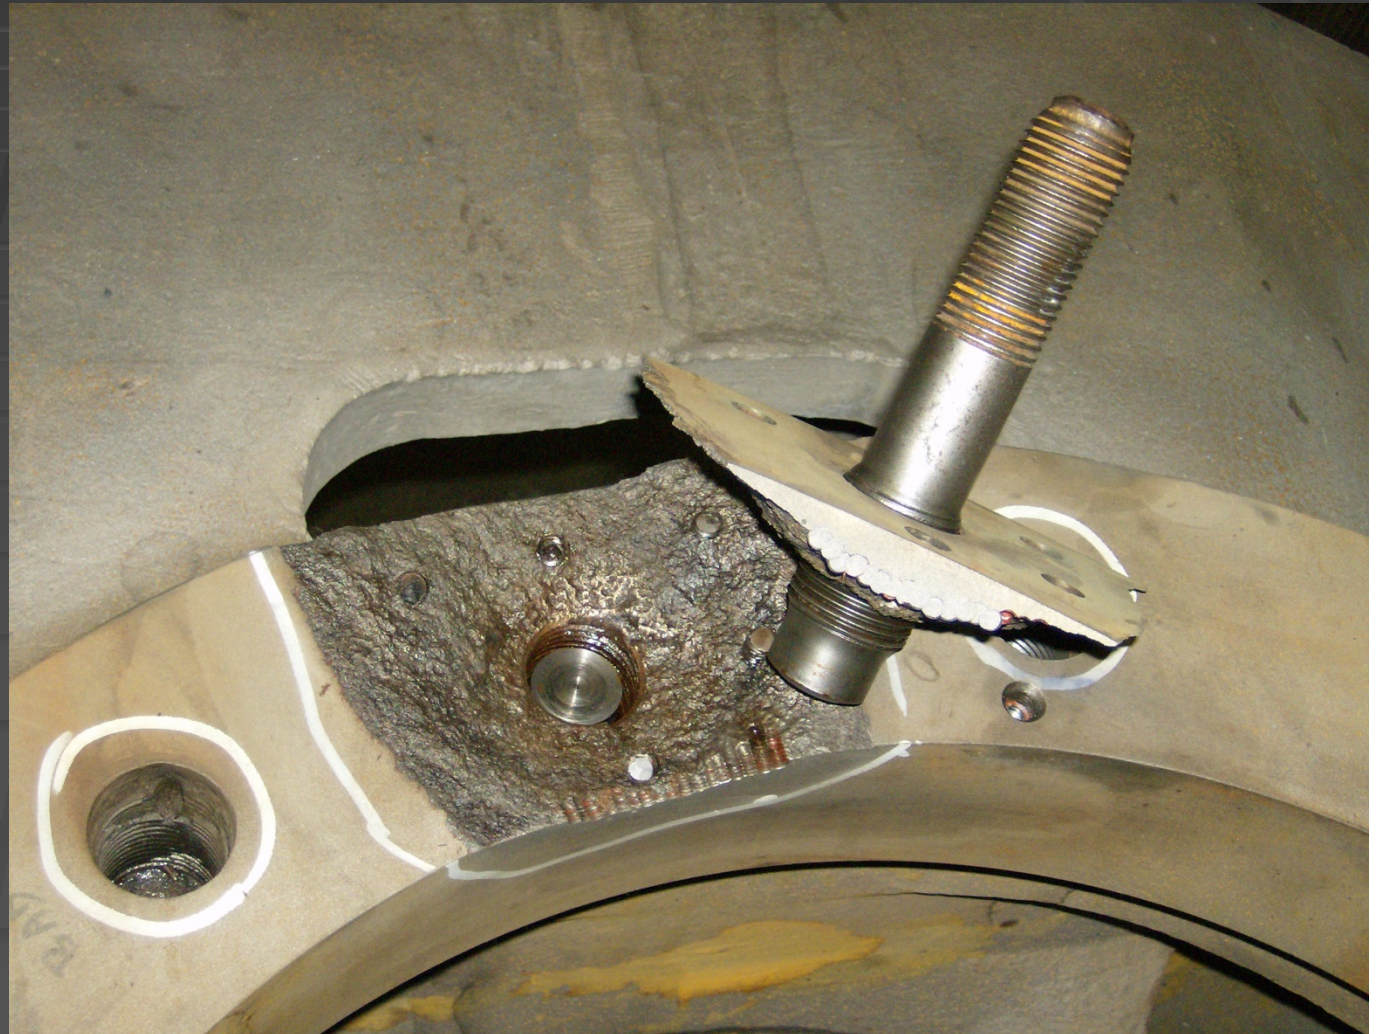
Multiple damaged bolt holes

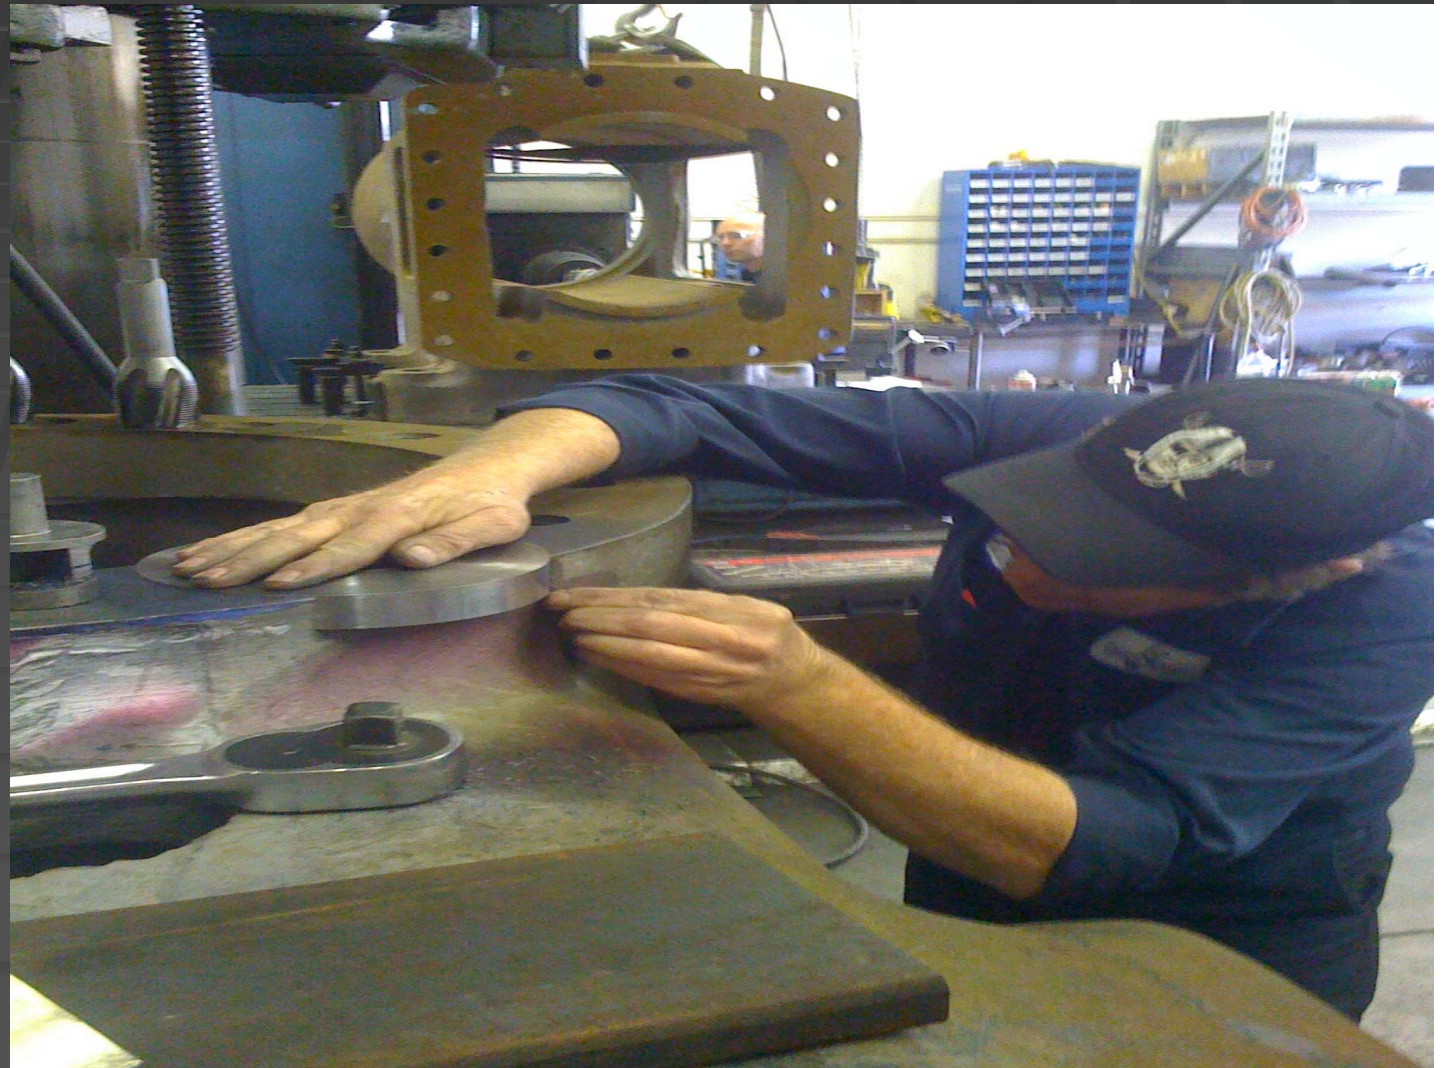
After the plates are stitched in to fill the voids the bore and face are machined

- Full-Torque inserts are installed to increase the strength of all of the bolt holes to make them stronger than the bolts

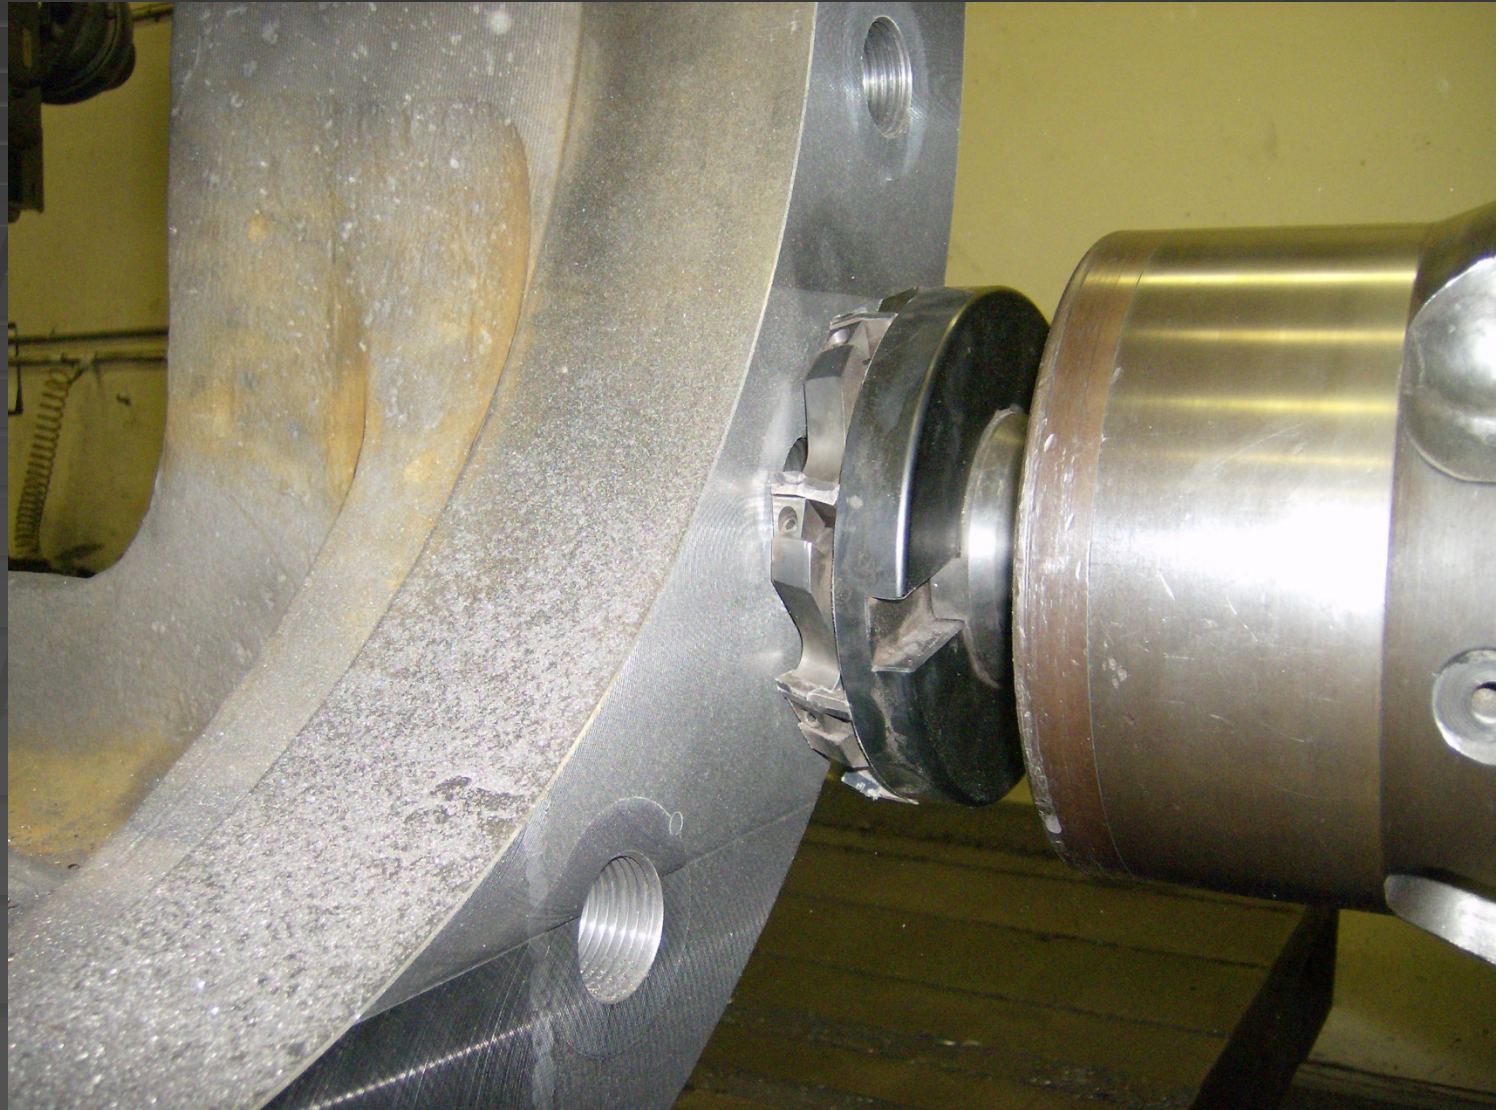
Completed repair is now stronger than new
