### Crusher bowel Crack repair

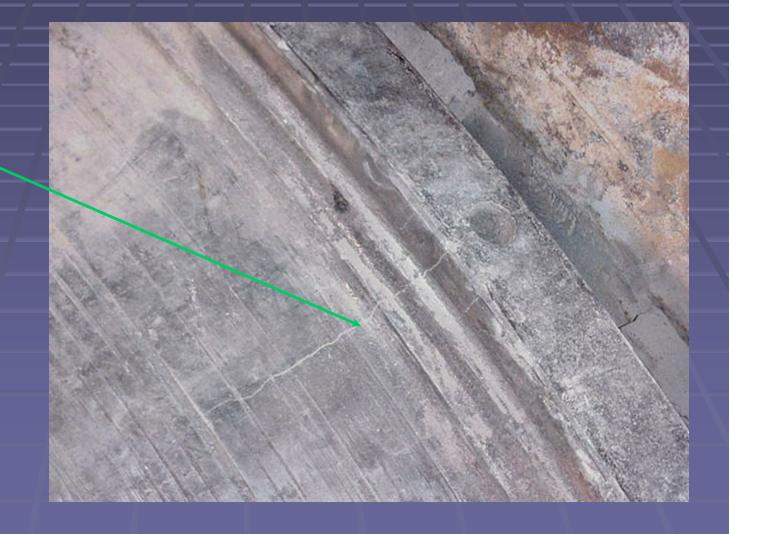
10" long by 6" thick

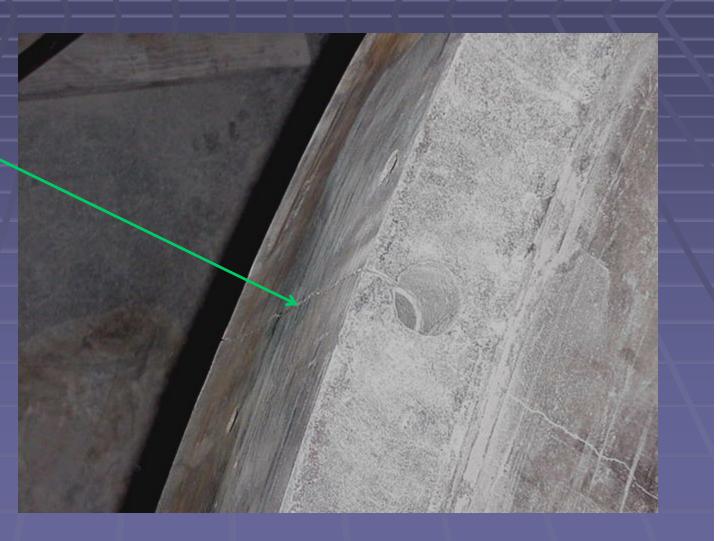
# Crack extended through the outer flange

Crack
extends into
the through
bolt hole

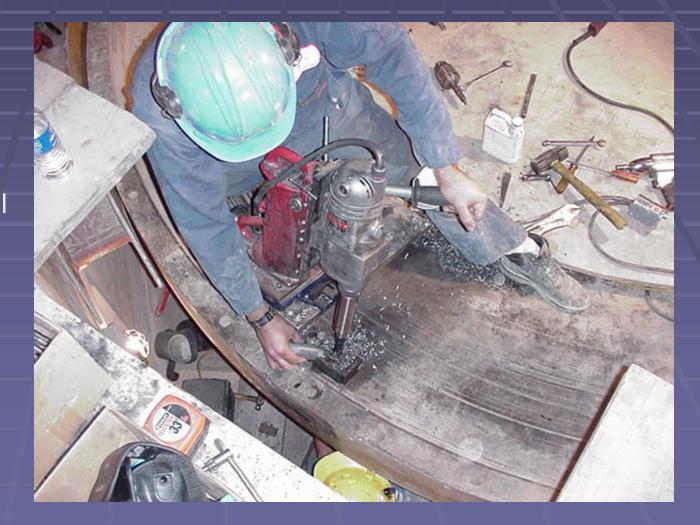
### Drilling the receiving patterns for L60 locks

A portable Magnetic base drill is used to drill the large holes through the precision drill fixture

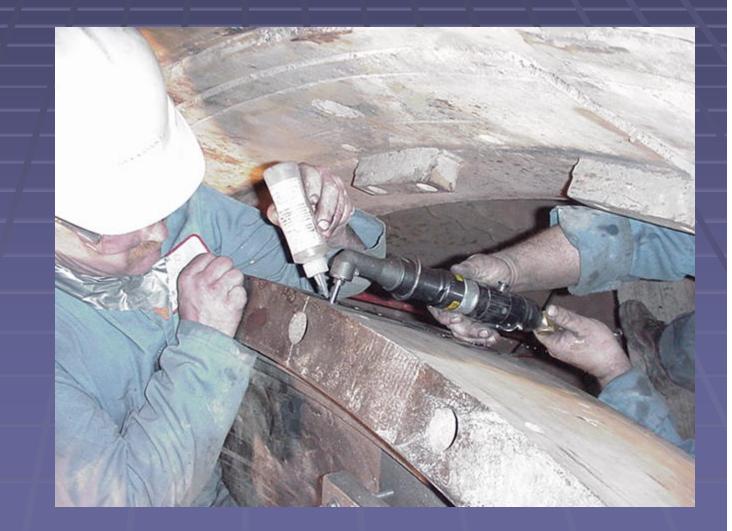
## The crack is metal stitched using special right angle tooling

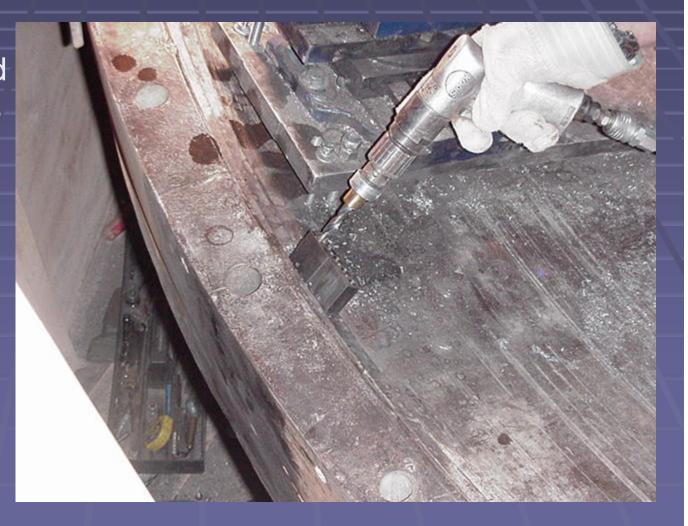
#### Smaller lock patterns are drilled

Hand held drill fixtures are used for smaller locks

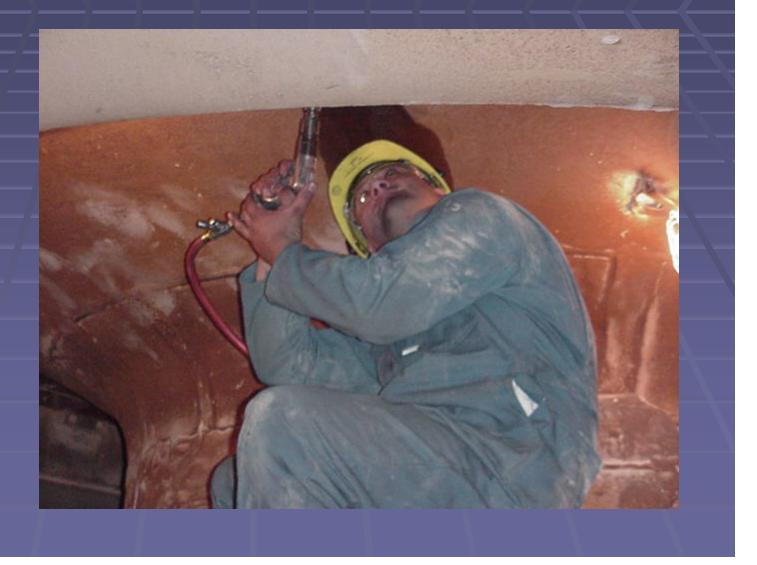
### The crack on the bottom side is metal stitched

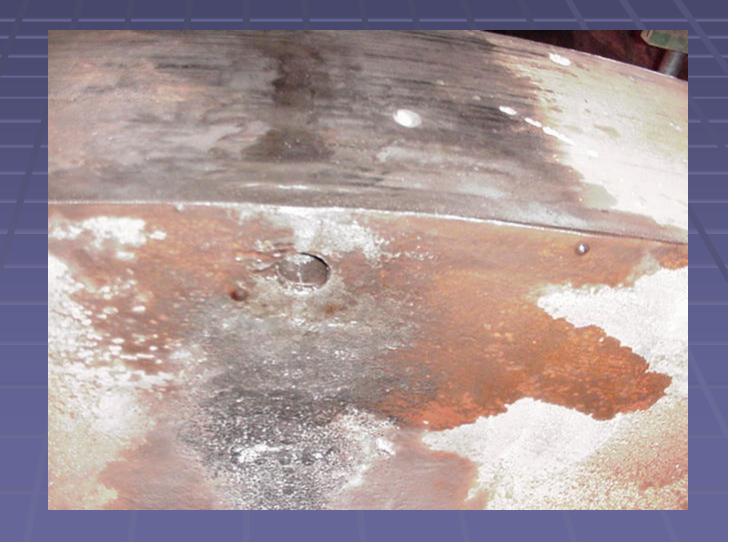
## Metal stitching on the bottom side is completed

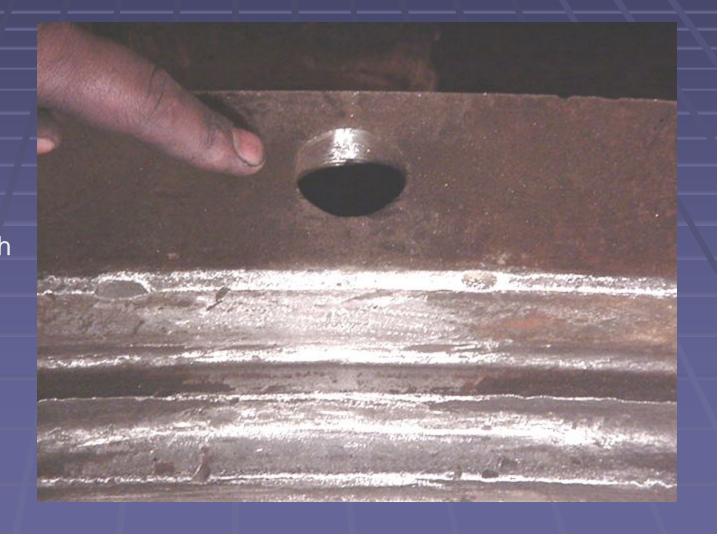
#### The top side metal stitching is completed

The crack is completely removed and replaced by interlocking and overlapping stitching pins with locks for extra strength

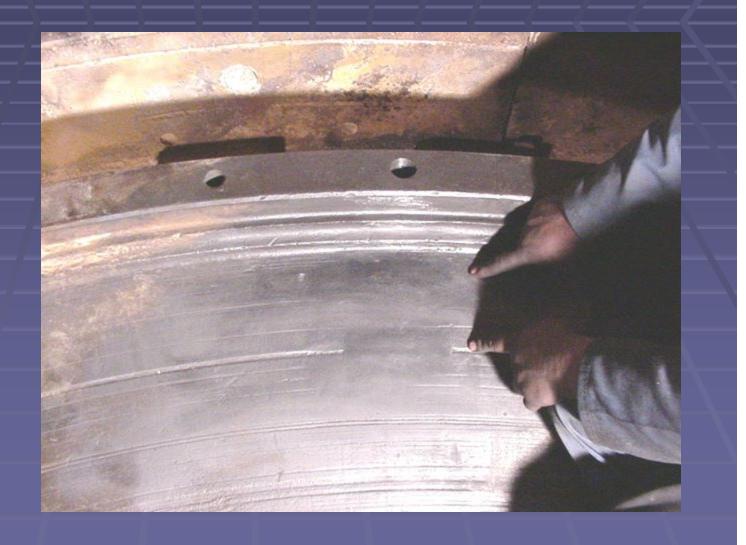
### Finished repair
