CHEVRON RICHMOND P6 PUMP AT 21 PUMP STATION

Scope of work

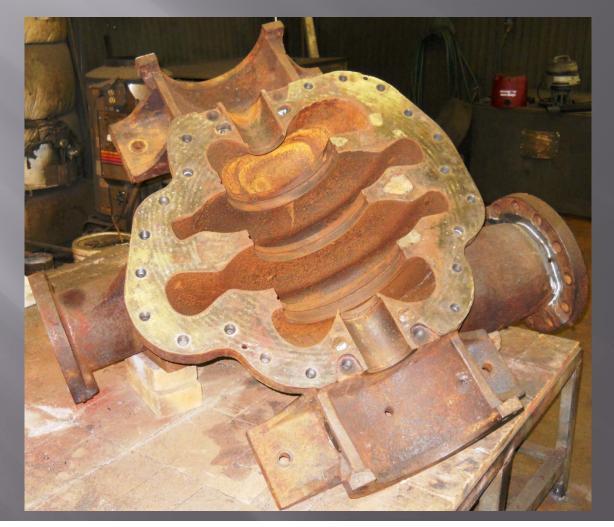
P6 Pump prepped

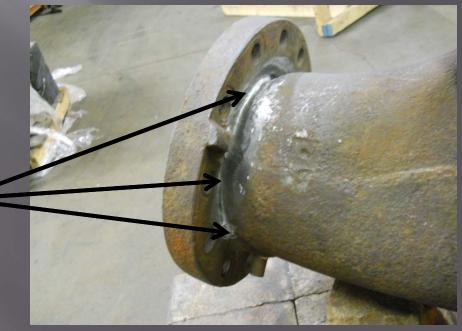
Pump positioned to be Furnace Brazed

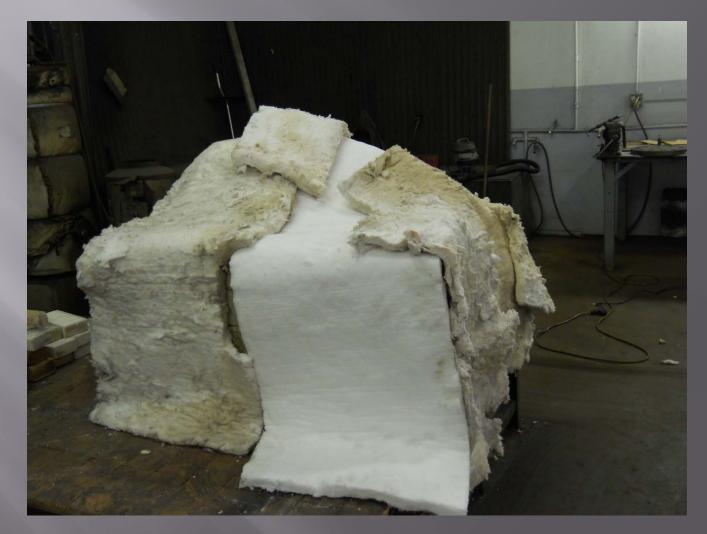
1200 degree pre-heat

We have been using this process for over 40 years with 100% success. The part is pre-heated to 1100-1200°F until the entire casting temperature is uniform. While in the oven it is brazed with an acetylene torch. This requires heating the area to be brazed to 1750°F. The part is not removed from the oven during the brazing process.

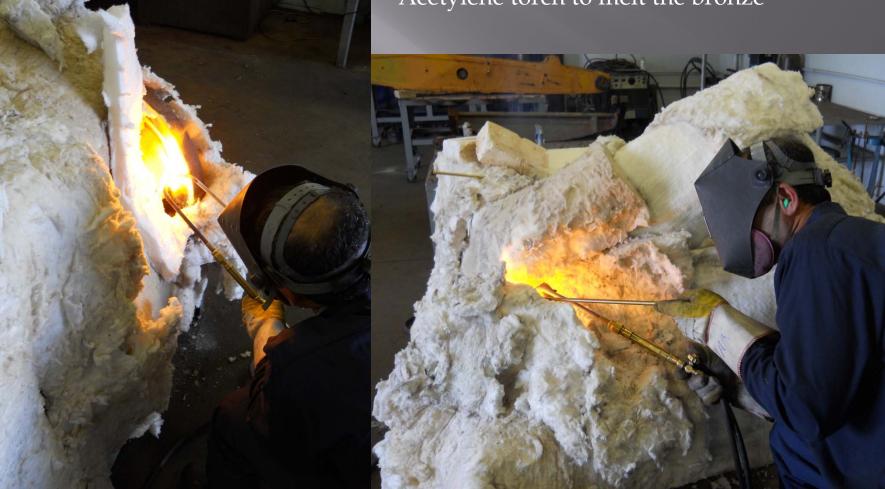
Post Weld

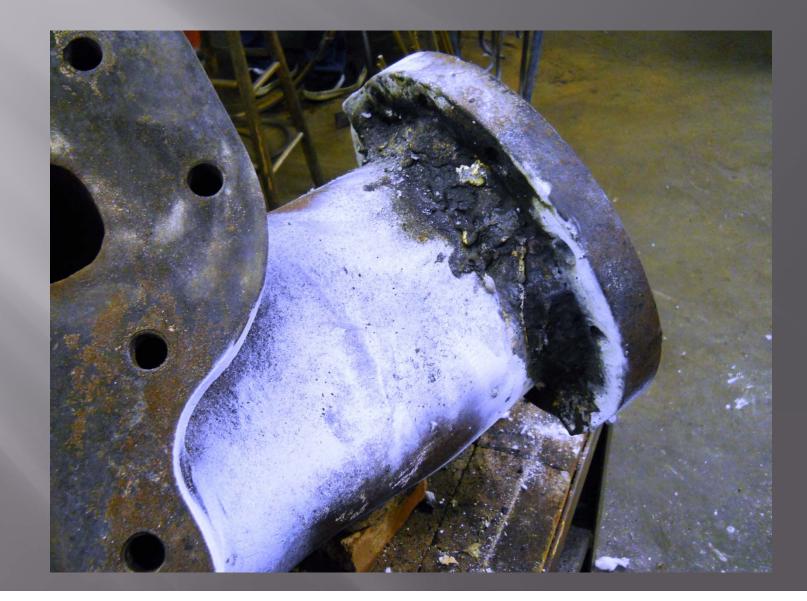
After hand finishing the repair

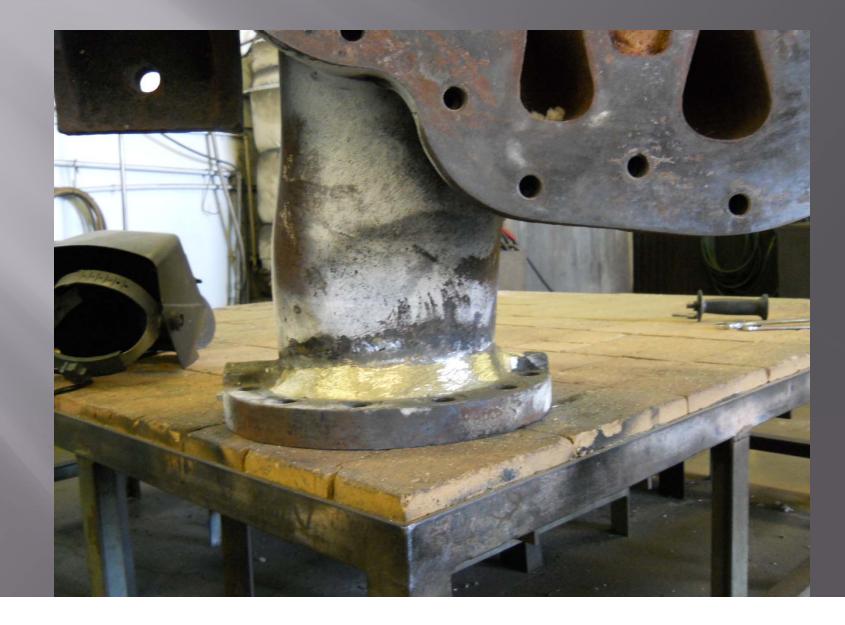
Machined Flange

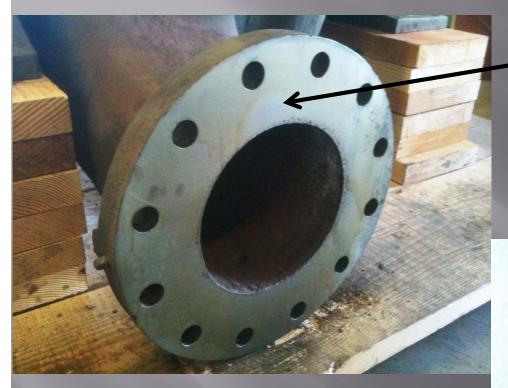
Machined flange ready for assembly

The repair on the cracked flange is - complete.

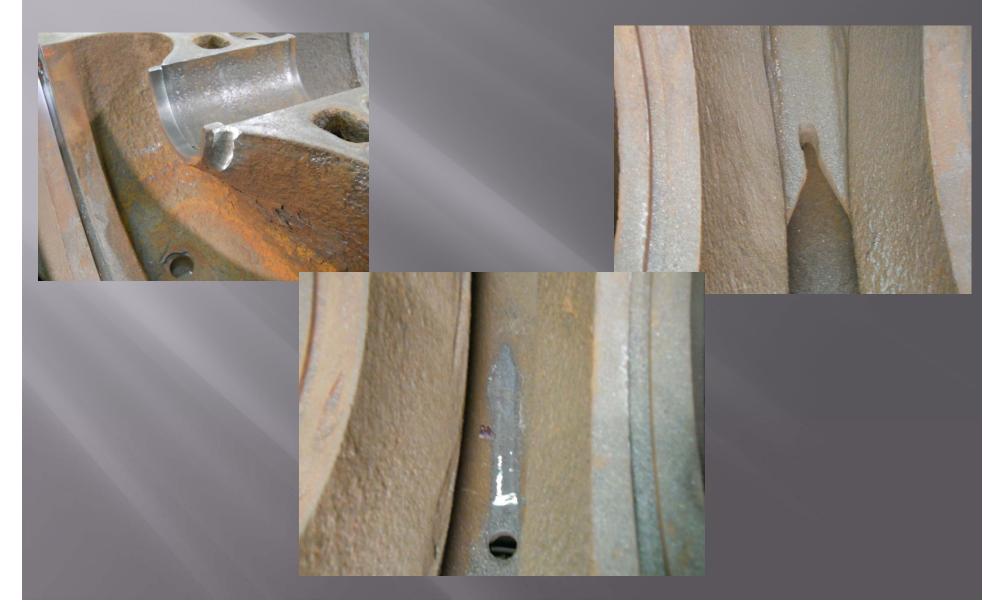
Additional damage discovered

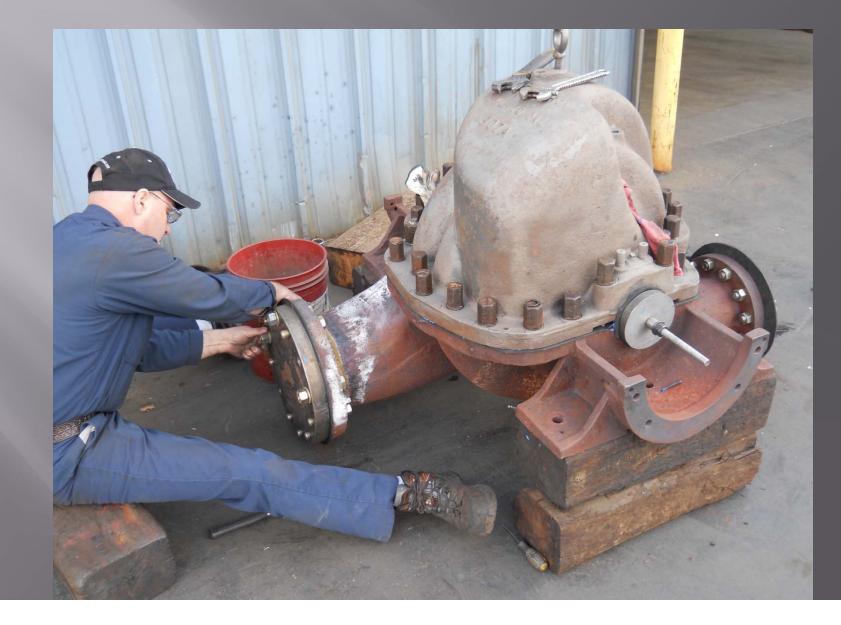
Getting ready for Hydro Testing

Hydro Test Report

On 2-29-12 Hydro test was done by Alaa Al'Robaie, Brian Schoppet of *LOCK-N-STITCH* Inc. and Rob Wieben of Chevron, Richmond, CA.

Hydro test was done at 400 psi for a duration of one (1) hour. No leaks where present during this time.

The test was verified by Rob Wieben on 2-29-12
