Crack on side of diesel engine.

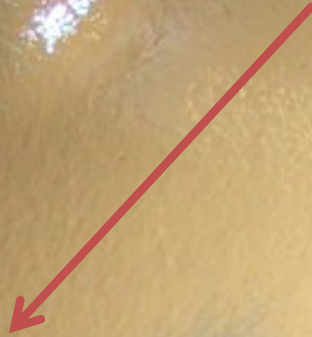
Using spacing jig to space the stitching pins

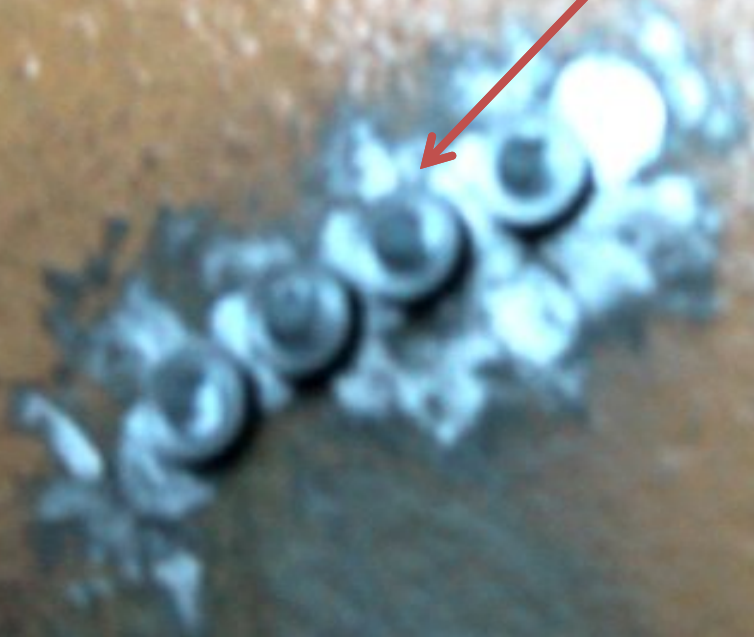
Stitching pins installed in continuous row  
of overlapping pins.

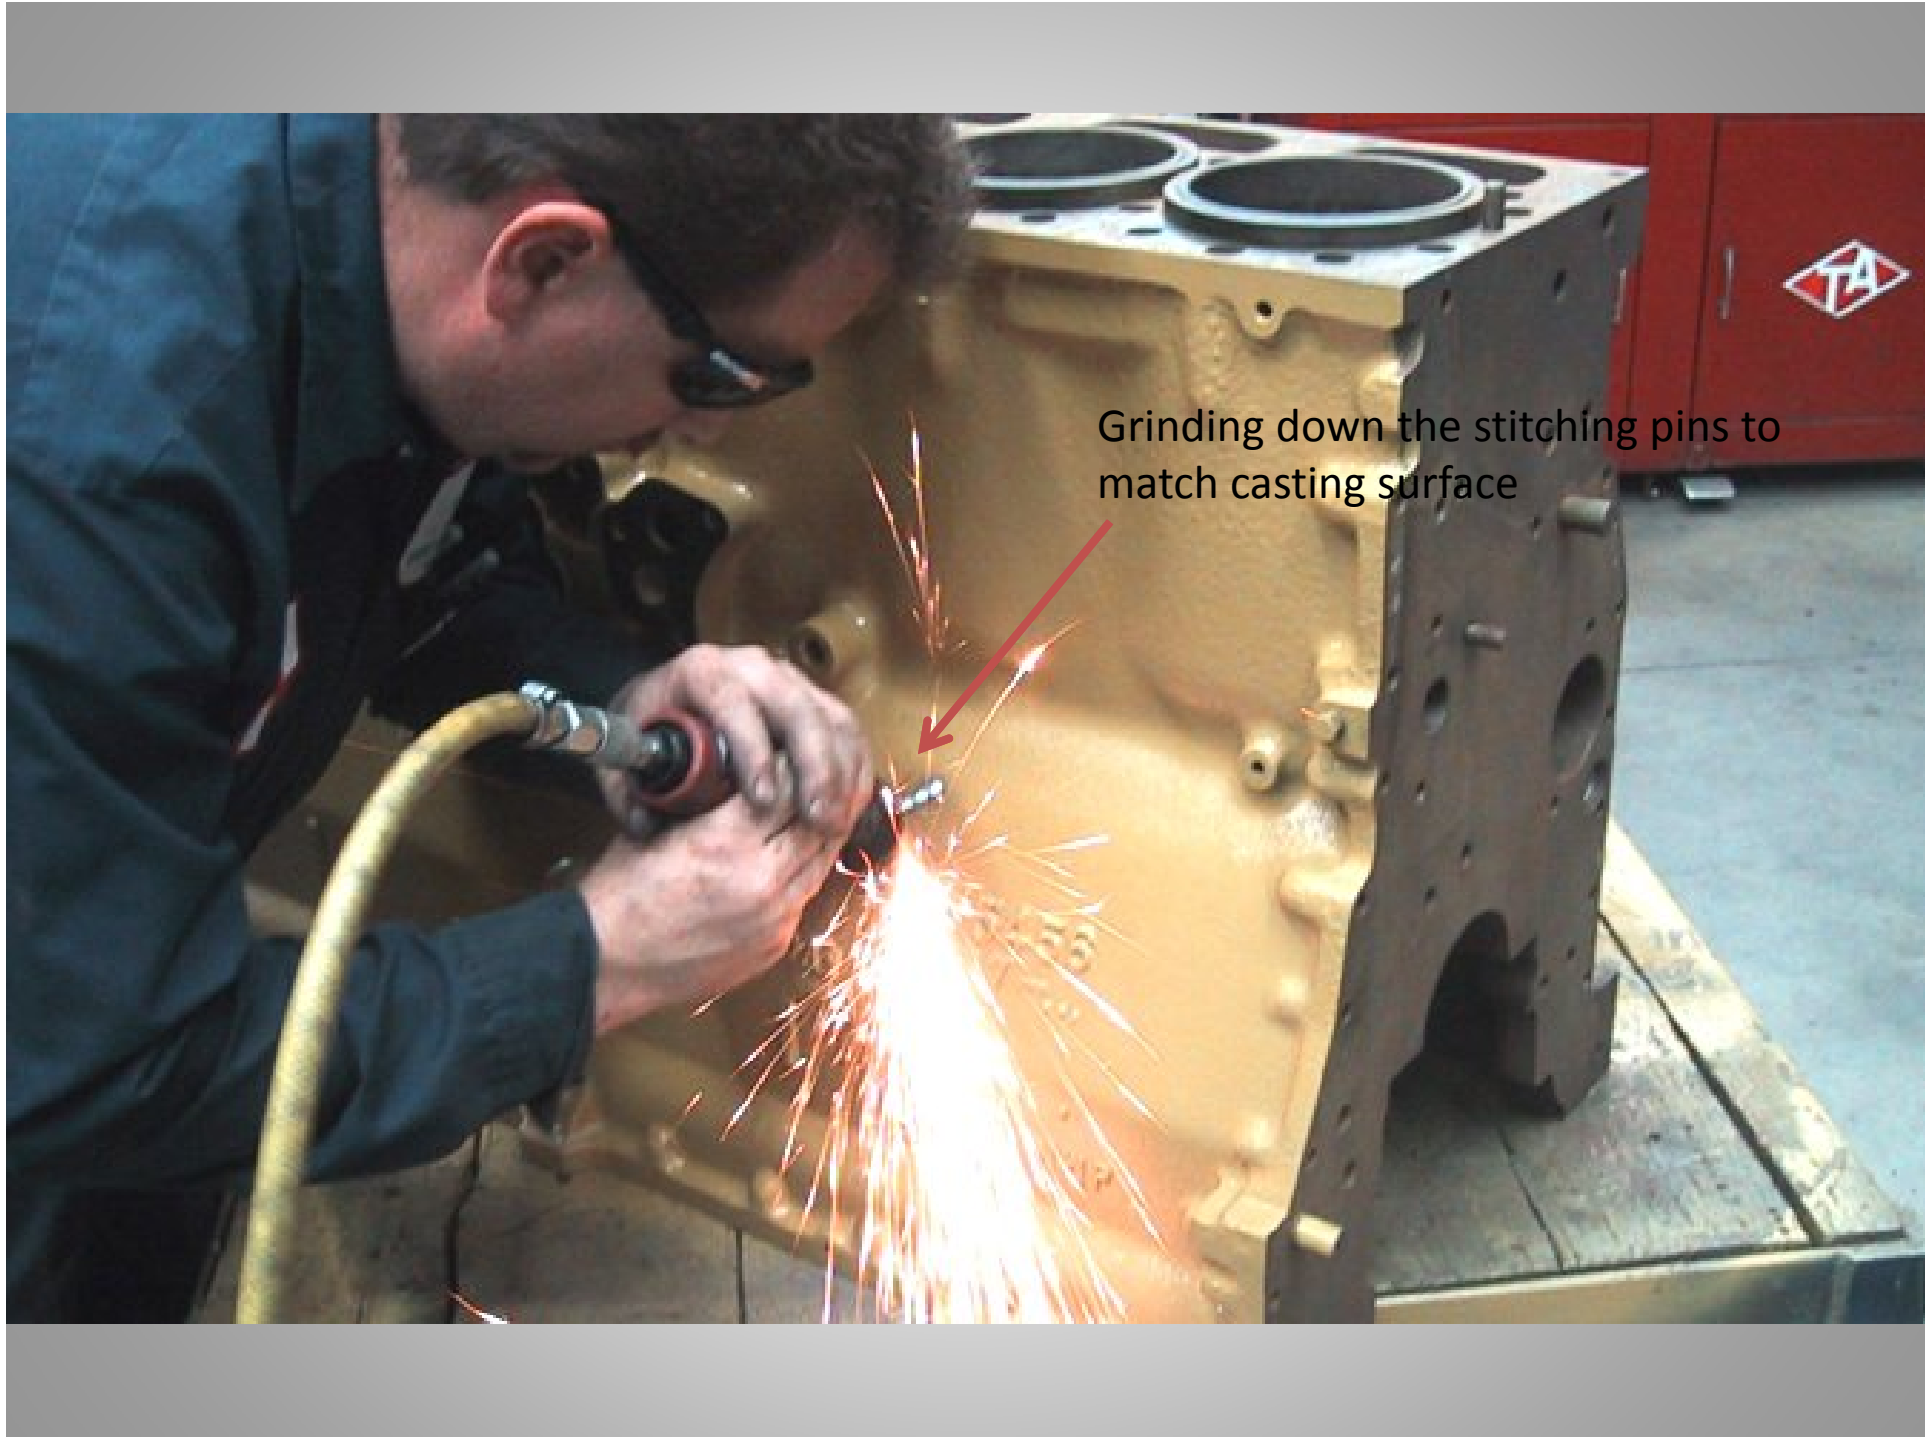
Grinding down the stitching pins to match casting surface
