Cooper Bessemer LSV 20 Crankshaft repair

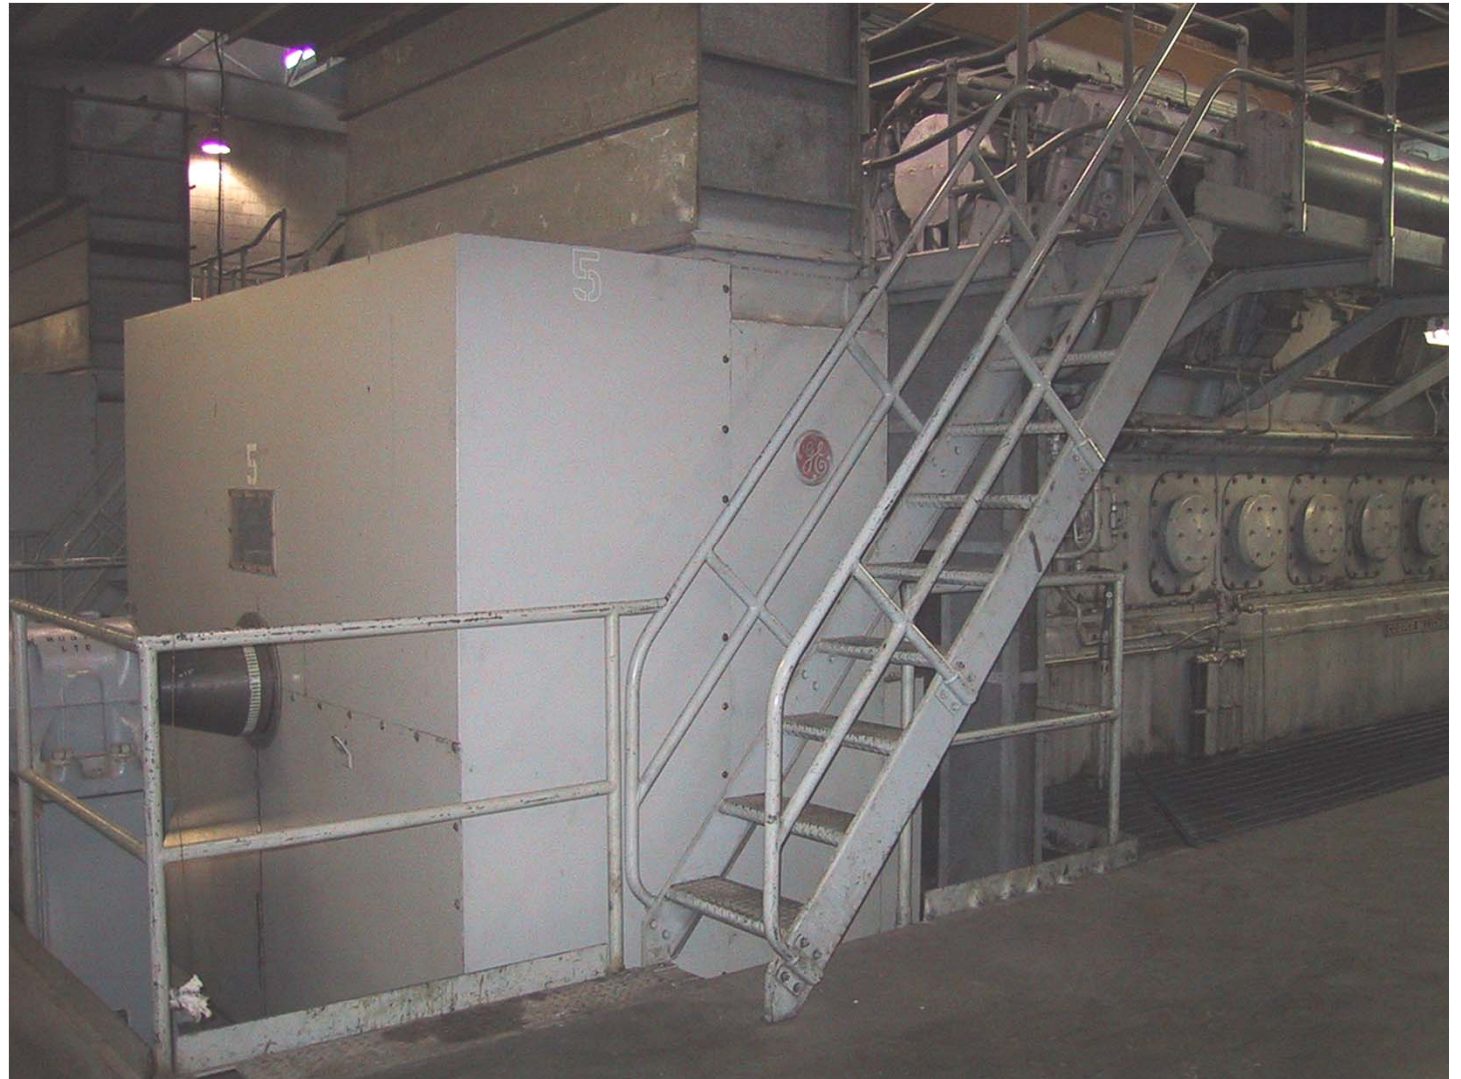
Assembly is complete and the unit is placed back on-line

This repair was performed
in the summer of 2000
and is still in service today along with
three others that LNMS has repaired
with the same type of cracks
