Repair Final report

DIESEL GENERATOR # 4
CYLINDER UNIT # 3

Scope of work for metal stitching and machine work for GMT- Sulzer 8 ZAL 40 S

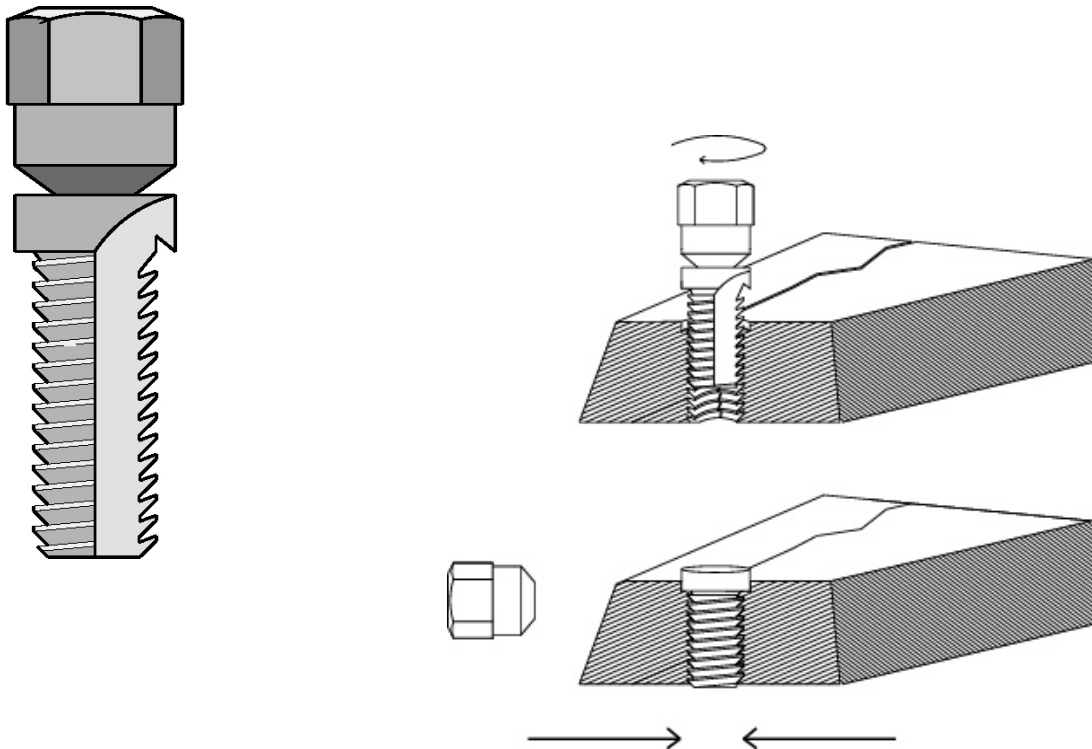
CASTMASTER® Stitching Pins

CASTMASTER stitching pins have the unique ability to draw the sides of a crack together when tightened into the drilled, Spotfaced and tapped hole.
