Drilling ship

Repair completed by *LOCK-N-STITCH* Inc.

September 2012

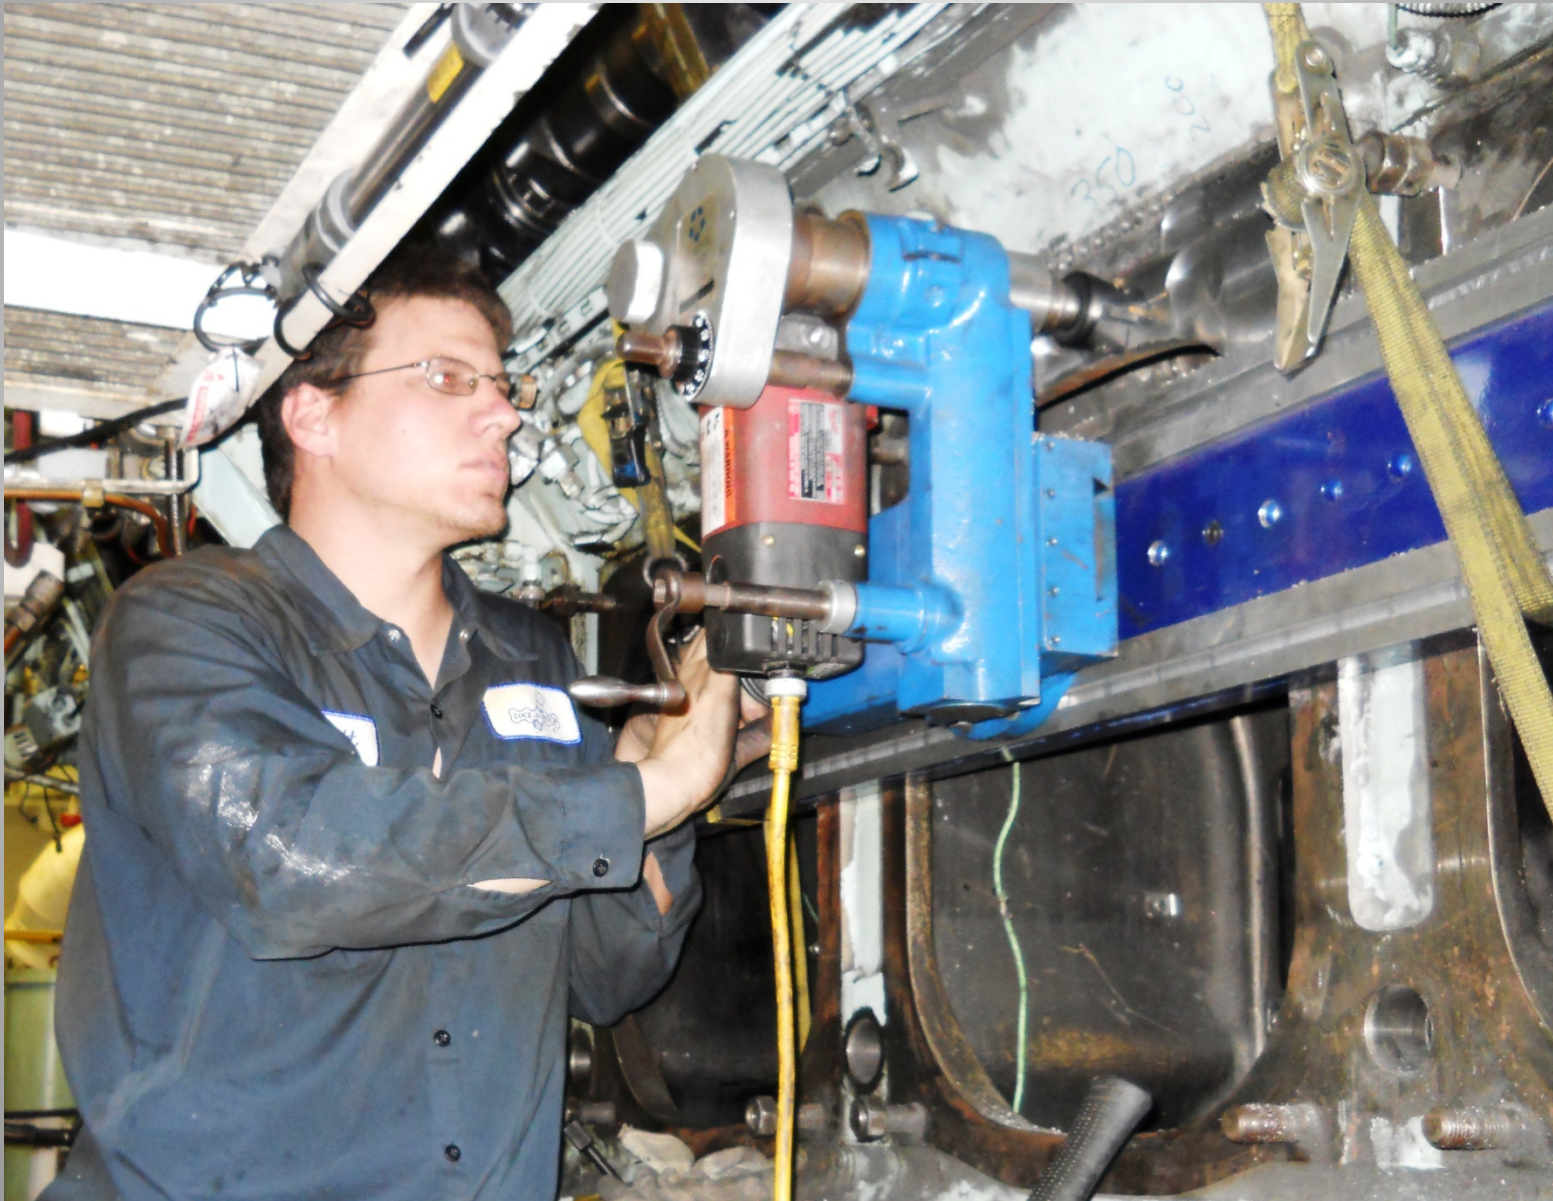
7' Climax bed Mill machining the gasket surfaces on the inspection door
