US Capitol Dome Metal Stitching Crack Repairs

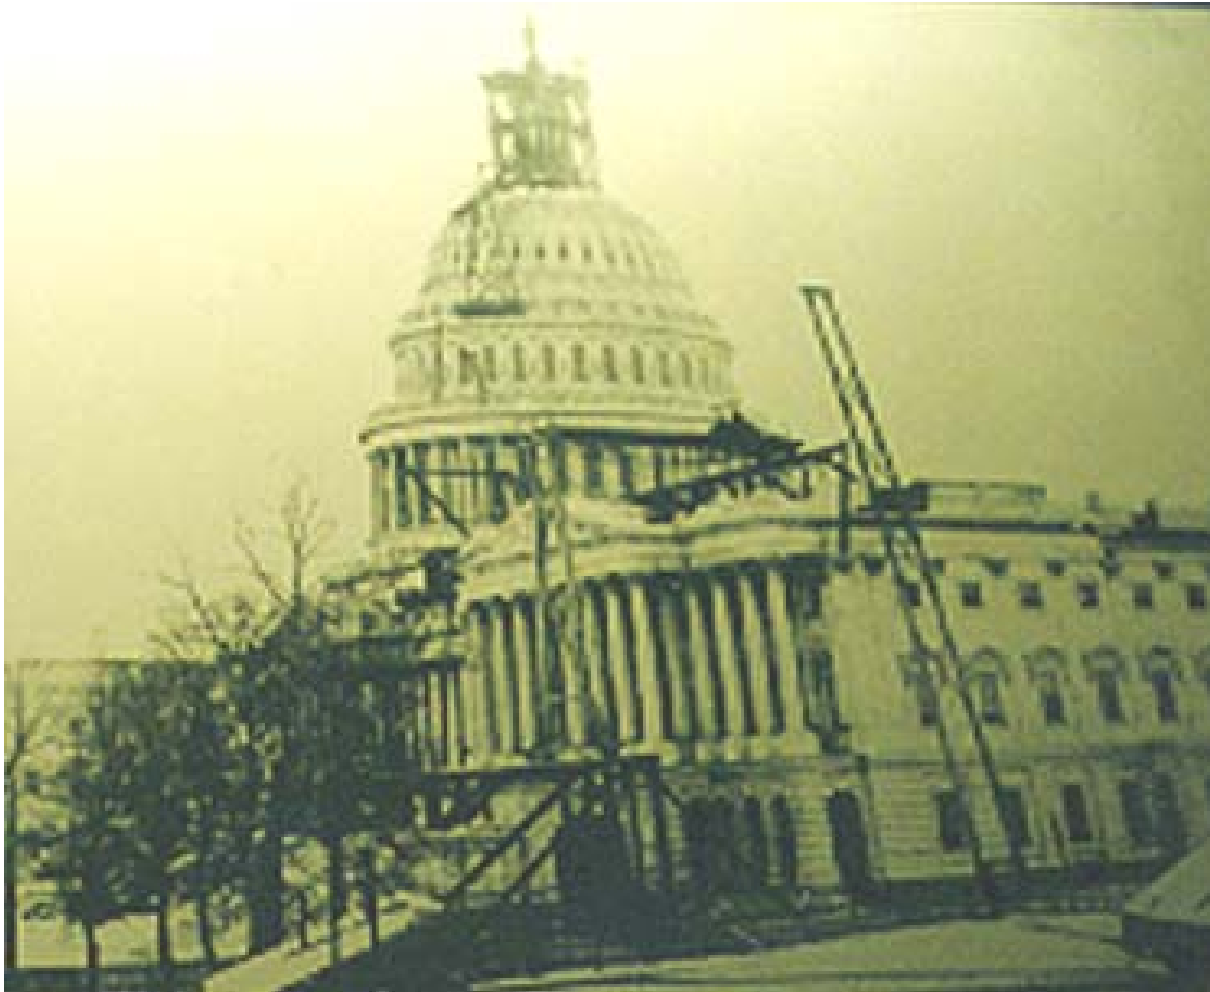
View of the damage before the repair demonstration began

This section of one of the ornate plate on the lower balcony was actually broken off
