Repairing a crack across the exhaust valve seat on a 2.5L GM cylinder head

This procedure has been approved by General Motors.

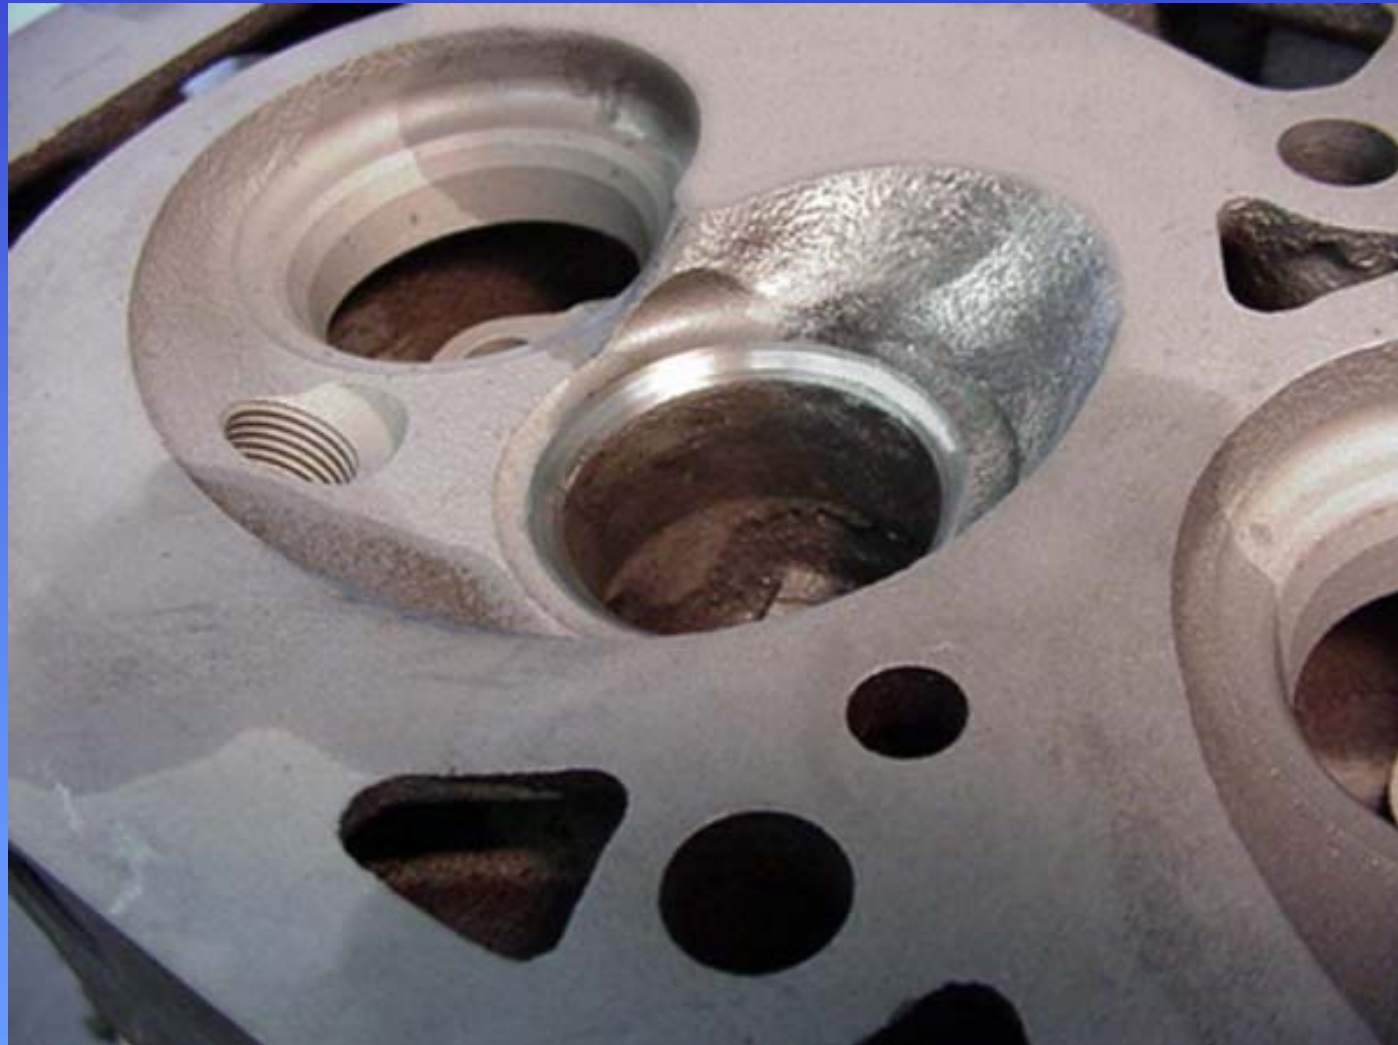
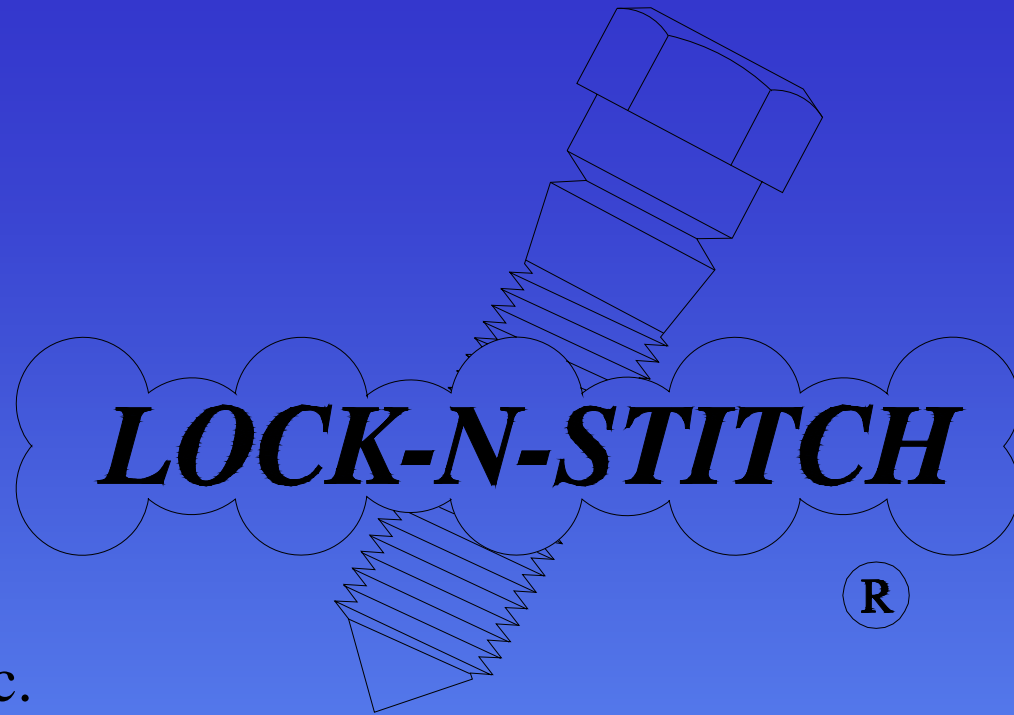
The repaired head should be pressure tested to 40 psi.

It is not necessary to install a hard seat insert even on the exhaust seat. A better repair can be made if you do not install a seat insert over the repair.
