Repairing an OMC marine engine damaged by freezing

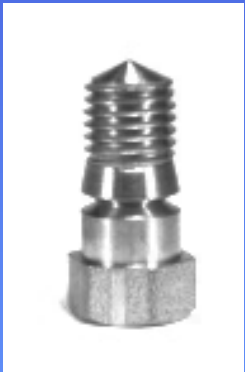
Four L6AS pins are used to secure the patch

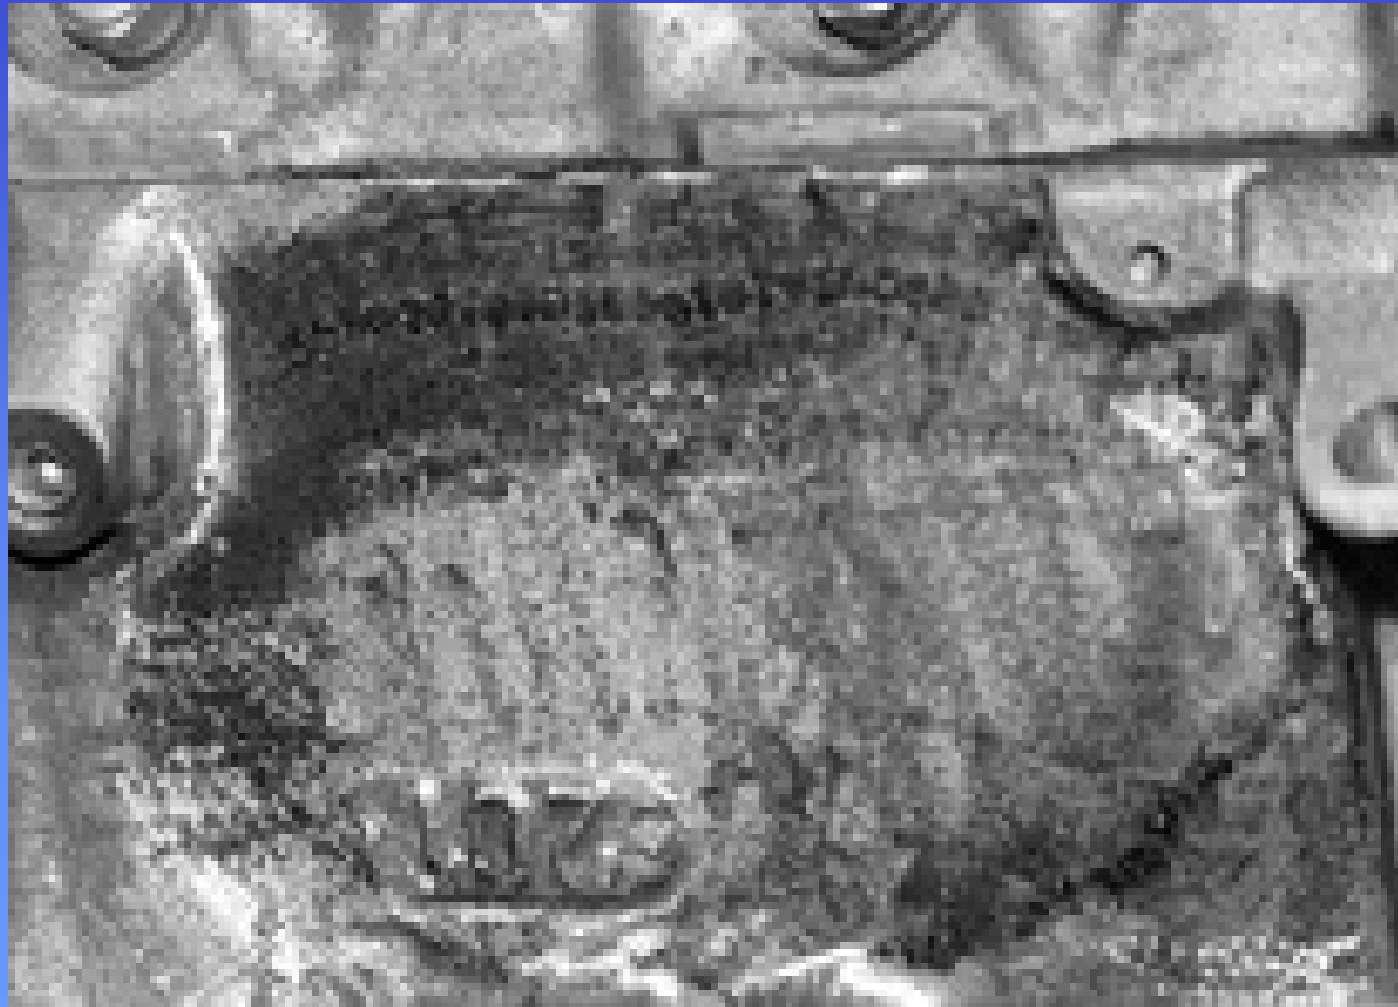
Installation of the pins continues until there are no spaces left

The pins must overlap each other. After all pins are installed and ground flush, the repair is pressure tested to check for leaks. If a leak is found, simply install another pin.
