MAN V18 Crack repair

Repaired July 2010

Scope of Work

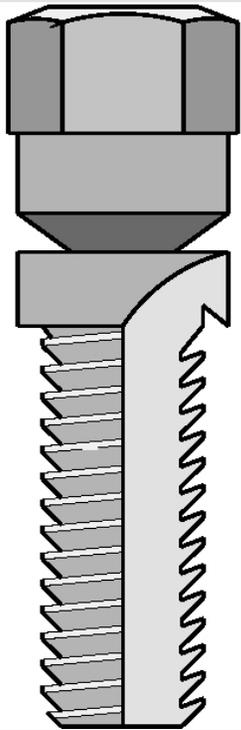
CASTMASTER® Stitching Pins

CASTMASTER stitching pins have the unique ability to draw the sides of a crack together when tightened into the drilled, Spotfaced and tapped hole.
